# A discussion on the collapse of four curtain beams on the Ellis Brown Viaduct – 23 June 2012

On the early morning of Saturday 23 June 2012, four curtain beams on the east (sea-facing) side of the Ellis Brown Viaduct over the Umgeni River at Blue Lagoon, Durban, became disconnected from the main structure and collapsed into the river.

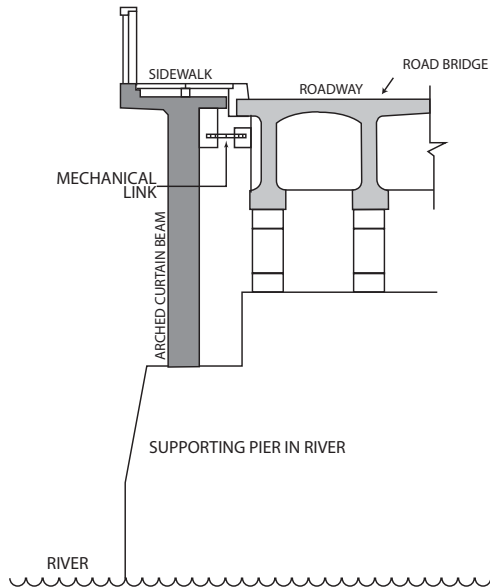
Figure 1a: Existing structural system

The existing structural system of the bridge consists of a pre-stressed concrete beam-and-slab composite deck supporting the roadway with an arched concrete curtain beam façade on the outer edges that forms the sidewalk and parapet. These beams are not connected rigidly to the main structure, but are held in the lateral direction with a series of mechanical links at seven points along each beam (Figures 1a and 8).

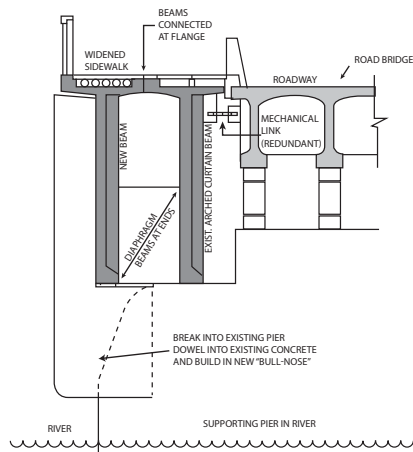
Figure 1b: Widened sidewalk as done on the western edge of the bridge

The recently constructed new cycle lane / widened walkway on the west edge of the bridge consists of an additional matching set of arched façade beams resting on an extension of the piers and have been rigidly connected to the existing curtain beams along the top flange, as well as at the ends with a concrete diaphragm, thus effectively making the structure self-stable and no longer reliant on the linking system to the main roadway bridge (Figure 1b).

The ideal solution would be to widen the sidewalk with an additional set of matching beams on the outside edge, as done along the western side of the bridge. This alters the structural system to one which is stable, independent of the main structure. The 'arched' sidewalk beams adjacent to one another and fixed to each other along the top flange, and braced at the ends with diaphragm beams form an upside-down 'U' beam. The metallic links causing the sensitivity of the structure to vandalism and corrosion are thus rendered redundant.

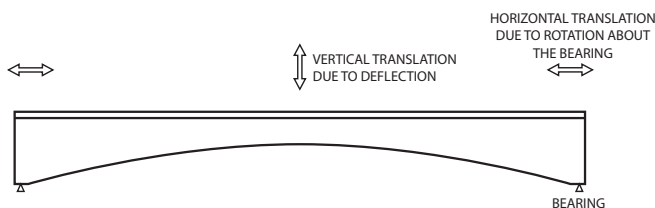
Figure 1c: Direction of freedom for hinges

part of a bearing or thrust of an arch. They are also limited to rotation in one direction only. The situation we are dealing with requires a hinge that must act in tension and allow translation in the vertical direction at mid-span of the beams and in a horizontal direction at the ends of the beams (Figure 1c). The horizontal movement required at the ends is as a result of rotation about the bearing, along with the normally expected longitudinal movements due to creep, shrinkage and thermal effects.

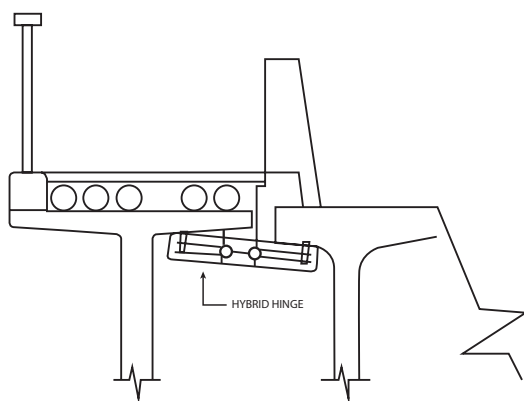
Figure 1d: A hybrid of the Mesnager Hinge is being considered

Currently, a hybrid of the Mesnager idea is being considered. Without revealing too much information about its weaknesses to vandalism, the idea is to cast a 'double-jointed' link in a polymer concrete encasement that could be fixed to the soffit of the

bridge deck and curtain beam flanges, allowing the connection to simultaneously operate in tension, as well as vertical and horizontal translation (Figure 1d).

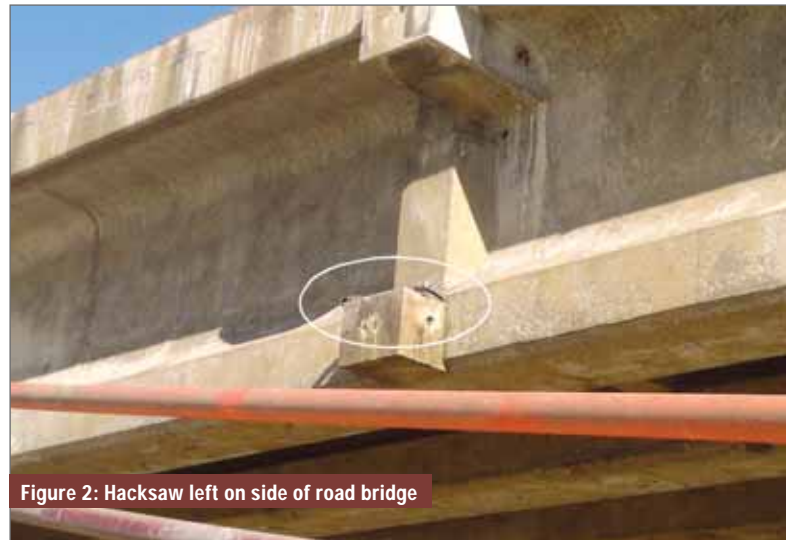
Figure 2: Hacksaw left on side of road bridge

Clearly, vandalism for scrap had resulted in the removal of a number of the original links, as well as the newly replaced links throughout the structure (see Figures 2 to 5 for evidence of such).

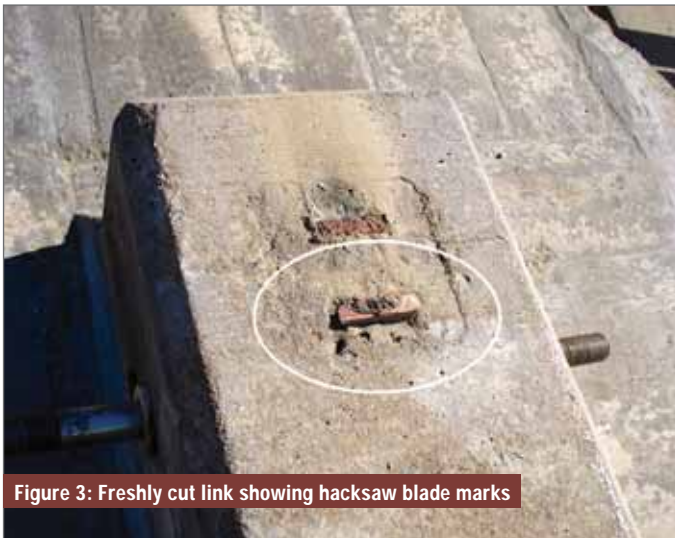
Figure 3: Freshly cut link showing hacksaw blade marks

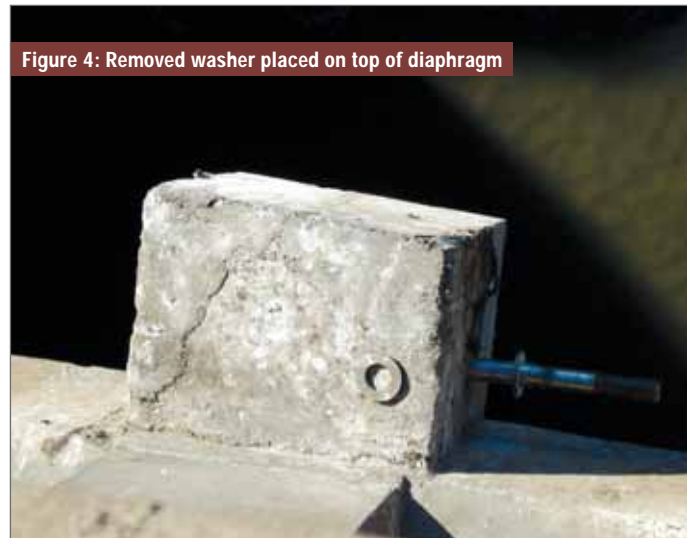
Figure 4: Removed washer placed on top of diaphragm

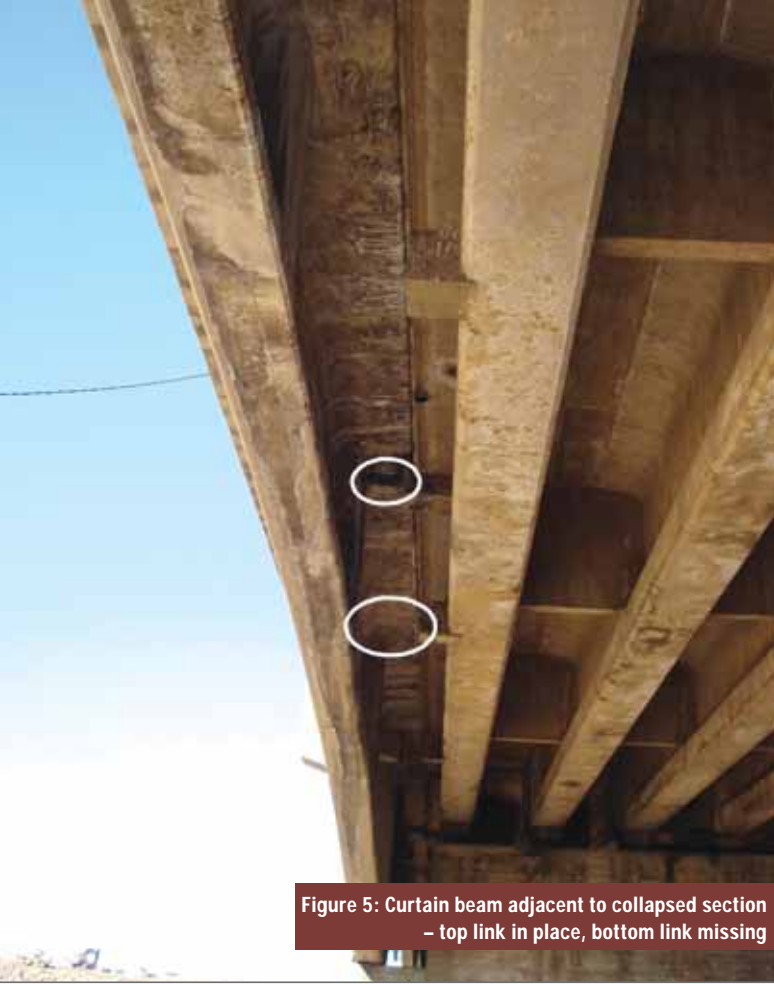
Figure 5: Curtain beam adjacent to collapsed section – top link in place, bottom link missing

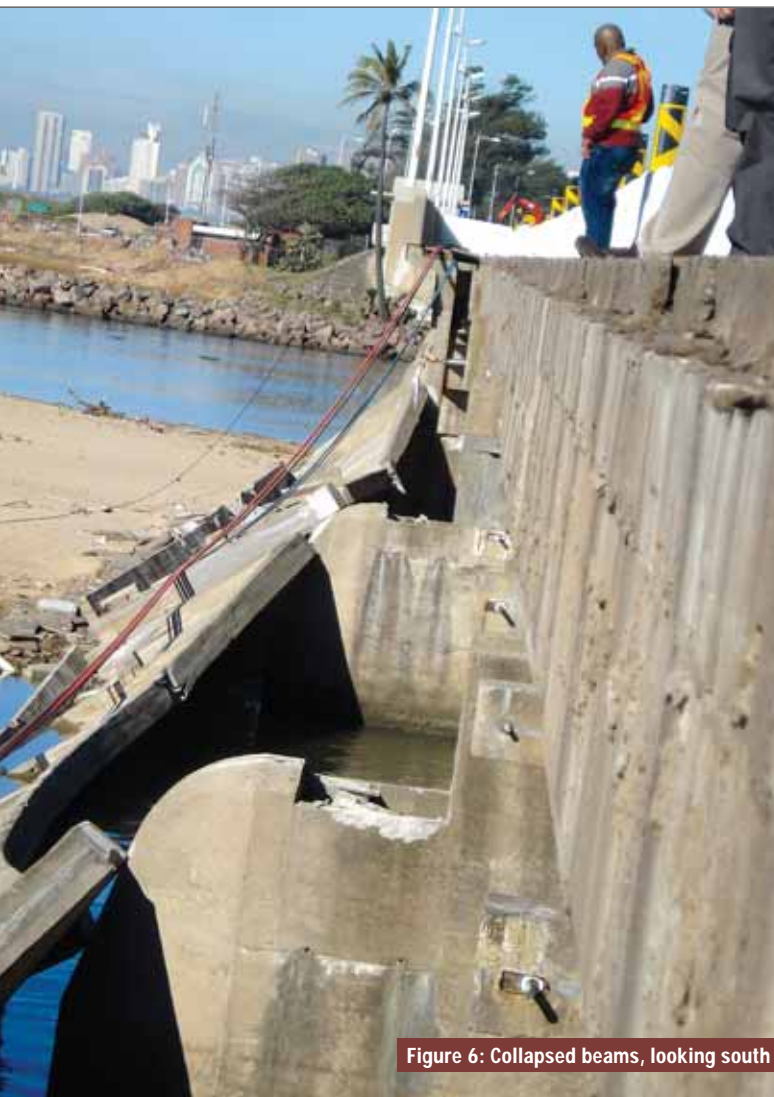
The four beams along the mid-section of the bridge are over a section of a built-up sand 'island' at the river mouth which makes access without detection a little easier than other portions of the bridge. Notwithstanding, the links are still very difficult to gain access to and are some five metres above the river. It is here that the vandals were able to work methodically at removing almost all of the links, effectively rendering those beams un-propped in the lateral direction and potentially unstable. It is assumed that one of the beams toppled as a result of sufficient traffic vibration from the roadway bridge and dragged the potentially unstable adjacent beams along with it.

Figure 6: Collapsed beams, looking south

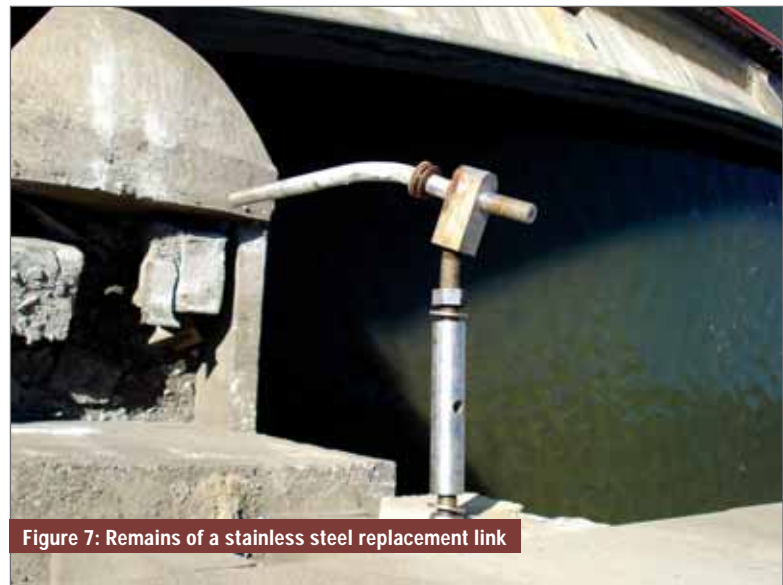
In certain places it was noticed during maintenance inspections that some of the links had begun to corrode, and a replacement programme using stainless steel was carried out as part of programmed bridge maintenance on several of the beams.

Figure 7: Remains of a stainless steel replacement link

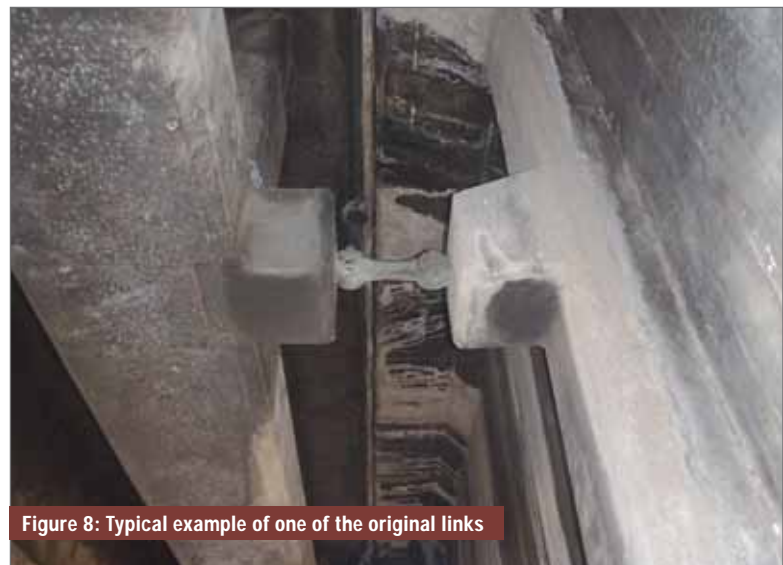
Figure 8: Typical example of one of the original links

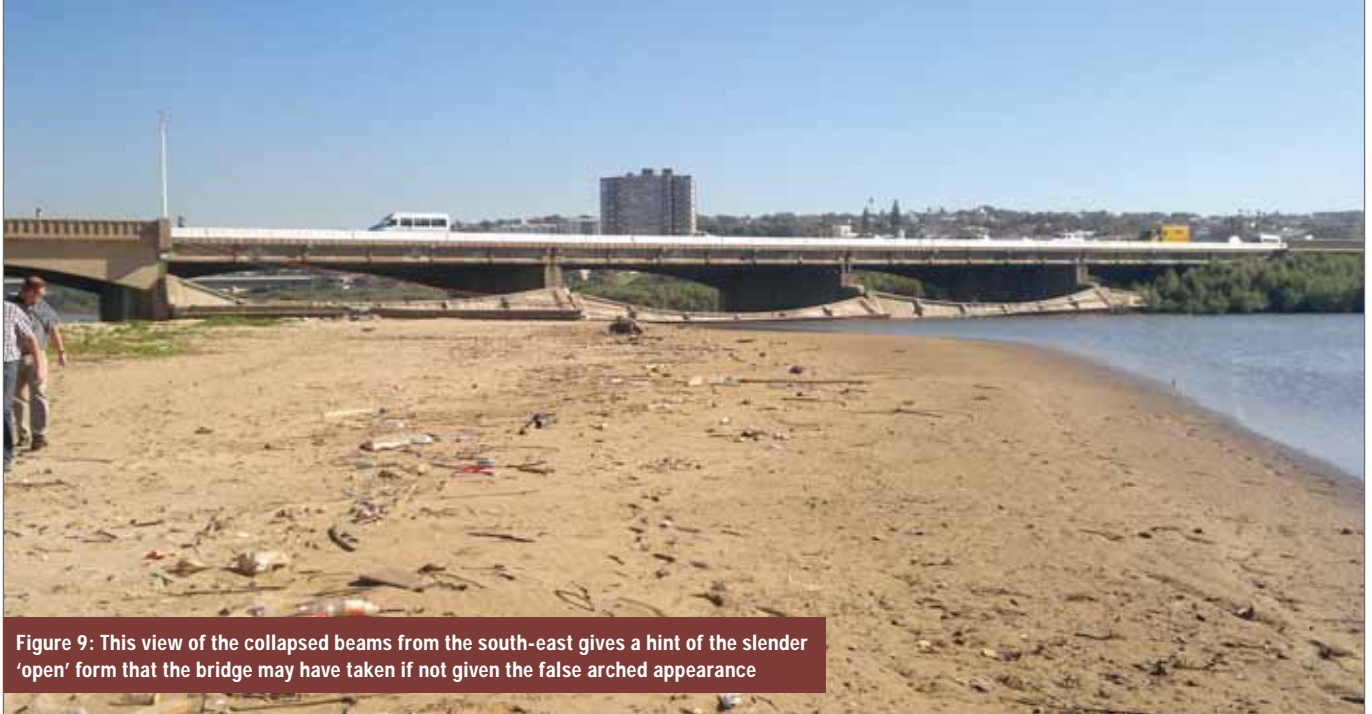
Figure 9: This view of the collapsed beams from the south-east gives a hint of the slender 'open' form that the bridge may have taken if not given the false arched appearance
