# Bridge reinstated to its

**Bridge No 422 over the Orange River near Zastron in the Free State was constructed in 1934. It is a magnificent feat of engineering and concerted efforts should be made to preserve it for posterity. The bridge, which was seriously damaged by vehicular impact, was recently repaired. Innovative answers were found for the challenging demands of structural stability, safety and economy**

## BRIDGE NO 422 REPAIRS

### Category Technical Excellence

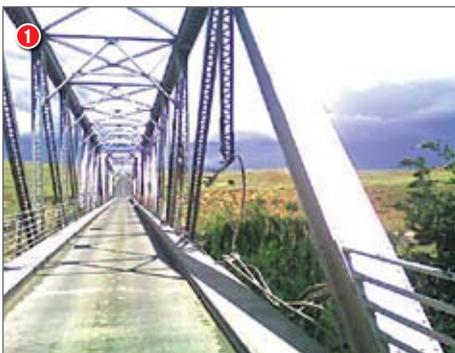
The photographs demonstrate the seriousness of the structural damage to the bridge. Photo 1 shows a vertical member completely ripped out. This vertical member acts as a hanger to support the longitudinal deck beams. Without it the span of the longitudinal deck beam was doubled, which had a very detrimental effect on the load-carrying capacity of the bridge.

The vertical hanger that was ripped out resulted in a permanent 10 mm settlement of the deck at that point. It was important to recover this deflection as the new member had to be fitted using the same gusset plate holes the rivets used before.

This was easily accomplished by using temporary adjustable tension ties to pull the members together. Two temporary ties were used to pull the settled deck back into position. The ties consisted of angle irons welded to 25 mm diameter bolts with adjustable nuts that were used to safely recover the deflection in a controlled manner.

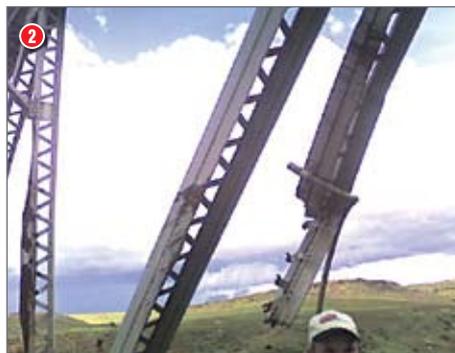
Photos 2, 3 and 4 show the local damage to compression members. The compression resistance of these members was seriously reduced due to a breakdown of composite action between the laced members.
