Emergency repair of Bridge B421 over the Olifants River after flood damage

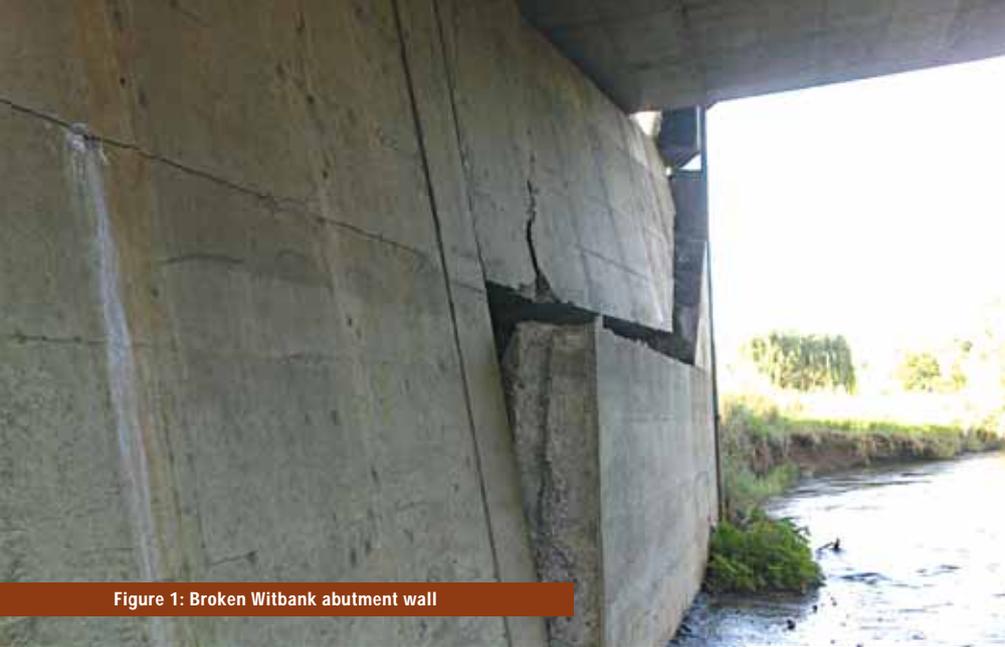
The Witbank abutment had been founded on silty sand, as was confirmed by the geotechnical investigation (discussed later in this article). The whirlpool caused the backfill material behind the wing wall to become saturated, resulting in minor scour at the back of the wing wall and below the wing wall foundation. The scouring around the wing wall foundation and the additional water pressure behind the wing wall then resulted in the wing wall footing starting to rotate forward.

wall with dowels and a concrete shear key. The abutment wall supported the weight of the deck, resulting in the abutment wall being partially propped at the top and therefore unable to rotate with the wing wall. This resulted in additional moments and forces on the abutment wall, for which the mass concrete wall had not been designed. The additional forces and moments caused the abutment wall to break at the construction joint at mid-height (see Figure 1).

Figure 1: Broken Witbank abutment wall

- remove the existing failed abutment
- found the new abutment on a piled foundation with raked piles to ensure long-term stability, and
- reconstruct a new abutment.

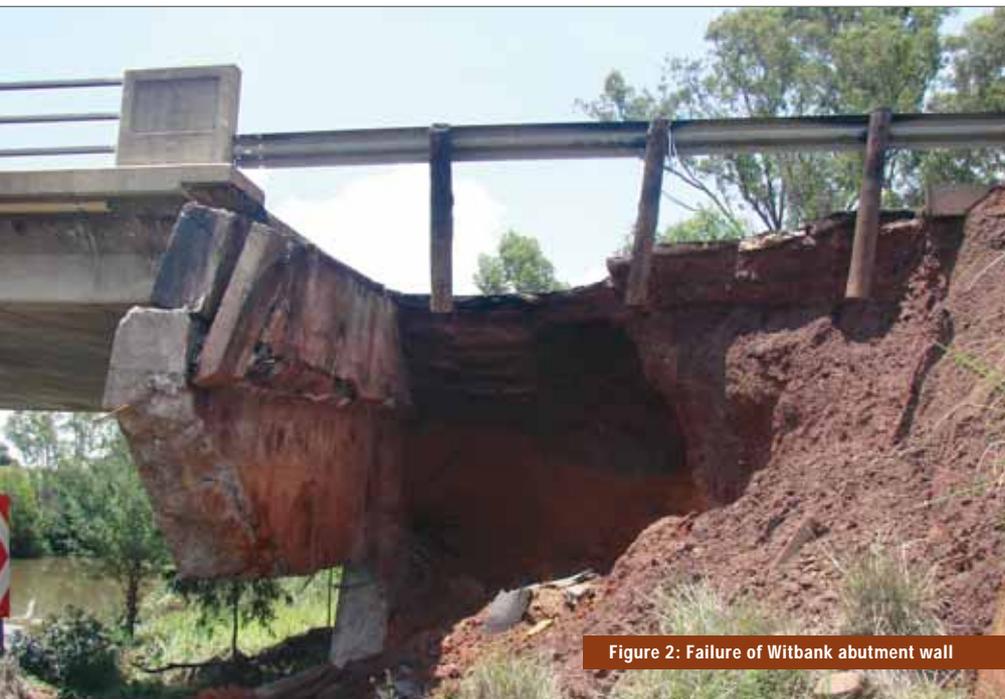
Figure 2: Failure of Witbank abutment wall

The inflow behind the wing and abutment wall increased the size of the whirlpool, which in return increased the erosion behind the wing and abutment wall. This resulted in the abutment and wing wall collapsing and leaving a large sinkhole in the road (see Figures 2 and 3).

The failure of the wing wall and the Witbank abutment wall on the downstream side, up to a vertical construction joint, led to the deck being supported only by the remaining half of the Witbank abutment. This, coupled with the appearance of the sinkhole, resulted in the road being closed.

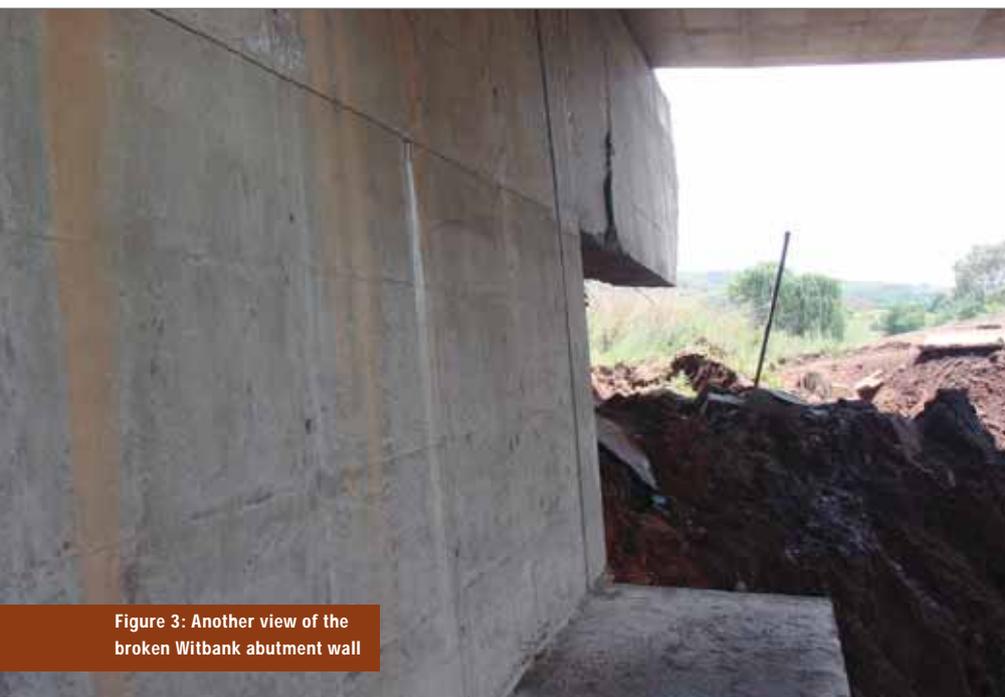
Figure 3: Another view of the broken Witbank abutment wall

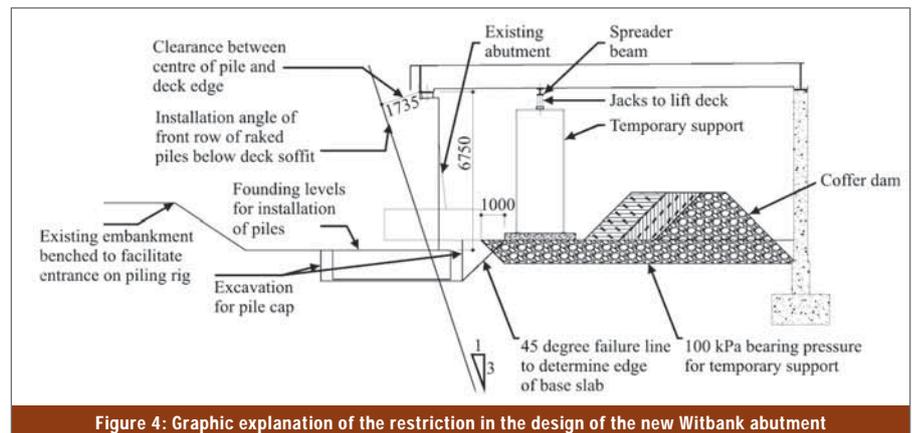
The position of the temporary support work was calculated to ensure that, during the excavation of the new pile cap, the vertical excavation face would not jeopardise the temporary support work should the vertical excavation face collapse. Therefore the edge of the temporary support footing had to be outside the assumed 45° angle of failure. The founding level of the base slab was chosen to be on the same level as the existing abutment footing to reduce the risk to the temporary support work when the existing abutment is demolished (see Figures 4 and 5 for a graphic and photo explanation of the above).

Figure 4: Graphic explanation of the restriction in the design of the new Witbank abutment

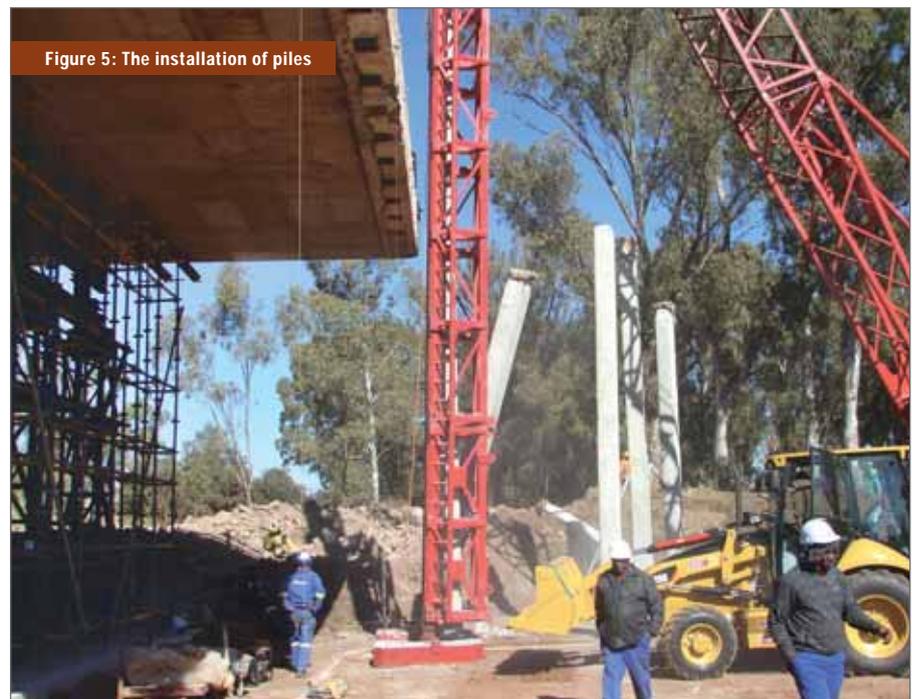
Figure 5: The installation of piles

The final solution was to utilise 350 mm square precast driven piles fitted with a rock shoe to ensure end bearing on at least soft rock.

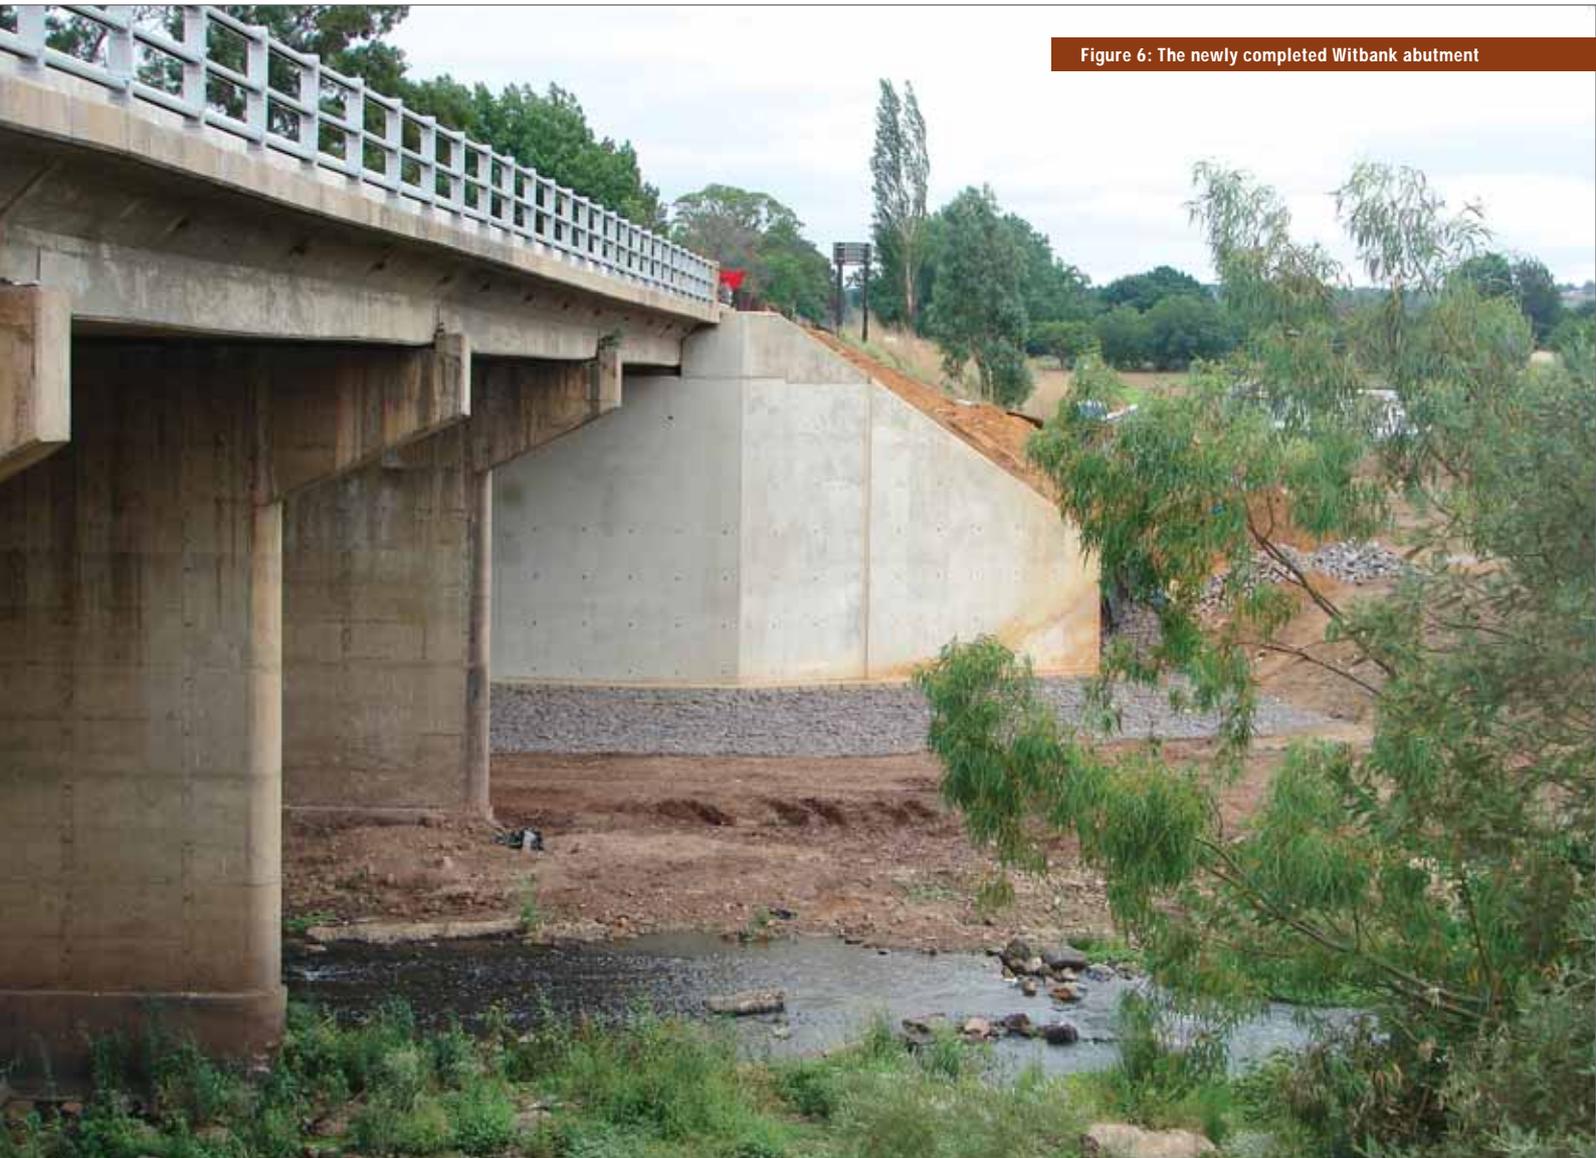
Figure 6: The newly completed Witbank abutment

design process SANRAL and BKS communicated daily regarding the design and progress with the tender documentation, in order to speed up the process of getting a contractor on site. This involvement from SANRAL ensured that the approval process of the tender drawings and documentation was fast-tracked. The teamwork between the client, consultant and contractor during the construction period led to the R555 being reopened to the public after only ten months of closure (see Figure 6).
