Mike Chemaly
Associate
WSP Africa Coastal Engineers
mike.chemaly@wspgroup.co.za

Failure of the Gansbaai leeward breakwater

Civil Engineering | December 2011

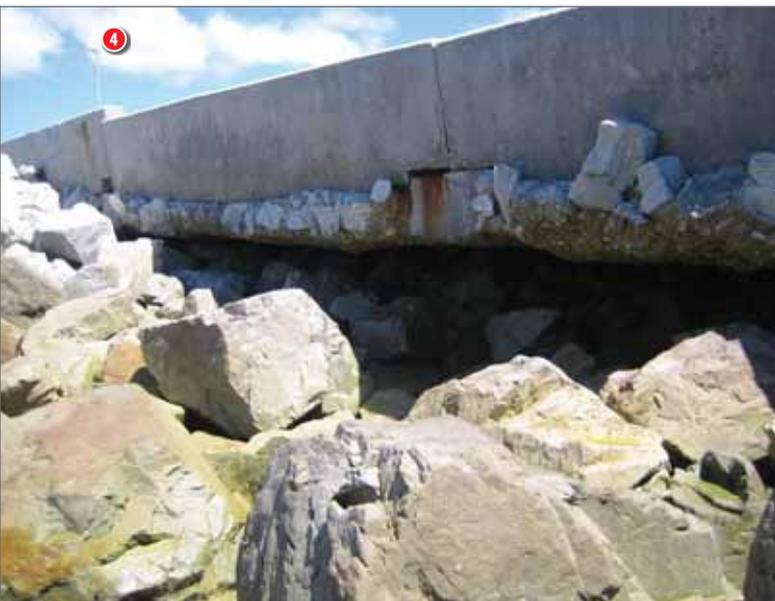
- 1 Gansbaai – South Africa
- 2 Gansbaai – New Fishing Harbour and location of damage
- 3 Existing typical section (Ch 66 – Ch 126)
- 4 1 000 mm deep by 30 m long entrance under structure
- 5 Shear crack running for 30 m along structure length
- 6 Rock armour defence collapsed
- 7 Breakwater founded on rock reef

breakwater core (Failure Mechanism 2). This resulted in a massive cavity 30 m long by 0,5-1 m deep forming under the concrete roadway. Subsequently the concrete roadway started to collapse into this cavity.

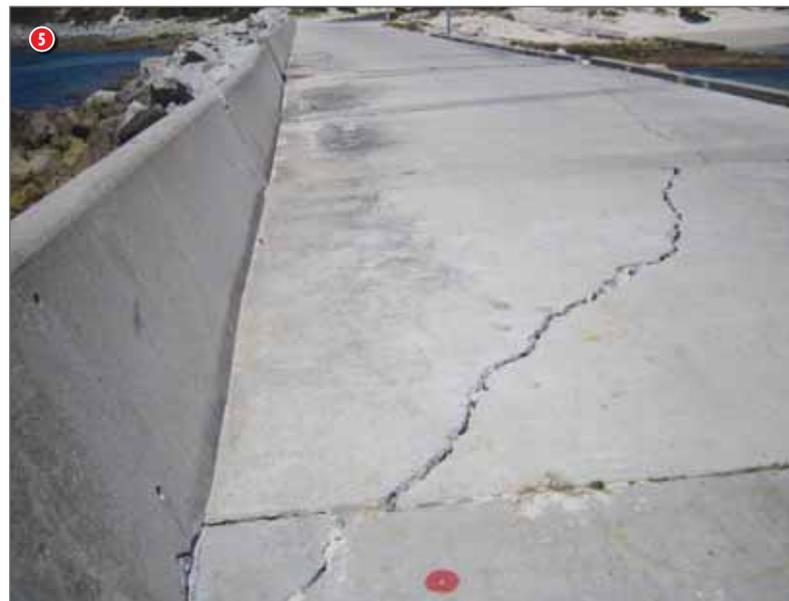
Along the first 30 m (Ch 66 – Ch 96) of the 60 m section of failed breakwater, rock armour had been displaced over a distance of 30 m from the breakwater, due to severe wave action in May 2010. Wave-breaking along this section of the breakwater is in the form of plunging breakers on a hard rock bed (resulting in Failure Mechanism 1 – see Table 1). In addition the original core that predominantly consisted of fine material, unprotected by a geomembrane, had washed out from the

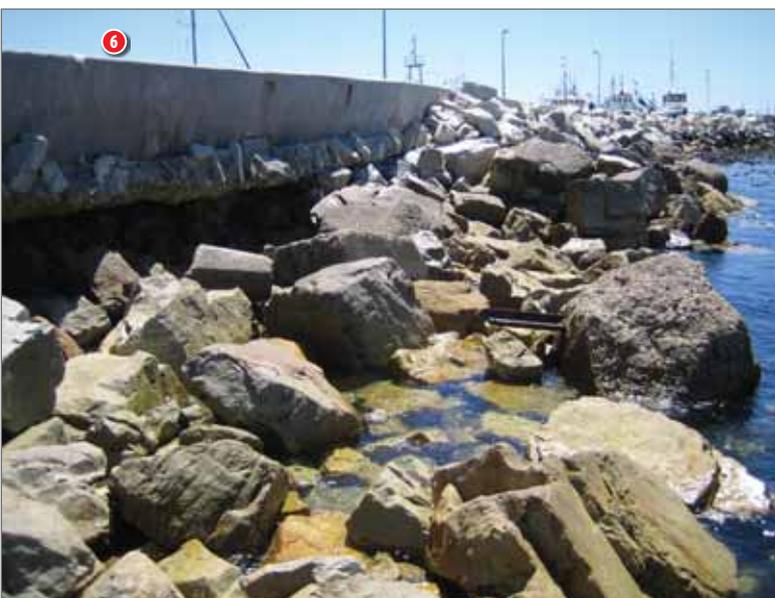
Along the second 30 m (Ch 96 to Ch 126) stretch of this 60 m section of failed breakwater, armour rock was displaced downwards from the toe, slope and crest areas of the breakwater. This in turn exposed the underlying core. In addition the parapet wall was exposed and had to absorb direct wave impact.

- The original 1-3 t double-rock protection was salvaged and reconstructed.
- A new single layer of 4-6 t armour rock was constructed.

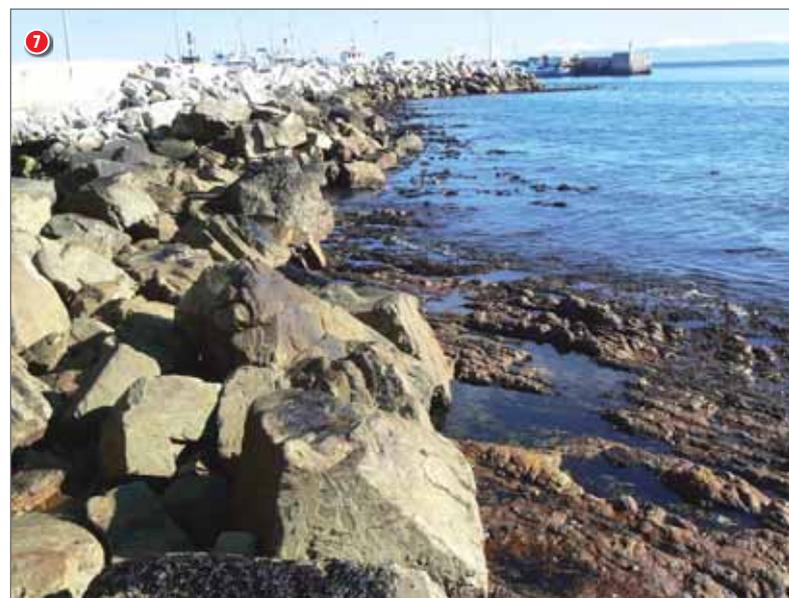
plane of bedrock. This bedrock profile has a final ground level on roughly +0,3 m CD. This level coincides with the Mean Low Water Spring level of +0,27 m CD. This horizontal plane of bedrock extends roughly 2 m past the armour rock toe, after which it dips steeply to form a vertical reef-like edge.

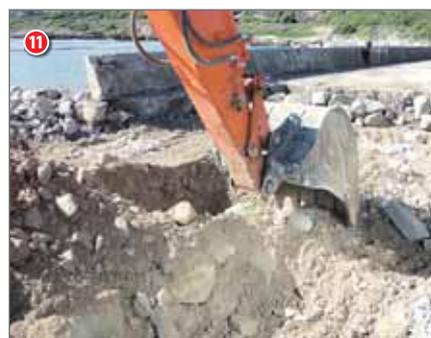
- 10 Proposed typical section (Ch 96 – Ch 126)
- 11 After removal of concrete deck: test hole at 1 m deep
- 12 After removal of concrete deck: test hole at 1,5 m deep

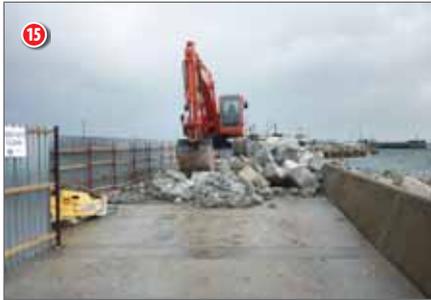
- 15 Stage 1: Demolition of existing concrete roadway
- 16 Stage 2: Trimming back existing sand core
- 17 Stage 3: Placing geotextile with 10-50 kg layer overlay

- The existing concrete roadway was demolished.
- The existing sandy core was trimmed back and overlain with geomembrane, 10-50 kg rock and 10-500 kg rock.
- The concrete roadway was rebuilt to 800 mm thickness and the precast parapet walls were stitch-cast to the roadway.
- The original 1-3 t double rock protection was reconstructed.
- A new single layer of 4-6 t armour rock was constructed.

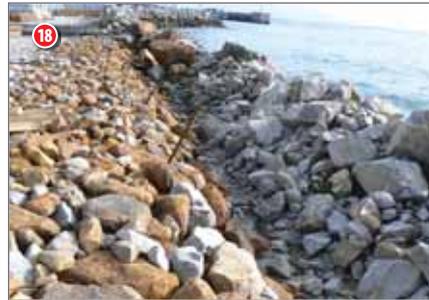
- 18 Stage 4: Construction of 10-500 kg layer to profile
- 19 Stage 5: Casting 800 mm segmented roadway panels
- 20 Stage 6: Completing double layer 1-3 t rock

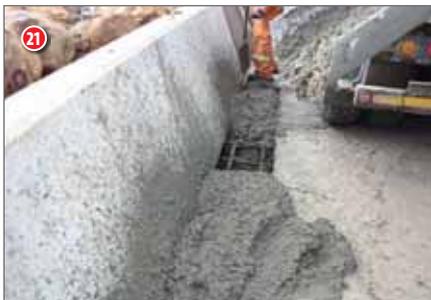
- 21 Stage 7: Stitch-casting parapet walls to concrete roadway
- 22 Stage 8: Completing single layer 4-6 t rock
- 23 Stage 9: Completed 7 m wide, 800 mm deep concrete roadway
