RAILWAYS AND HARBOURS

Innovative investigation and repair of the Overvaal railway tunnel

THE 4 KM LONG Overvaal railway tunnel on the Coal Line between Ermelo and Piet Retief was constructed in 1974 by blasting into dolerite of the Ecca Group and Dwyka formation. After serving more than 30 years as the only permanent single line section on the Coal Line, foundation problems dictated the need to investigate and rectify the movement of the tunnel slab and supporting foundation.

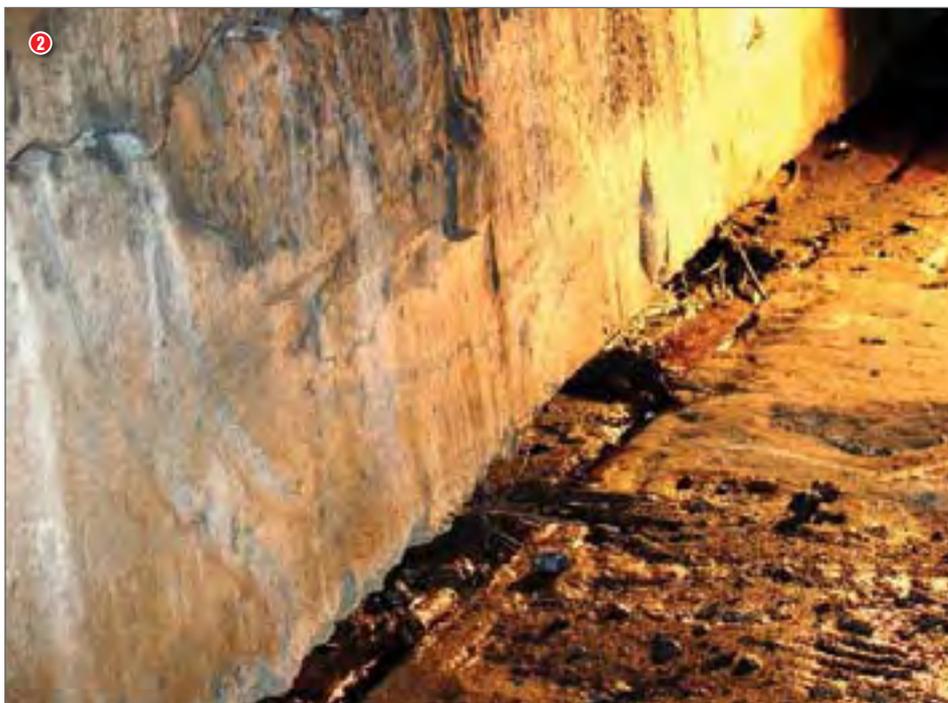
Figure 2 Water entering the tunnel foundation through openings at the mass concrete drainage channel interface

cracks between the slab and the mass concrete (especially from the shallow drainage channel) and also from the deep drainage channel through cracks in the mass concrete.

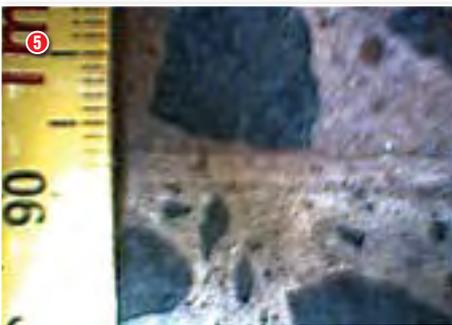
(a) Interface between slab and mass concrete – no cracking

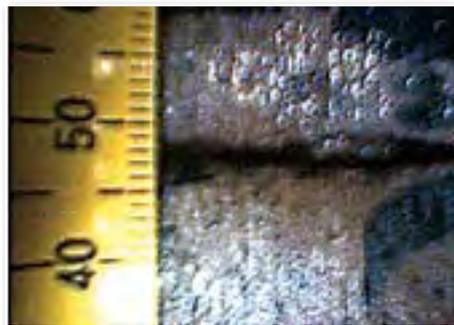
(b) Interface between slab and mass concrete – 2 mm crack

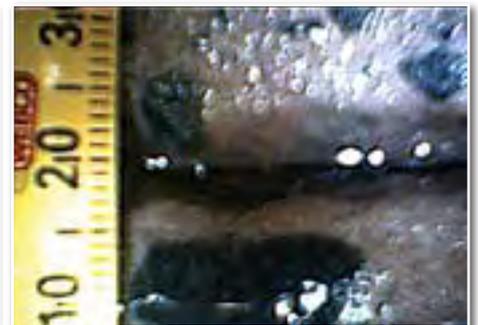
(c) Water flowing through opening between slab and mass concrete

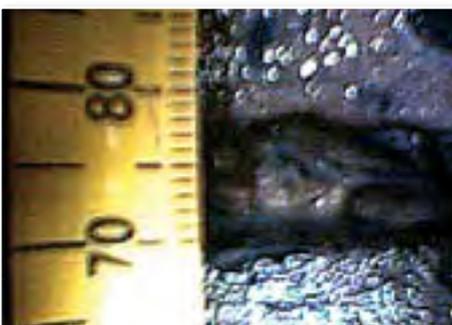
(d) Large cavity in mass concrete

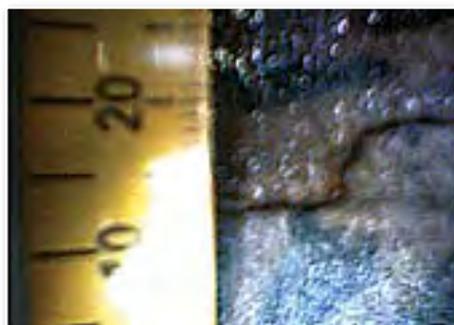
(e) Crack in mass concrete

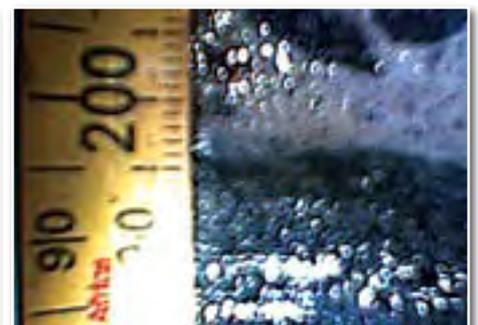
(f) Undamaged in-situ rock and mass concrete interface

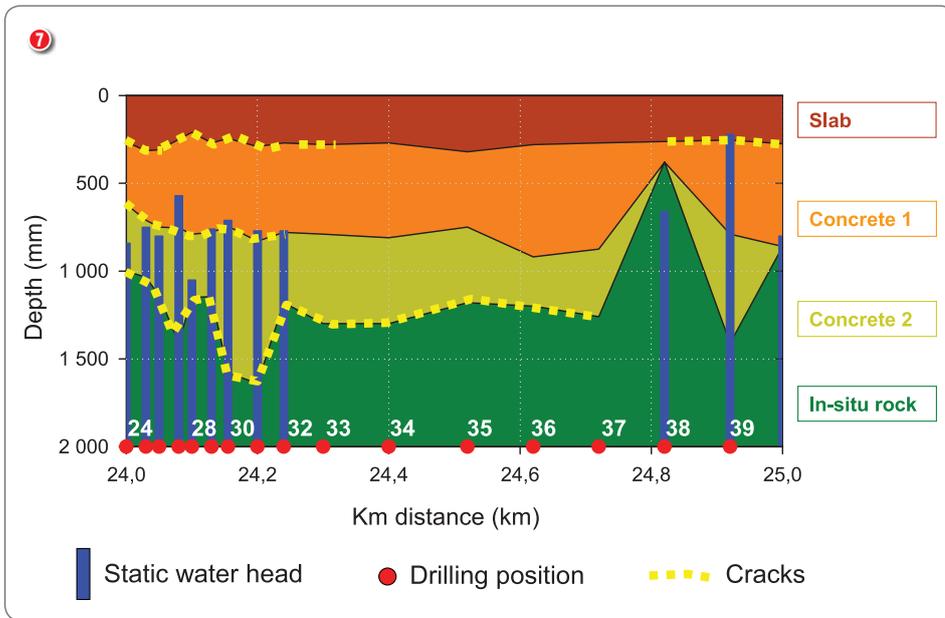
► **Figure 7** Example of detailed graph showing core-drilling results (km 24–25)

- The static water table (indicated by the blue bars at each testing location). A completely dry hole is indicated by the absence of a blue bar
- The presence of any cracks or voids at especially the mentioned interfaces (indicated by the yellow dashed lines)

From the core drilling investigation, it was concluded that the cyclic loading, combined with water entering the tunnel foundation through relatively small cracks in the concrete, led to the pumping action of the track slab. Repeated movement resulted in the generation of pore pressures and the gradual growth of the voids at the respective interfaces, thereby slowly pulverising the concrete and washing fines out of the voids. Excessive slab movement caused the tunnel chair component failure, which in turn created severe dynamic impact loading – a vicious circle.

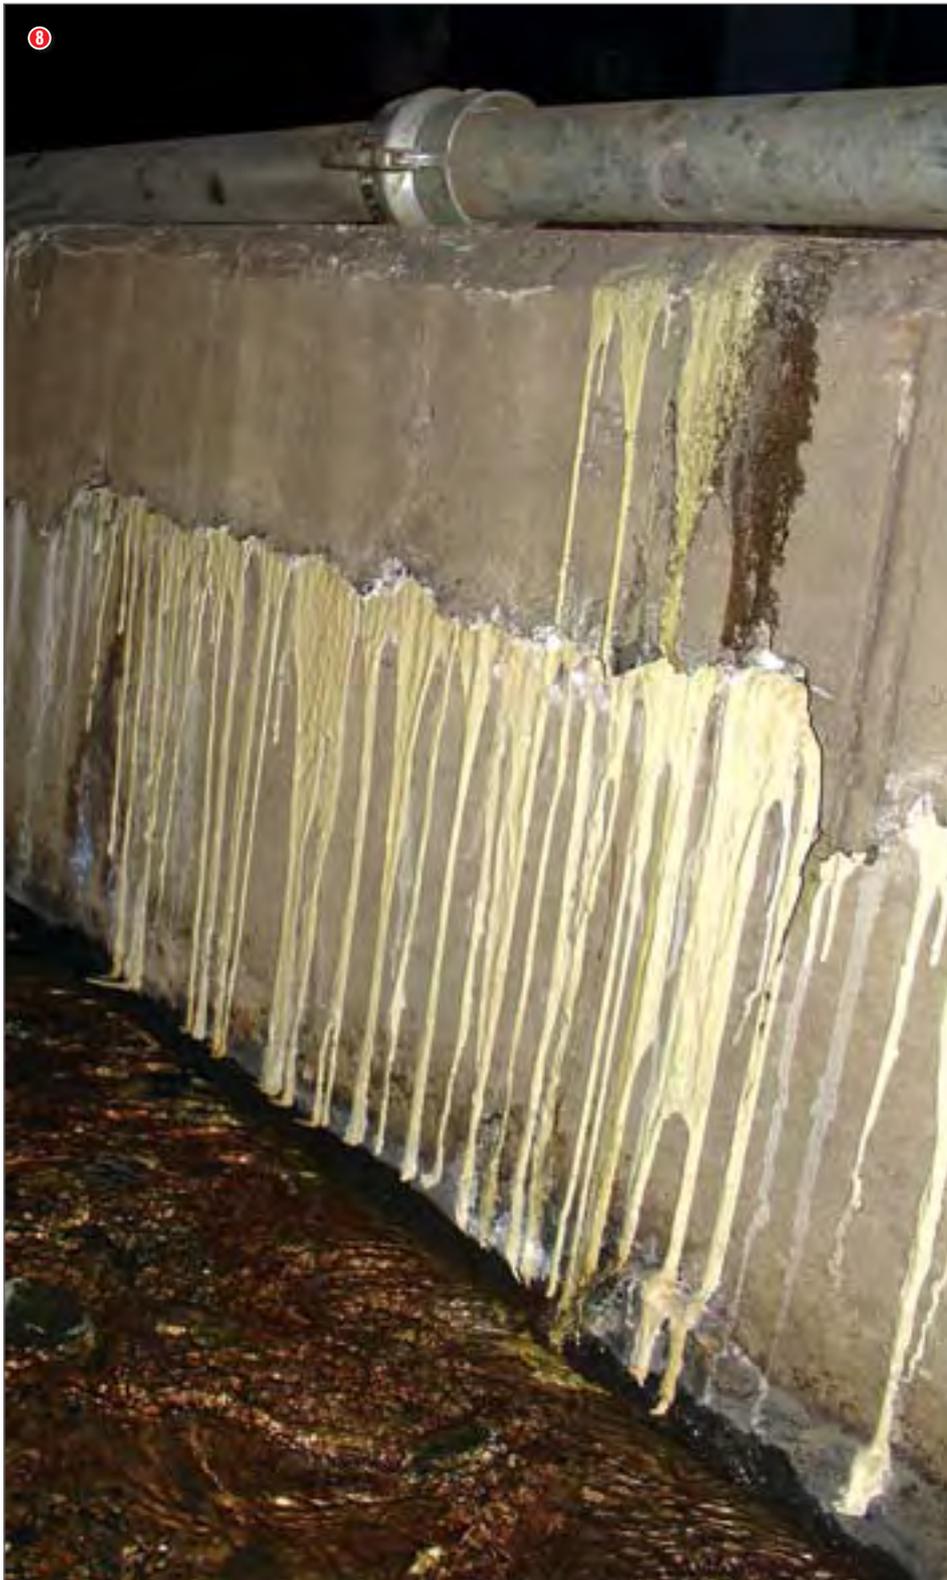
► **Figure 8** The epoxy exiting the crack between the tunnel slab and mass concrete

Excellent penetration of the epoxy into all voids was achieved as evidenced by the appearance of epoxy flowing from the various concrete discontinuities as described earlier. As soon as epoxy emerged, the injection was halted, allowing the epoxy to set. This method blocked the exit points, thereby allowing more epoxy to be injected under high pressure and preventing spillage.

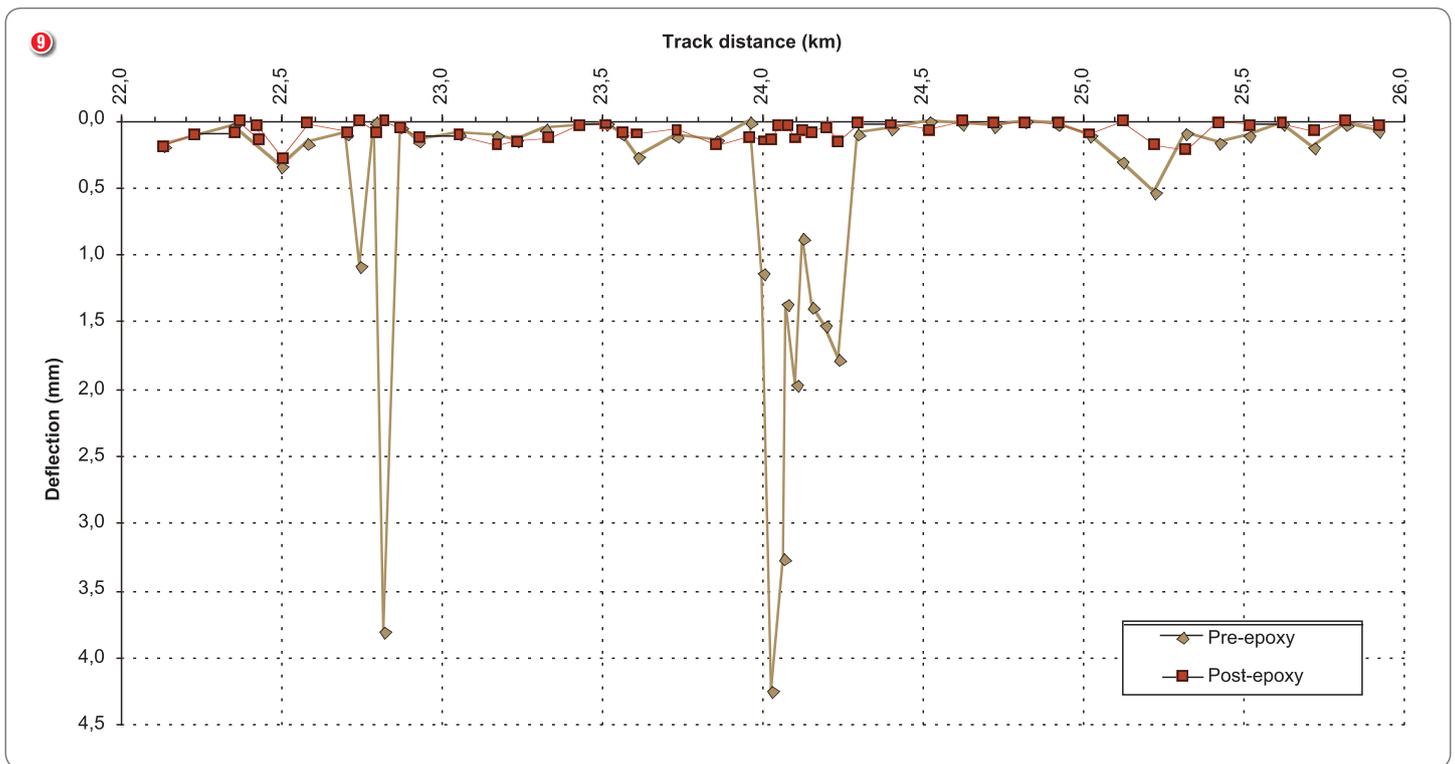
► **Figure 9** Deflection measurements under a 26 t axle load vehicle

Deflection measurements of the track slab were done by using a digital indicator to measure the vertical displacement of the slab under train loading. These measurements were taken before any grouting was done as well as shortly after grouting was completed. Before grouting, maximum deflections of up to 4,3 mm was recorded under 26 t per axle loading. Post-epoxy deflections were limited to 0,2 mm
