# Sealing foundations of existing buildings by grouting: A case study from Turkey

Erdal Akyol, Gulmustafa Sen, Salih Yilmaz, Y.Selim Tama and Hasan Kaplan

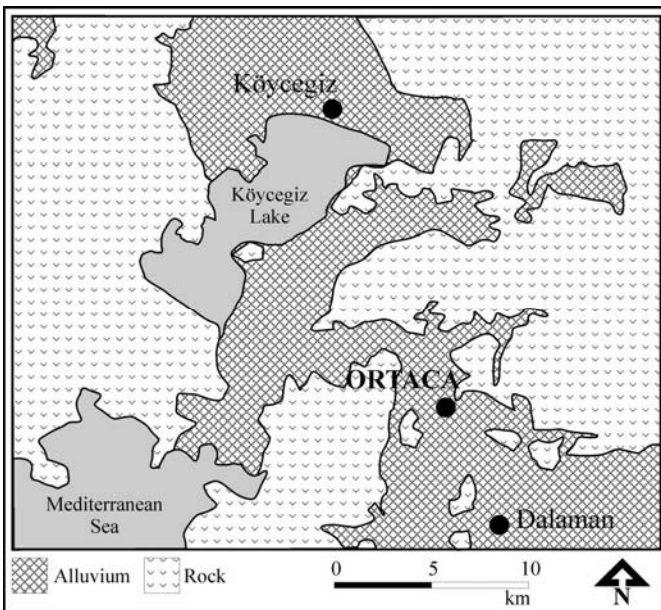
Fig. 2. Geological map of the study area (from MTA 2010)

The study has been carried out in Ortaca town of Turkey as shown in Figure 1. Figure 2 illustrates a simplified geological map of Ortaca and its surrounding area. Quaternary aged sediments cover a large area and overly rock units. These sediments are related to watercourses and in gravel size.

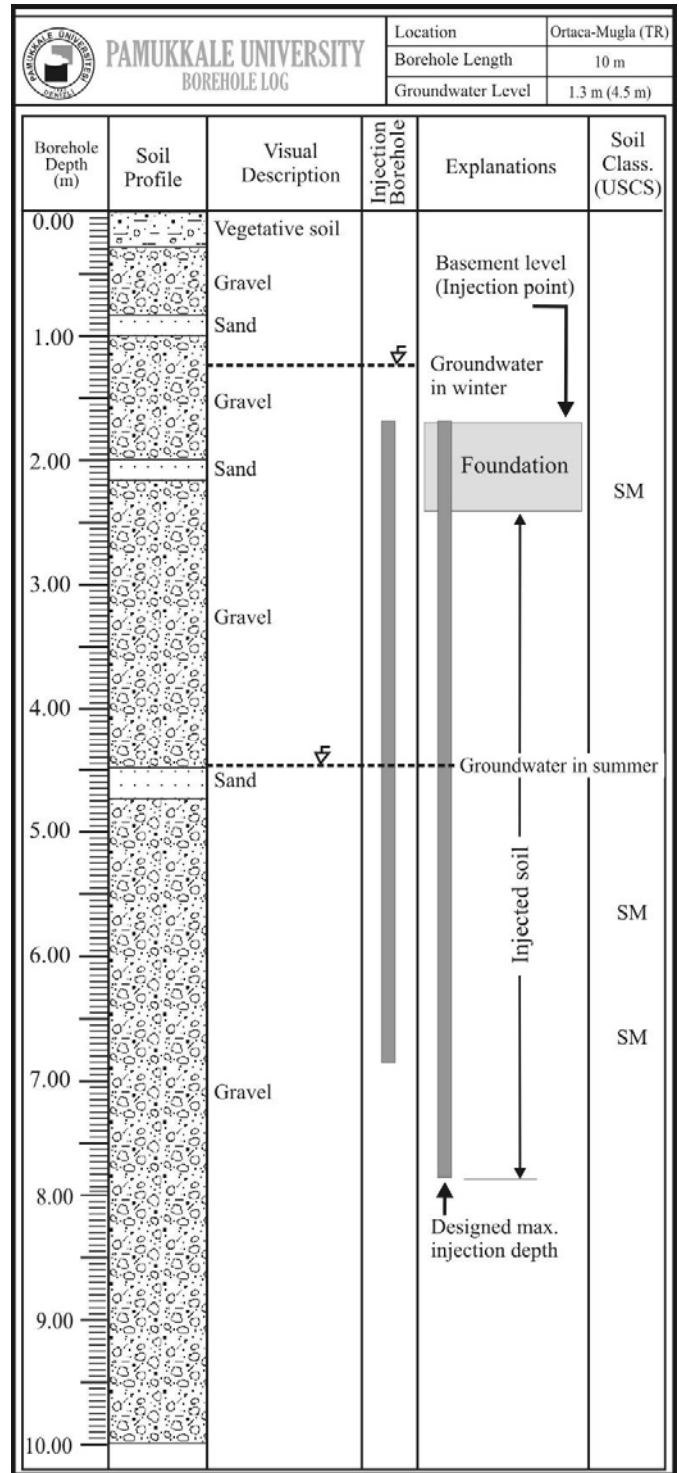
Fig. 3. Borehole log of the area

Figure 3 illustrates a borehole 10 m in length. Soil profile consists of gravel and includes some sand bands at several depths. Sieve analysis of a sample, taken just beneath the foundation level, is given in Figure 4 and it contains 66% gravel and 34% sand. Groundwater level was variable between 4.5 and 1.3 meters in summer and winter seasons respectively. Chemical contents of groundwater were another issue because it would speed up corrosion and they are listed in Table 1 [5]. These values were not high enough to accelerate spoil of concrete. However, water fluctuation was more harmful because of oxidation of steel.

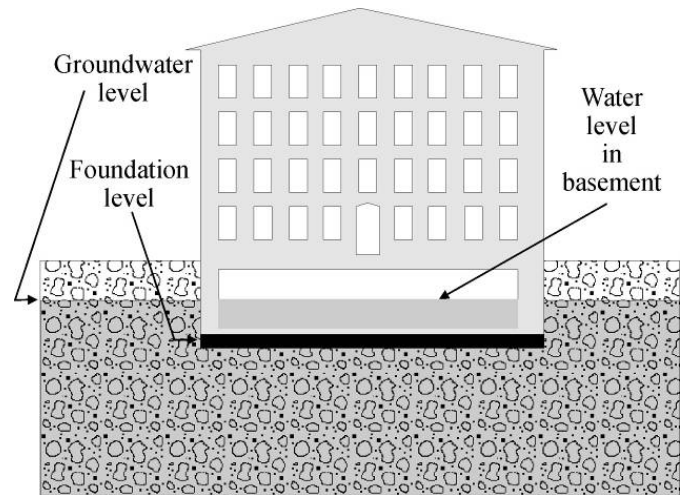
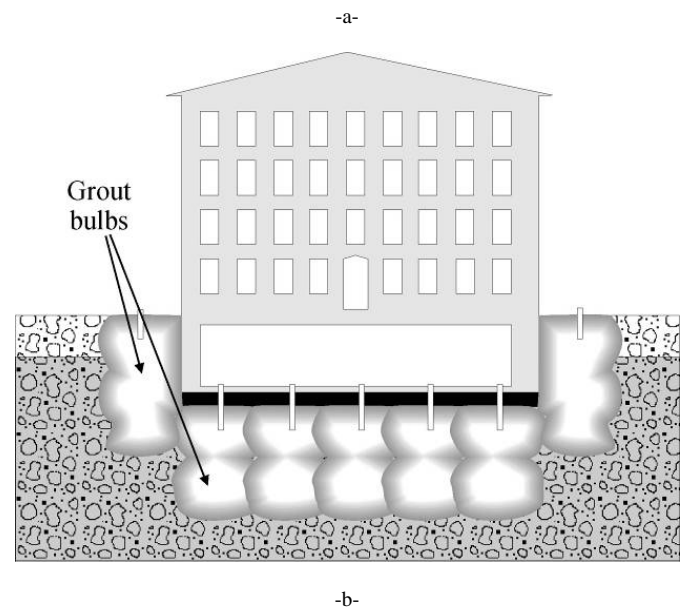
Fig. 6. Schematic view of the building (a) before and (b) after injection

Groundwater can cause destructive effects on concrete and reinforcement. The examined foundation of a reinforced concrete building was below the groundwater level and there was an enormous water seepage into basement storey during winter seasons. Four water pumps were not enough to drain the water seepage and building was prepared to sacrifice.

In this study, 1/3 cement-water mixture is injected into soils. The grouting was enforced from bottom to up and 25 kPa pressures were applied for every meter (Table 2). Evenly distributed borehole pattern was employed as illustrated in Figure 5. Twenty grouting holes were drilled 6 meters in depth. Schematic view of the building before and after injection is illustrated in Figure 6.

It was sealed successfully and there was no seepage during the last three winter seasons. The method can be employable to all existing buildings with seepage problems.
