Optimization of maintenance, diagnostic technique and design of substation equipment based on analysis of service experience

C. Neumann, B. Rusek

RWE Transportnetz Strom, Dortmund

G. Balzer

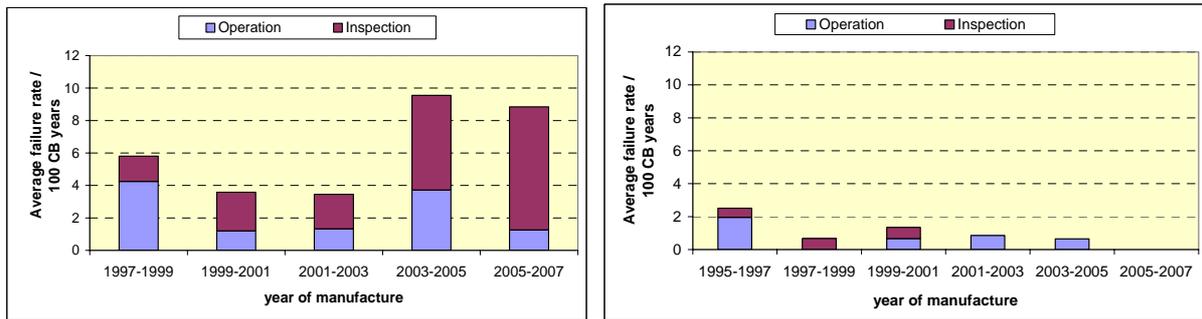
Fig. 2.1: Average failure rate of 110 kV SF6 self blast circuit breakers depending on the year of manufacture

The average failure rates of CBs of type A are significantly higher than those of type B. Moreover, the failure rate of type A has increased in the last years, which is an indication of quality deficiencies in the manufacturing process. The first manufacturing series of type B exhibits failure rates distinctly above the average. The decrease in the following years shows that the manufacturer evidently improved the manufacturing and quality assurance process and removed the weak components as well causing failures in previous years.

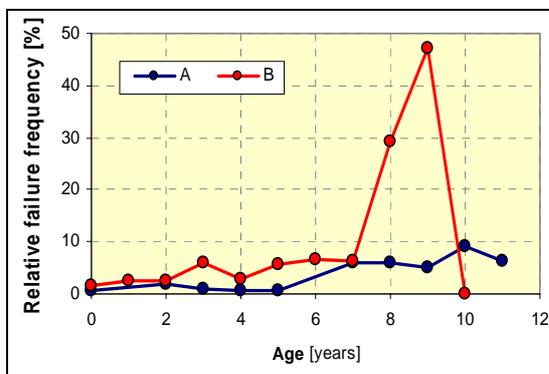
Fig. 2.2: Relative failure frequency for self blast circuit breaker type A and B

The consideration of failure frequency depending on time (Fig. 2.2) shows a similar relative failure frequency for both types of CBs up to the 7th year of operation. Every data point gives the ratio of number of failures at the relevant age of the CB related to the number of CBs as old or older than the CB in question. After that a distinct increase can be observed for breaker type A which reaches its maximum in 9th year of operation. The maximum is an effect of the maintenance activities that according to the company policy were carried out in an 8 years interval on both CB types. However, the CBs of

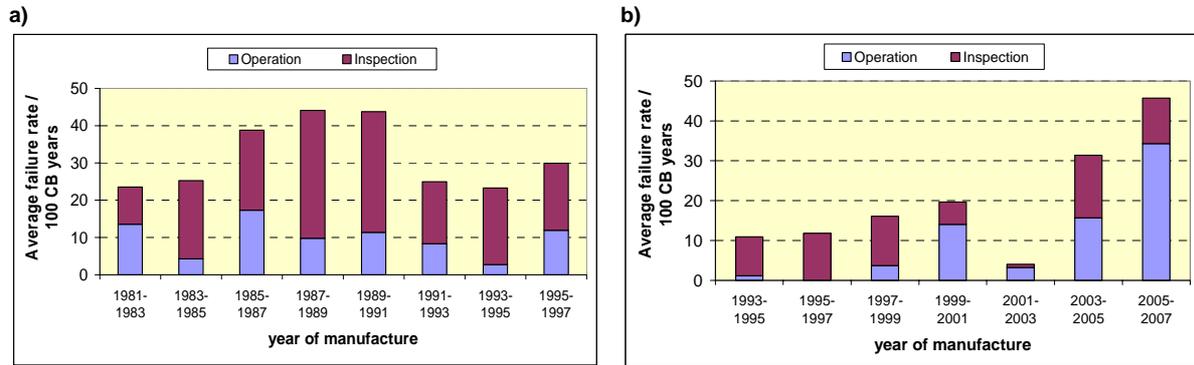
Fig. 2.6: Average failure rate for 380 kV circuit breakers
a) 1st generation

generation. From that, particularly from the reduction of failures occurred during operation one can conclude that manufacturing improvements have been achieved with the 2nd generation. However, the failure rate in following periods increases which means that the quality standard could not be maintained. The reason for that might be the necessity of material and manufacturing cost reduction caused by a stronger competition.

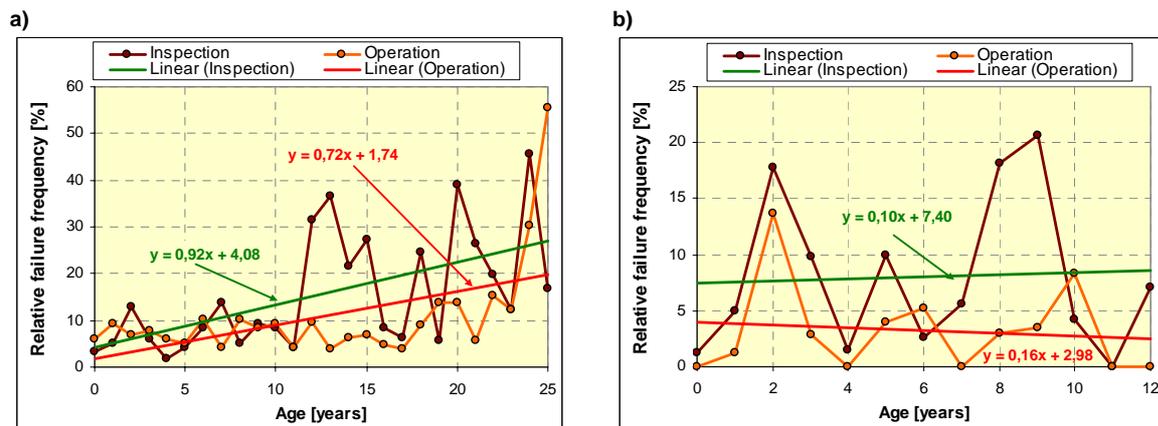
Fig. 2.7: Relative Failure frequency for 380 kV circuit breakers
a) 1st generation

The failure frequency of CBs of the 1st generation (Fig. 2.7 a) remains below 10% until 20th year of operation. Afterwards the failure frequency increases rapidly reaching its maximum of 55% in the 25th year of operation. The number of failures that were detected during inspections also increases with the age of breakers. Assuming, that the regression curves show the correct development of ageing effects, it can be expected that in the next 10 to 15 years the 1st generation of CBs will have to be replaced. In order to sustain a high degree of reliability of these breakers until they will be replaced, the grid operator has to count with additional expenditures for maintenance and repair.

The failure frequency for CBs of the 2nd generation (Fig. 2.7 b) decreases with time. The peak during the second year is nevertheless interesting. At this time an additional inspection of the CB is performed before the warranty of usually 2 years expires. An increase of the failure frequency during operation points to “teething” failures. The next increase of failures detected during inspection is connected with the maintenance strategy of the grid operator which requires for extended maintenance every 8 years. Obviously for some CBs the maintenance actions were postponed in the next year, since the equipment could not be de-energized in time due to increased load flow. Hence it can be concluded, that the failure frequency found during inspections should be in the 8th year much higher, if the maintenance actions would be carried out in time. Faced with this fact, an extension of the maintenance intervals, as it was discussed, should not be taken into consideration for the breaker type in question.

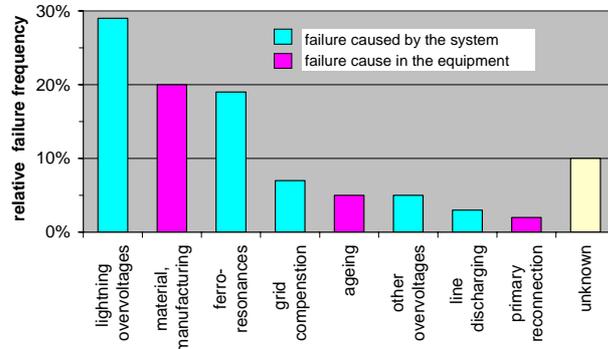
Fig. 3.1: Main failure causes on instrument transformers

Fig. 3.1 shows that nearly 50% of the failures experienced with HV instrument transformers for outdoor application are caused by electrical overstressing. Mainly two failures causes are dominant: stresses by lightning overvoltages and thermal and partly dielectric stresses due to ferro-resonances. Failures due to lightning overvoltages mainly occurred on SF₆ gas insulated instrument transformers, but sometimes even on oil immersed equipment. By more sophisticated investigations by means of simulations and laboratory test it was found out that this problem is mainly caused due to insufficient insulation coordination [6].

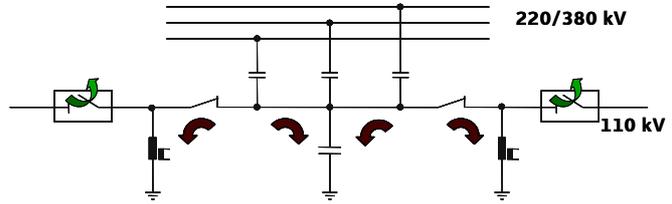
Fig. 3.5: System configuration generating ferro-resonance phenomena

The secondly frequent failure cause is over-stressing due to ferro-resonance phenomena. There are various configuration which can lead to ferro-resonances [8]. One configuration typical for systems where multi-circuit arrangements are applied, is given in Fig. 3.5. De-energizing the 110 kV circuit oscillation due to ferro-resonances may be excited in the voltage transformers at the line entrance. The damping of these oscillations might be insufficient, since the circuit is further on fed by capacitive coupling from the energized 220 kV or 380 kV circuits.

To avoid ferro-resonance phenomena the basic design of the voltage transformers at the line entrance has to be modified. Different remedial measures were studied. However, the only one which provide sufficient damping for this case is to fit the core with a small air gap. This modification is very efficient and produces little additional costs, only. It is also suited for damping of ferro-resonance phenomena occurring in other configurations described in [8].

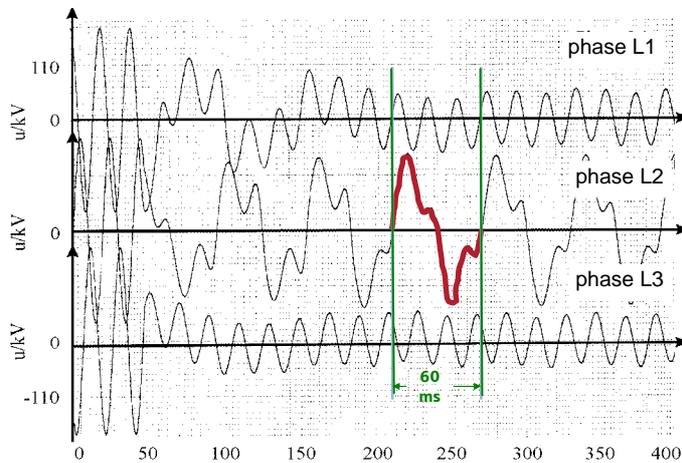
Fig. 3.6: Typical oscillogram of an oscillation caused by ferro-resonances

Fig. 3.6 shows a typical oscillogram of such an oscillation caused by ferro-resonances. In phase L2 an undamped oscillation is excited after the breaker is switched off, whereas in phase L1 the oscillation disappears after some hundred milliseconds [9].

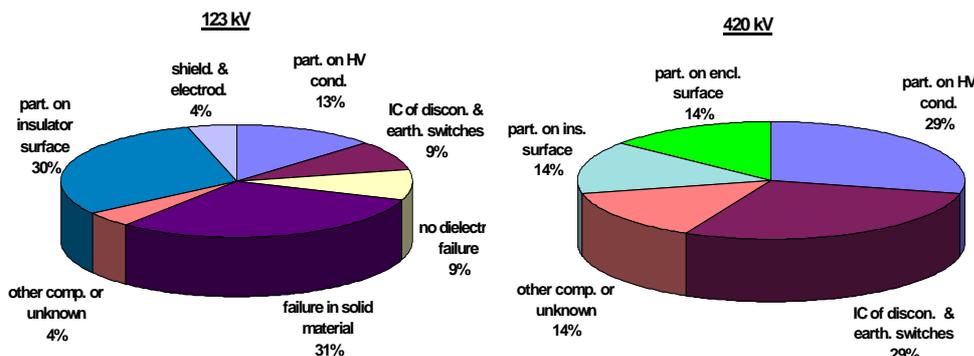
Fig. 4.1: Cause of dielectric failures in 123 kV and 420 kV GIS

The majority of failures were caused by particles, either free moving, fixed on the HV conductor or on the insulator surface. A further failure cause was due to deficiencies in insulation co-ordination of dis-

connectors and earthing switches during switching processes. This failure cause was more dominant in 420 kV, did also exist in 123 kV, but less remarkable. Insufficient long-term strength of solid insulation, in particular of cast resin insulated current and voltage transformers was found in 123 kV only, since in 420 kV SF6 insulated current transformers and SF6 plastic film impregnated voltage transformer are applied since the very first beginning.

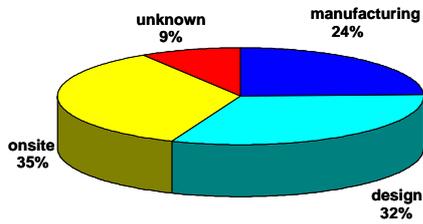
Fig. 4.2: Origin of dielectric failures in GIS

With regard to origin of failures (Fig. 4.2) one third can be traced back to insufficient design and 25 % to deficiencies during manufacturing or assembling and one third to commissioning onsite. Design failures can be avoided by adequate type testing.

As an example, since the type tests ensuring the switching capability of disconnectors and earthing switches were introduced, no failure due to deficiencies in insulation co-ordination of disconnectors and earthing switches during switching processes has become known in Germany. Failures due to deficiencies during manufacturing or assembling are meanwhile prevented by a distinctly improved manufacturing and quality assurance process. Failures due to insufficient commissioning onsite have been essentially reduced by a better qualified testing after erection on site, e. g. by additional PD testing.

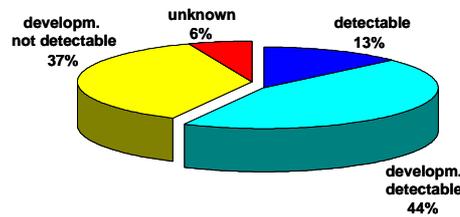
Fig. 4.3: Detectability of dielectric failures in GIS by diagnostic methods

As to be seen from Fig. 4.3 60 up to 70 % of the failures could have been detected by adequate monitoring and diagnostic. The defects would have been detectable partly during their development partly directly after occurrence. In any case the failures could have been avoided, a sufficient measuring sensitivity presumed. Here significant progress could be achieved by development of the UHF PD measuring technique in the recent decade. Therefore insulation monitoring of GIS seems to be reasonable [12]. But the application of permanent monitoring devices can only be justified in case of substations with high importance, in particular from the economical point of view [13]. Normally periodical measurements which can be performed by the use of mobile measuring devices should be sufficient.

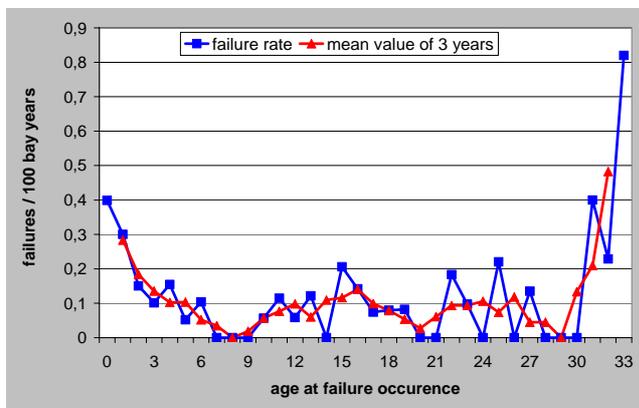
Fig. 4.4: Failure frequency of dielectric failures at a certain age of the station

The long-term performance of GIS of the previous development stages can be taken from Fig. 4.4. It shows the failure frequency of dielectric failures (number of failures per 100 bays) depending on the age of the stations. The service period considered amounts up to 33 years of. A distinct accumulation of dielectric failures can be recognised at the beginning of the service life and the period between 11 and 18 years of service. The first is due to the “teething” faults.

The second accumulation is mainly caused by failures in the solid insulation, primarily cast epoxy resin instrument transformers, but occasionally also tracking on insulators. After that period the failure rate remains on a low level. However, after a service time of 30 years and more an increase can be stated which might be a sign of certain aging phenomena. Additional investigations of the failure developing mechanism should allow to determine how far the failures could be avoided by preventive measures and precautionary exchange of faulty components. In any case it has to be clarified, if these failures are an indication that the equipment is reaching its end of service life.
