DETERIORATING RADIOS

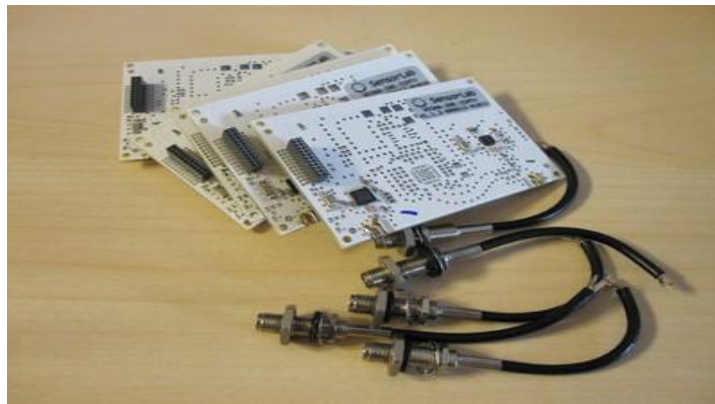
Since June, when the first batch of VESNAs was mounted, something curious has happened with the radio hardware. 2.4 GHz transceivers based on the Texas Instruments CC2500 integrated circuit degraded significantly on receiver sensitivity and transmit power. In some cases to such a degree that they became practically useless for any research work. In fact, this was discovered when we could not explain experimental results we were getting from some of VESNA nodes and started doubting that our equipment is functioning properly.

Since this hardware has been exposed for several months to daily temperature and humidity variations (boxes aren't airtight) and the antennas are mounted externally, my first guess was that perhaps the antenna connector oxidized or the coaxial cable deteriorated.

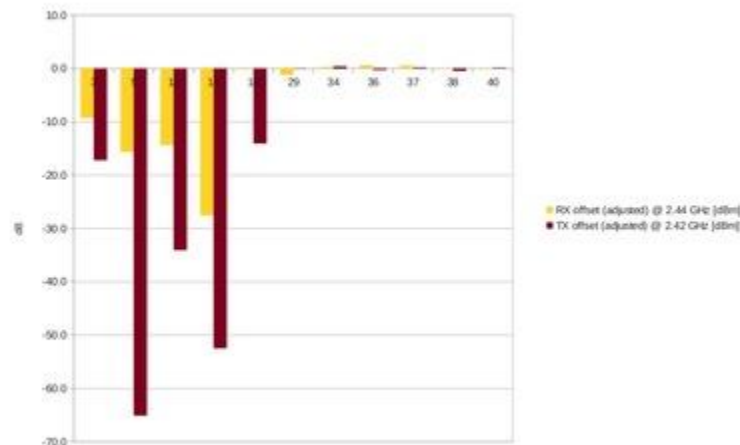
Here's a plot of receiver sensitivity and maximum transmitter power variations for a sample of VESNA nodes. First five from the left have been mounted out-doors in the test bed, while the other six have been deployed in-doors in the Institute. All printed circuit boards are from the same batch, and hence have exactly the same hardware and approximately the same number of operating hours. 0 dB here means nominal sensitivity and transmit power.

It's quite obvious that nodes from outside have a significantly larger deviation from typical values.

What's interesting is that transmit power and receiver sensitivity didn't change consistently, which as far as I can see contradicts the theory that this is due to some simple attenuation on the path between the transceiver IC and the antenna.

In fact, you have to replace both the circuit board and the short coaxial cable to the antenna to restore the original characteristics. This can only mean that both of these are responsible for the problem. Regarding the transceiver, I can't think of any environmental effect that would deteriorate a silicon chip inside a sealed plastic package in this way. I think more likely suspects are the balun circuit and the few other external passive components that might have absorbed moisture or got affected by temperature variations.
