REPLACING MOUSE BUTTON ON AN EEEPC

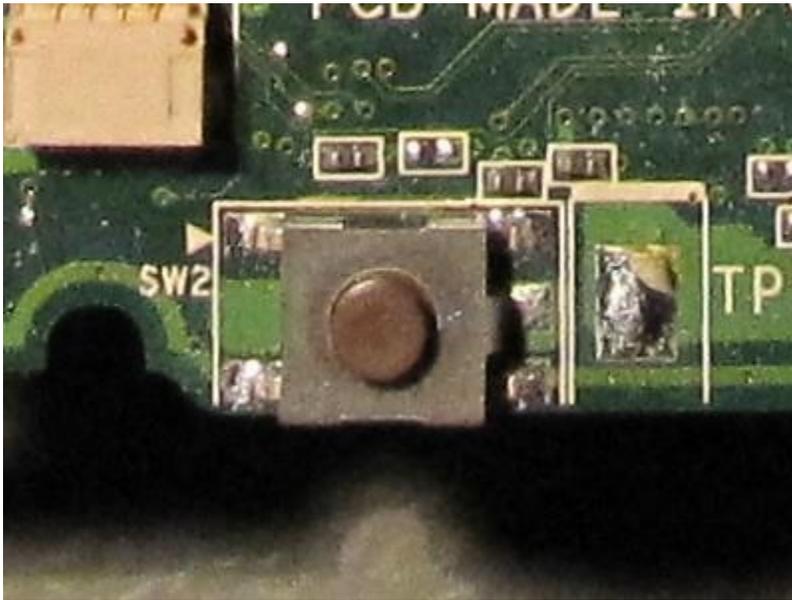
I took the laptop apart and it was immediately obvious that the SMD tactile switch wasn't making a contact when it should be.

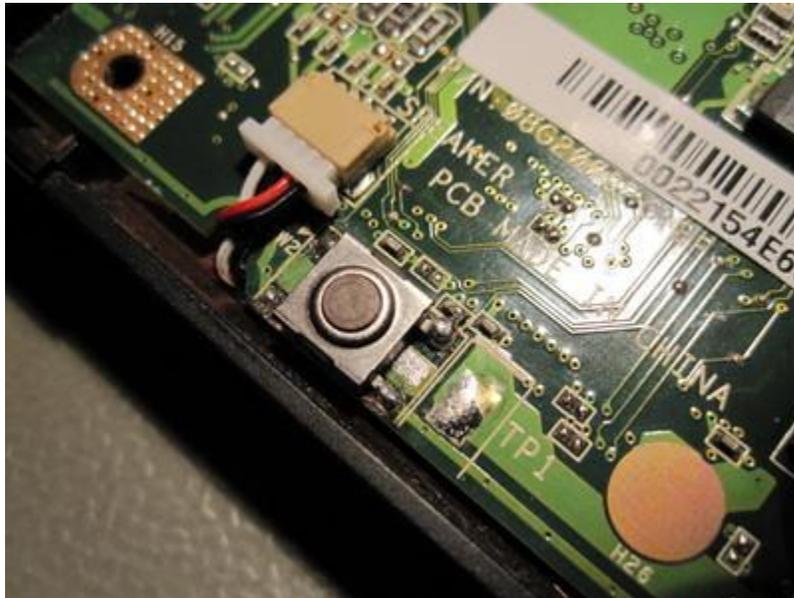
When I replaced the switch, the left click still wasn't working. After some more extensive searching for further faults I found that I must have had accidentally broken a minute PCB trace running from the button's contact to a tiny SMD capacitor nearby. I did a quick fix by bridging the gap with a blob of solder (you can see it at the button's top right pad on the photo above).

The **Diptronics DTSMW-66N**, as pointed out by [Carl on his blog](#), proved to be a satisfactory replacement and was available from the local electronics shop. This switch has the same

outside dimensions as the original, except the button is concealed inside a raised edge. The 901 has an extra millimeter of space under the touch pad (unlike 701) and the button is pressed by a needle that fits inside the circumference, so the raised edge isn't a problem and no other modifications were necessary. This Diptronics switch doesn't have a grounding connection, but as far as I can see, this doesn't affect its operation or the operation of the capacitive touch pad above it.
