# UPDATE ON CC2500 DETERIORATION

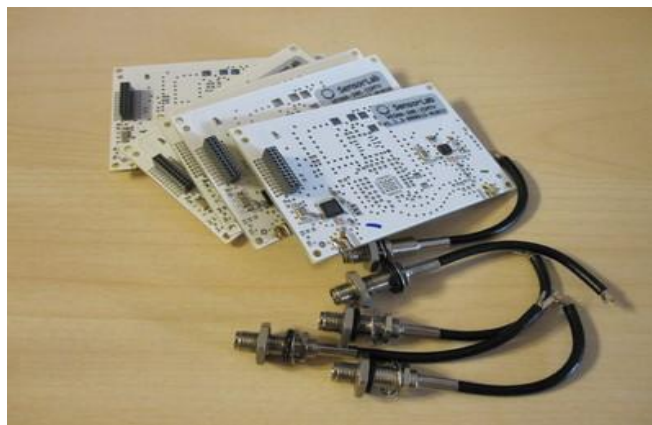
The leading theory at the time was that some component has deteriorated over time due to environmental effects. After some initial testing it appeared that the coaxial cable between the radio PCB and the connector is to blame. However having more boards with this issue in the lab showed that in most cases it's not possible to restore original characteristics only by changing the coaxial cable.

I then fired up the soldering iron and did a brute-force approach: on three bad radio boards I manually replaced components one by one, performing automated tests of the board after each replacement. While replacing the coaxial cable did have a small effect (0.3 dB in the best case), only replacing the CC2500 integrated circuit itself seemed to restore the correct performance. So the suspicion immediately fell on the transceiver chip itself.

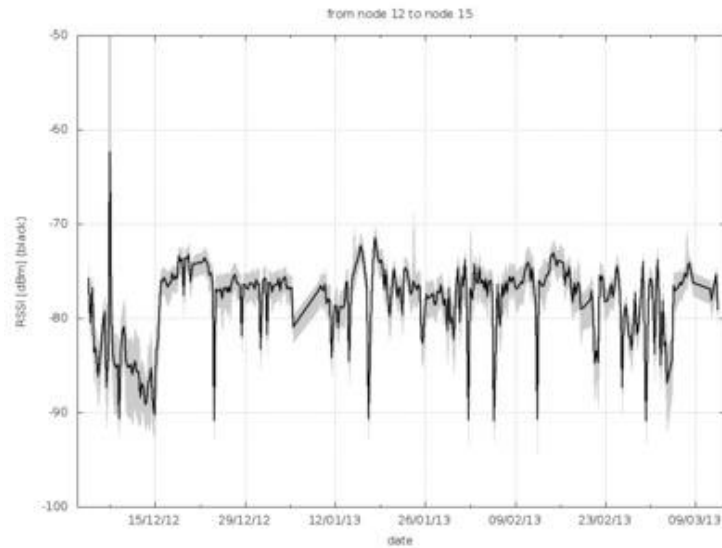
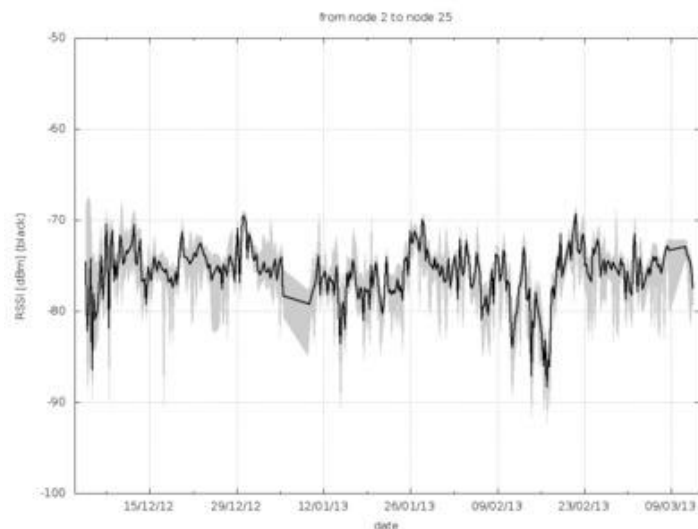
Here are two typical plots of these measurements over time:

As you can see, while there is a lot of variation in the signal strength, there is no obvious downward trend. Variation is probably due to weather and or large things moving around the radios (these are mounted in an industrial zone, so moving trucks and other such things are not an uncommon occurrence).
