Railroad rail sections hold rock in place in Cedar Bluff, VA

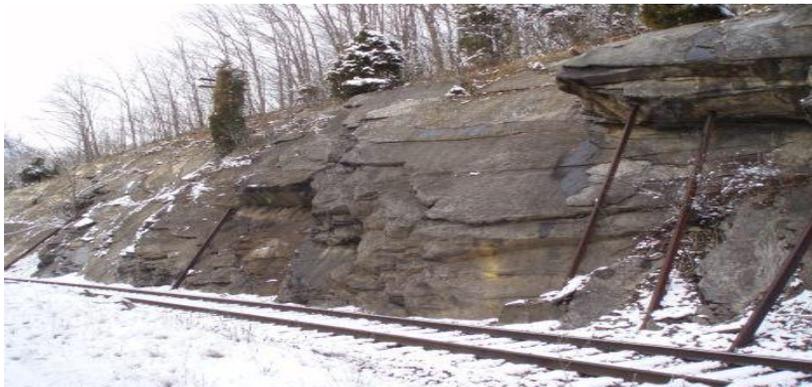
Railroad rails holding rock in place, some dowels are present about halfway up slope near center of image.

First, let's explore what is wrong with this picture. If you are an engineering geologist, you can immediately see a very problematic situation...the rocks here are dipping right towards the railroad. Essentially, the the discontinuities within the rock mass, in this case bedding planes, serve as surfaces on which overlying rock may slide across. When the friction between the rock above and below the discontinuity is overcome, a rock slide may occur, blocking the railroad. During dry weather, the friction is usually enough to hold the rock mass in place. However, in times of heavy rain or snow melt, water entering into the discontinuities causes an opposing pressure which results in a decrease in frictional forces and the failure of the slope. Such was the case in the nearby Interstate 40 Rockslide last October. This location is especially disastrous because this section of railroad is located on a turn through a large hillside cut. In other words, the train conductor would have no way of knowing that large rocks are blocking the rail and would hit them at full speed, most likely resulting in a derailment.

In an attempt to mitigate the problem, the railroad utilized what was readily at hand in order to keep rocks from sliding onto the tracks: they used sections of railroad track to prop up the rock masses which posed the greatest threat. In addition to the rail sections, steel dowels were placed at right angles through the rock and across discontinuities. These are few and very hard to see in the pictures, but they're there if you look for them. They're not rock bolts, which are much more robust, but because of the angle they work pretty well. While this seems precarious and should have been a temporary solution, the ties have been in place for a number of years with no signs of failure in the foreseeable future. Rest assured that should there be reason to believe a rockfall may occur at this location, the railroad would have the issue remedied quickly...nobody wants a derailed train on their conscience.

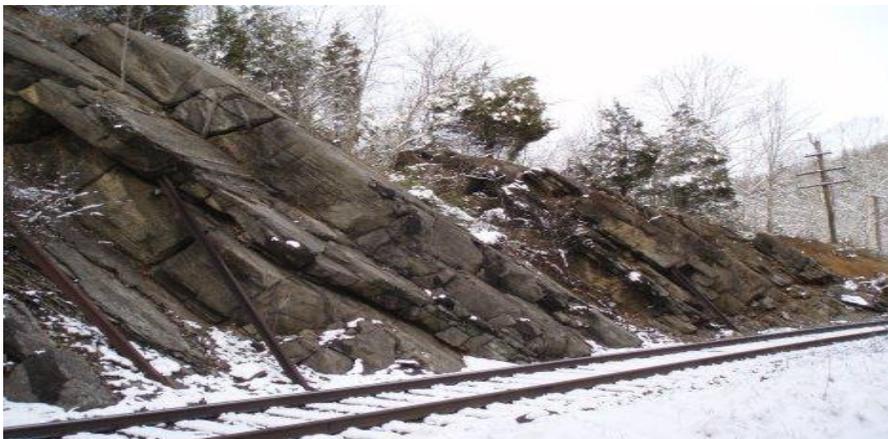
Another angle shows discontinuities more clearly

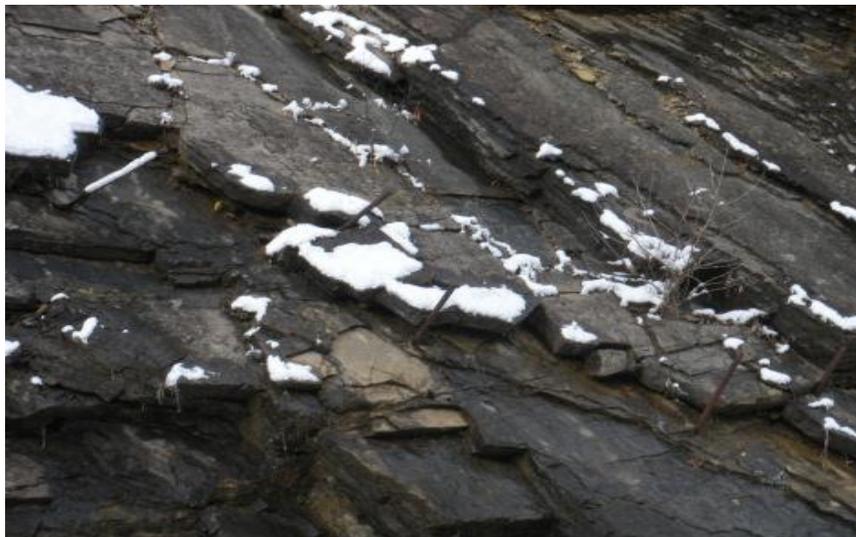
Close-up steel dowels
