Use of Phased Array Ultrasonic Testing For Sizing of Hydrogen Blisters In LPG Wash Water Vessel In INDMAX Unit

Mayank Banjare, Mahendra Pal, Ch. Nanacharaiah & B. C. Mondal

Indian Oil Corporation Limited, Guwahati Refinery, Inspection Department, Guwahati, Assam, India-781020
E-mail: banjaremayank@iocl.co.in, palm@iocl.co.in, nancharaiahc@iocl.co.in, desaiivs@iocl.co.in

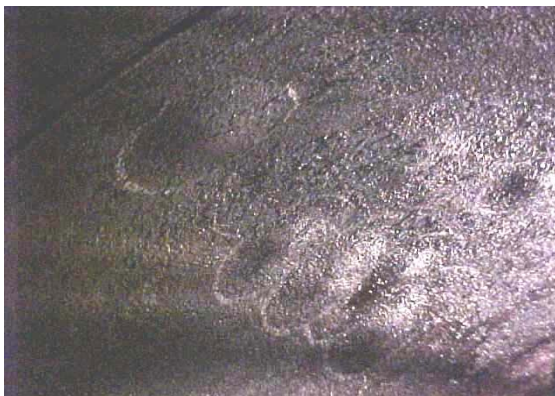
The LPG water wash vessel was opened and black muck was observed inside, which were cleaned manually. On visual inspection it was seen that the vessel had blisters which were found predominantly on the top 50%. These blisters were located with respect to a circumferential seam weld and from the edge of the manhole indicating their sizes as seen from the vessel internal surface. Some of the blisters were seen to have ruptures at their crowns. The height of the blisters was seen to vary between 4mm to 8.5 mm and their diameters varied between 35mm to 130mm. Cracks up to 50 mm length were observed at almost all the blisters. Most of the cracks were branched in different directions. The thickness of the bulged portion from inside was observed between 7 to 9 mm. Grooving up to 1 mm depth were also observed at distributed locations at the top half of the vessel. However, no blisters were observed at both the domes and the bottom half of the shell of the vessel.

Photograph No.01: Series of blisters on the shell.

The condition of the vessel has deteriorated considerably and it was recommended for replacement with a new vessel internally lined with refractory within three months.

- (a) The vessel was re-rated for a maximum operating pressure of 13 Kg/cm².
- (b) In case the operating pressure is further reduced from 13 kg/cm², it is to be ensured that same doesn't cause formation of LPG vapor in the wash water vessel.
- (c) All blisters were punctured by drilling on their crown. Hand drills were used for this purpose with adequate precautions for safety of the personnel. This precaution was required as a safe guard against accidental burning of hydrogen released by the blisters.
- (d) The PSV mounted on the vessel was set at 12.7 Kg/cm² as against the original of 19 Kg/cm², so during operation the pressure does not exceed the re-rated value.
- (e) Hydro test of the vessel was avoided to prevent unnecessary stresses being generated.

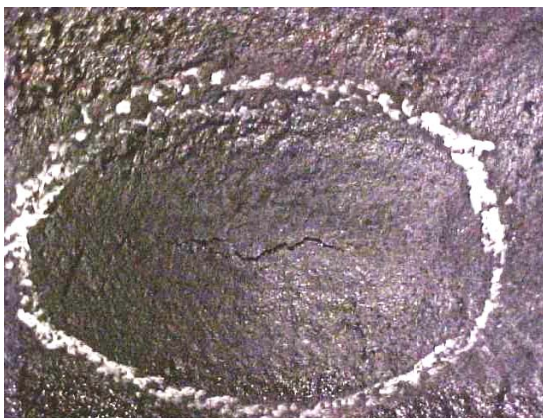
Photograph No.02: Close up view of a blister with branched cracks at its center.

From process parameters study, history of the equipment, nature of defects etc. it is inferred that the root cause of blister formation within short service of the vessel is on account of H₂S slippage resulting from insufficient caustic wash of LPG. The hydrogen liberated in the presence of wet H₂S facilitates diffusion

of nascent hydrogen in the metal. This hydrogen recombines at regions of heterogeneities/ discontinuities (laminations) within the material. The consequent localized increase in presence at these locations results in blisters. Presence of cyanides (normally formed in INDMAX/ FCCU) further accentuates the hydrogen diffusion into the material.

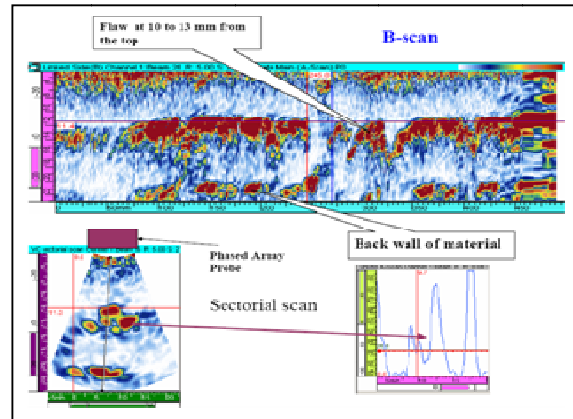
Phased array ultrasonic testing was carried out for determination of actual region of damage and for sizing of the defects. Ultrasonic B-Scan was used to find the distance between two individual indications in x-direction where as sectorial scan (S-Scan) was used to find out axial indications. 3D mapping of vessel using multichannel PA-UT revealed linear indications varying in size from a minimum of 4mm to 25mm at a depth varying within 10 to 13mm from outside surface. PA-UT also confirmed that the extent of damage is predominantly on the top half of the vessel as compared to that of the bottom.

Photograph No.03: Section view of vessel shell plate showing blisters in the mid-wall section under PA-UT scan.

PA-UT analysis reveals that most of the linear indications lie embedded near mid wall with a remnant thickness of minimum 10 mm from the outer surface.
