# Cape Town Stadium structural challenges

## CAPE TOWN STADIUM: STRUCTURAL CHALLENGES

### Technical Excellence category

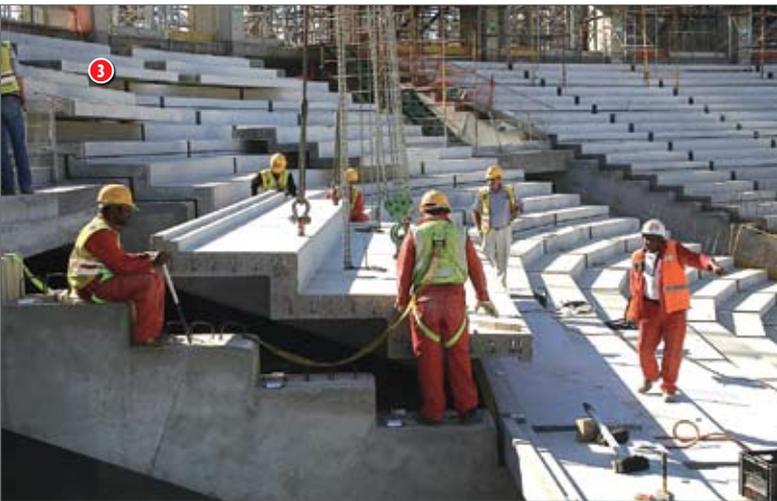
② Inclined pylon construction (Photo: Terry February)

As a direct consequence of these two changes, extensive RC elements were added to cater for in-plane forces in the radial planes, especially under seismic loading. More critical from a programming point of view, the pylons could no longer be constructed freely ahead of the rest of the structure (see photo 2).

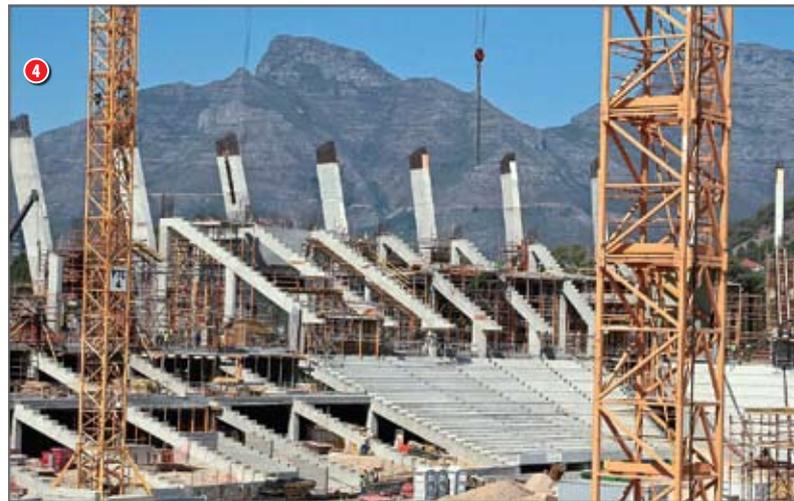
③ Pre-cast seating beam installation (Photo: Gerrit Bastiaanse)

- Finite element analysis was used to check the natural frequencies of the PC seating beams, which as a result were cast in 3-stepped Z-shaped sections, increasing their stiffness (see photo 3).
- Being supported on in-situ concrete raking beams, construction tolerance was built into the plan arrangement by incorporating a 200 mm strip of in-situ concrete between the PC seating panels. This provided moment continuity under live loads and assisted in stiffening the structure, improving both seismic resistance and frequency response (see photo 4).

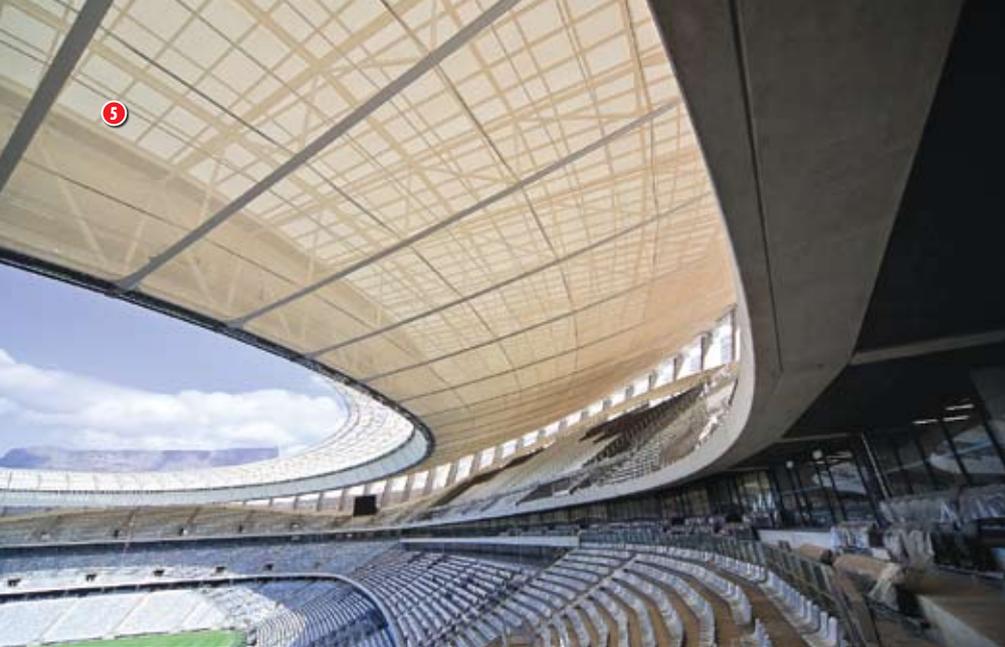
④ Pre-cast seating beams and their supporting raking beams (Photo: Gerrit Bastiaanse)

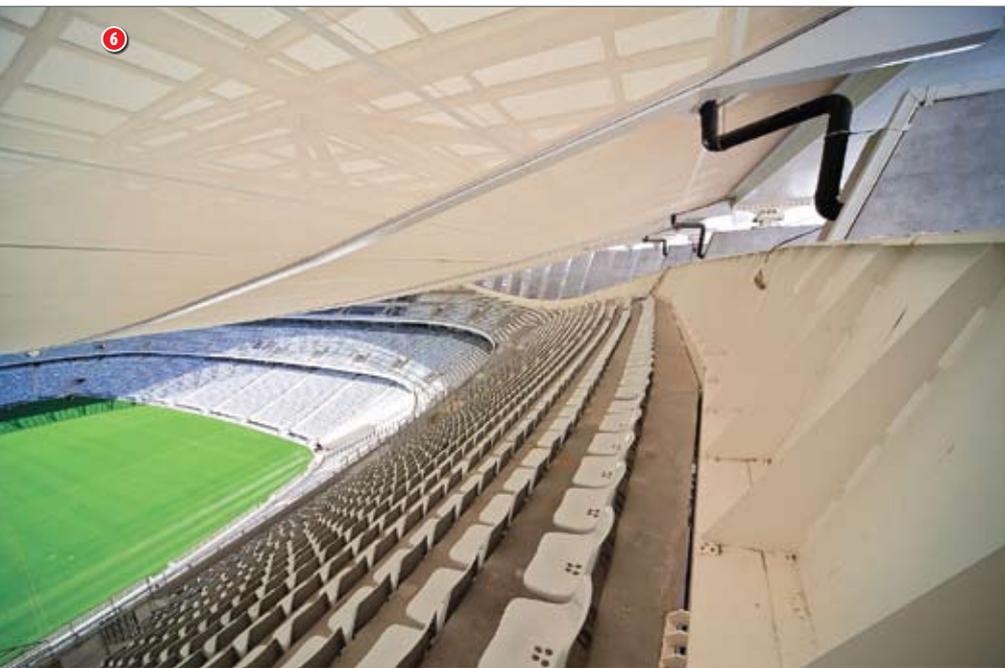
- 5 Tier front edge (Photo: Schalk Marais)
- 6 Steel balustrade beam (Photo: Schalk Marais)
- 7 Perimeter escape stairs (Photo: Terry February)
- 8 Steel and glass roof construction (Photo: Terry February)

- Considerable attention was given to the highly visible front tier edges. Unlike the segmented seat panels, they follow various radii to create the continuous curved front edge. These front edges are not supported directly on the raking beams, but cantilever beyond, providing an elegant edge to the concrete tiers (see photo 5).
