Chute lining

makes for improved refuse handling

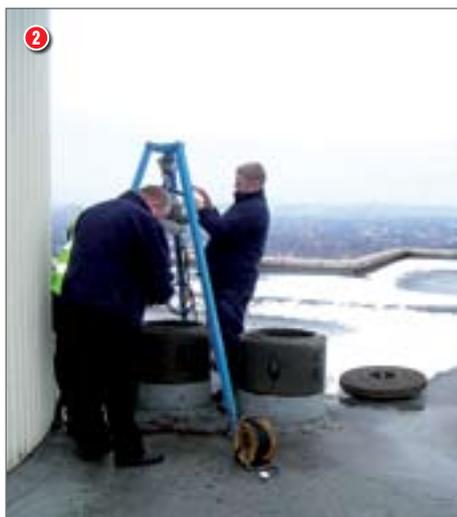
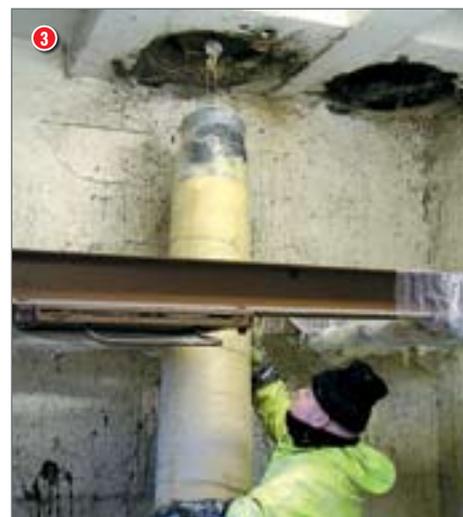
2 and 3 The roof top winching position for hauling the prepared liner into position from the chute bottom

Since no access is required to homes in any block, there are no particular access difficulties for the contractor to be overcome. Lining is achieved with the crew situated towards the top of the building, either on the roof or located at the highest refuse hopper location on the top floor of the building. Lining is completed from top to bottom in 5 m sections, this being the section length between hopper entry

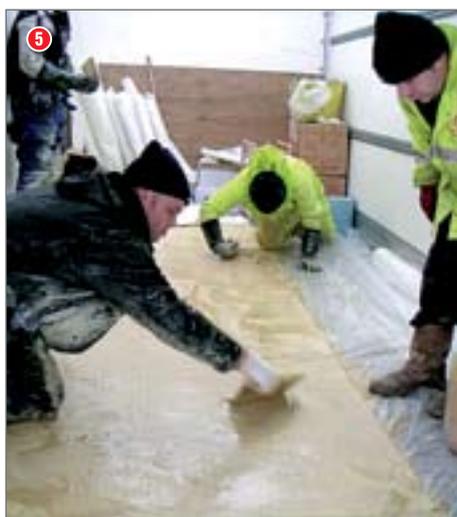
5 and 6 Each liner section is carefully prepared by hand and rolled onto the inflatable packer (figure 5). The liner is held in place around the packer using a special netting (figure 6)

The impregnated liner is placed around a packer and held in position using special netting around the outside. This packer is prepared on the ground floor, at the base of the refuse chute. The packer arrangement is then hoisted up into the chute from the roof or top floor working location until it is in the required position within the chute. The packer is then inflated with compressed air to push the liner into place against the inner wall of the chute. The liner is then held in place whilst the ambient cure resin sets. The use of the packer system can be compared to a typical patch liner system in a sewer repair operation, only vertically orientated. Once the liner has cured the packer is deflated and lower back down the chute to prepare for the next length.
