# Demolition of the Athlone Cooling Towers

**Technical Excellence category**  
**Submitted by the SAICE Western Cape Branch**

The Athlone Cooling Towers, also known as the “two ladies of Athlone”, used to be a distinctive Cape Town landmark. In February 2010, however, the stiffening rings on Tower One failed and the entire tower was at risk of collapsing. Following inspection and evaluation of the towers, it was recommended that both towers be demolished as a matter of urgency. Kayad Knight Piésold Consulting was appointed as consulting engineers and on 22 August 2010 the towers were imploded, collapsing exactly onto their footprint, as designed. The demolition was a world first in terms of stiffening rings being imploded, and regardless of all the initial concerns and issues raised, the results were technically perfect

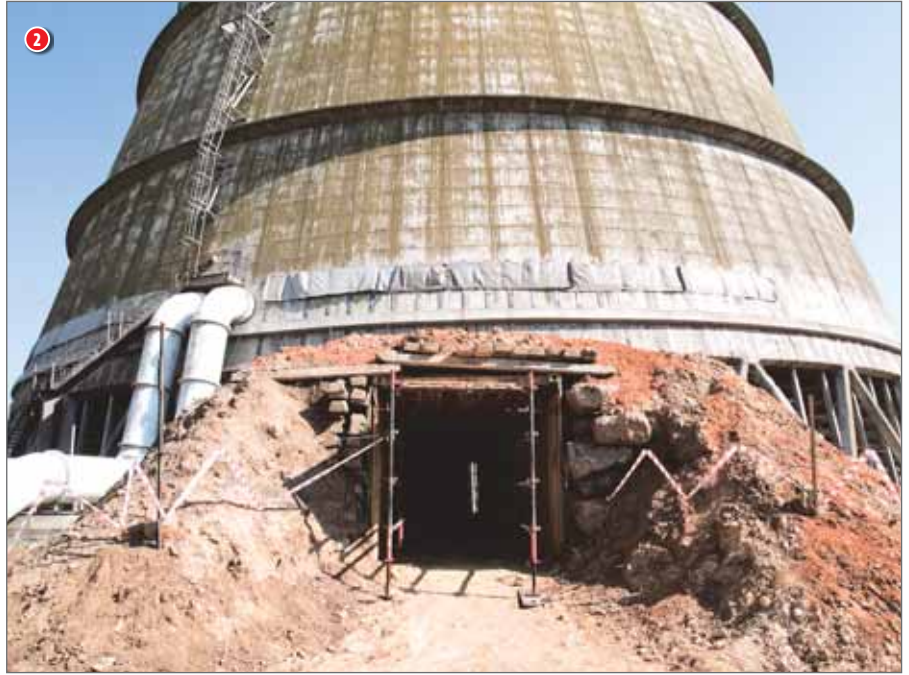
- 1 Visible concrete debris on Tower One following the failure of the stiffening rings
- 2 The constructed access tunnel to Tower Two
- 3 Use of "test blast" to optimise charge sizes

The Athlone Power Station and Cooling Towers were completed in the 1960s. Following the collapse of similar towers in the United Kingdom, the Athlone Towers were strengthened with stiffening rings in 1993. This solution was effective at the time, but 17 years later, on 14 February 2010 (many years after the cessation of power generation), the top ring on Tower One failed and came crashing down, taking the other rings with it. Tower One was at high risk of collapsing, and so was Tower Two, as the stiffening rings for both towers had been constructed at the same time. It was recommended that both towers should be demolished as a matter of urgency. A tender was called for by the City of Cape Town to implement this emergency project.

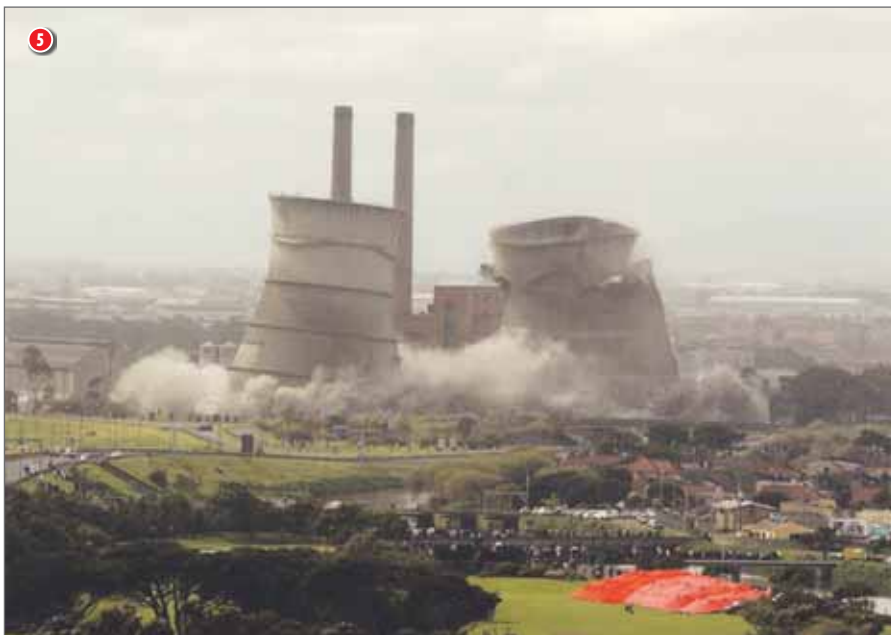
- 4 A view of the towers imploding, reflecting the tilt as designed
- 5 Tower One crumbling, followed by Tower Two
- 6 The bit that resisted the blast

The charges of Tower One would be detonated first, with Tower Two following approximately one second later. The demolition was being planned in such a manner that the towers would fall slightly towards each other, but would be largely
