# Geotechnical aspects of an Eastern Cape wind farm

Various wind farms are now under consideration by the South African power authorities, as part of the renewable energy drive to lower the reliance on coal. This article describes the geotechnical aspects of one at present under construction in the Eastern Cape.

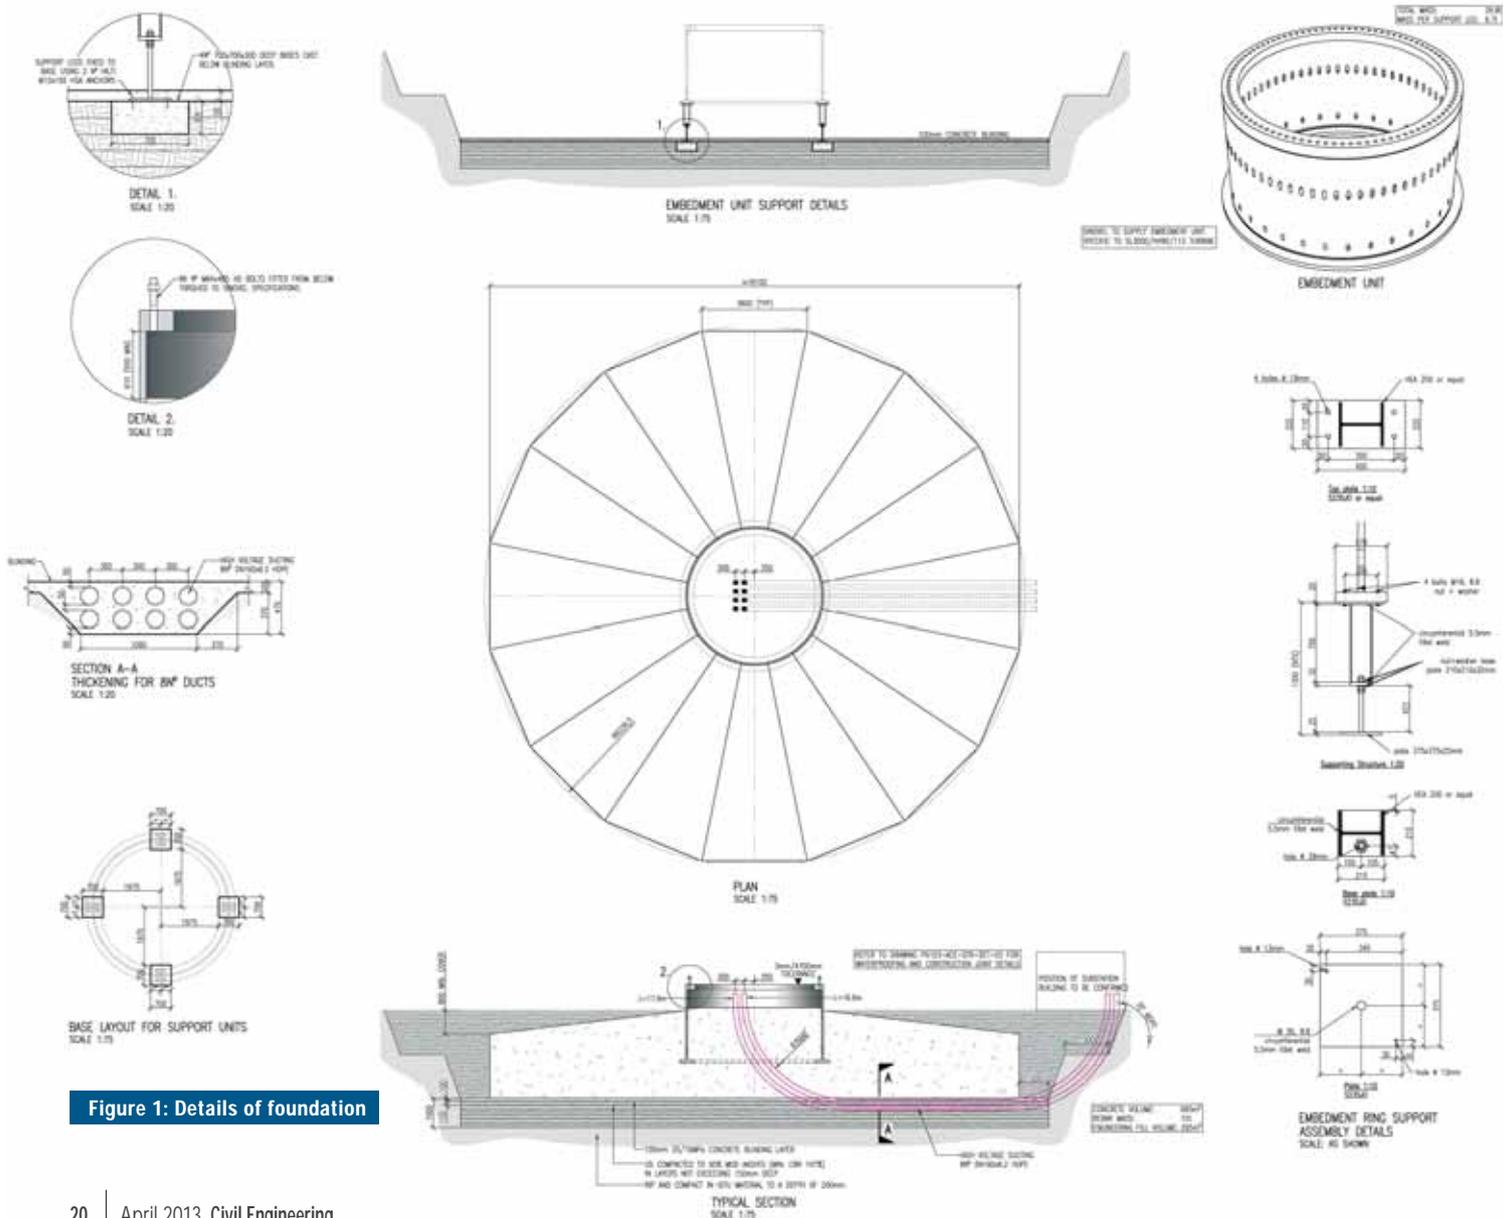
Figure 1: Details of foundation

Comprising 9 x 95 m hub-height, 3 MW turbines, the foundations are hexadecagon (16-sided) reinforced concrete structures 18.1 m across flats some 3 m thick, as detailed in Figure 1.

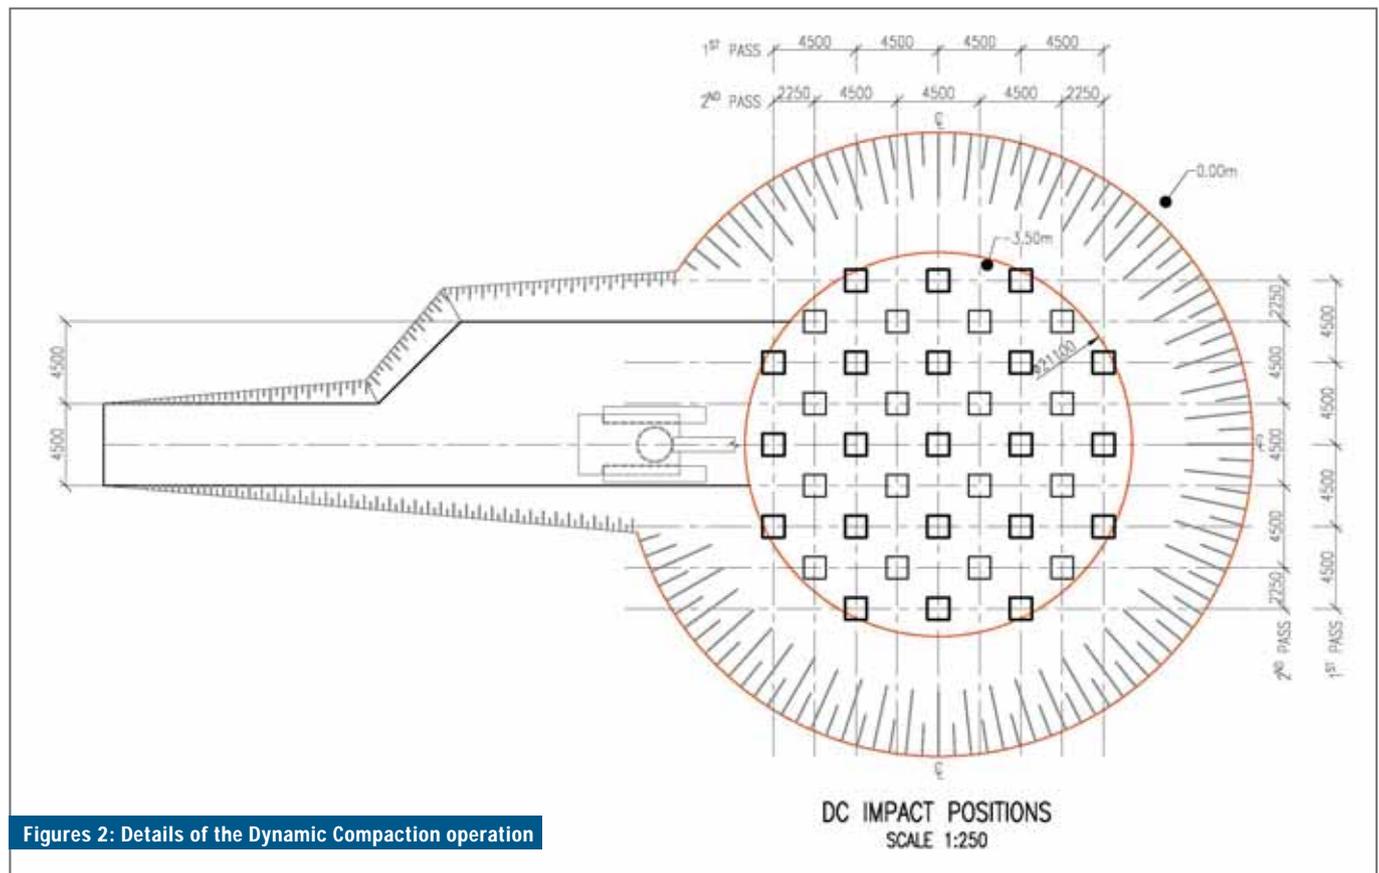
**Figures 2:** Details of the Dynamic Compaction operation

After much deliberation it was decided that DC would be used. The design, based on the formulations of Oshima & Takada (1997) called for 13 blows of a 12 tonne mass falling through 18 m on a 4.5 m grid, with one in the middle as detailed in Figures 2 and 3. This primary compaction was followed by an ironing operation.

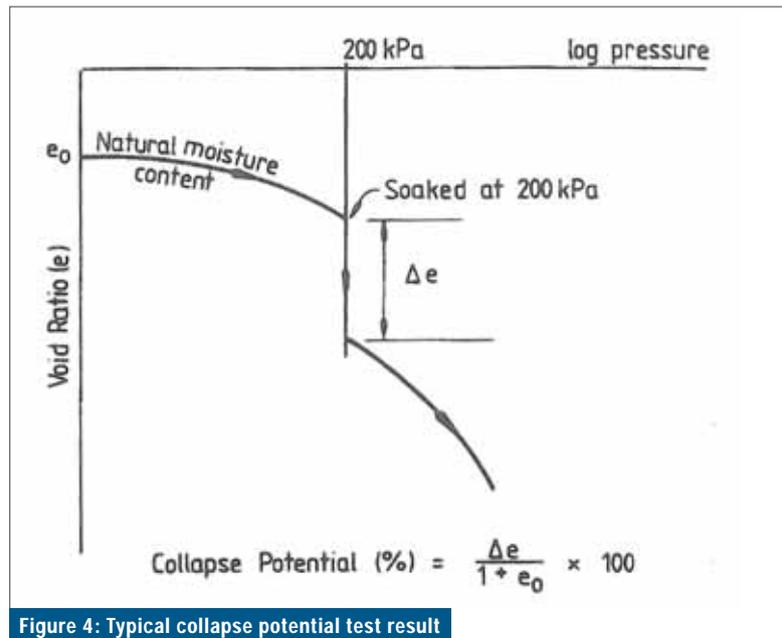
Figure 4: Typical collapse potential test result

In this regard consider Figure 4 taken from the seminal paper by Jennings and Knight (1975).

This figure represents a typical collapse potential test. As may be observed, before collapse the material exhibits a fairly stiff structure, as evidenced by the shallow slope of the initial portion of the curve. However, after collapse the slope is very much steeper, representing a less stiff material.

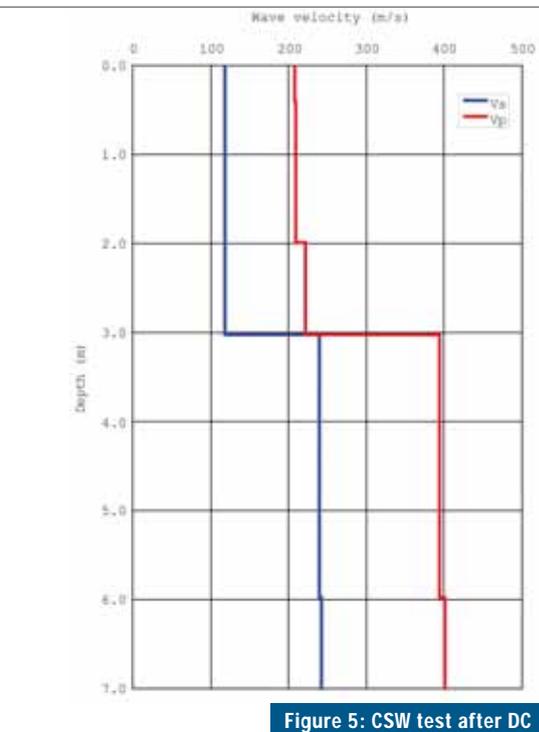
Figure 5: CSW test after DC

Thus, although the DC had the effect of generating a less stiff material after compaction than before, the open grain structure due to the cementation would have been destroyed and a much denser material obtained. However, this is not to say that the densities achieved are sufficient. An examination of the measured shear wave velocities revealed the following (also see Figure 5):

Shear wave velocity ( $V_s$ -values) in excess of 160 m/sec are deemed acceptable. This is not so where values of around  $V_s=120$  m/sec were obtained. Remedial action was deemed necessary. This action was, however, complicated by the fact that CSW testing was only conducted after base preparation works, which included a high-strength geosynthetic, 6 x 150 mm G5 layer, the blinding and the initial steel placement, as detailed in Figure 6 (which also shows the CSW testing being undertaken).

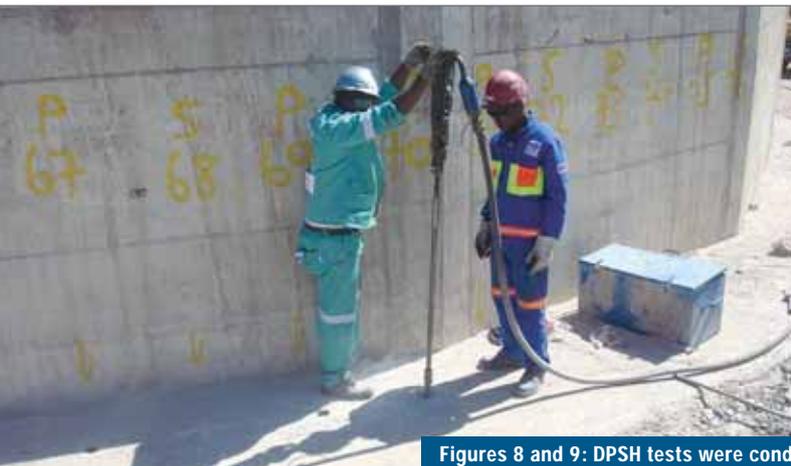
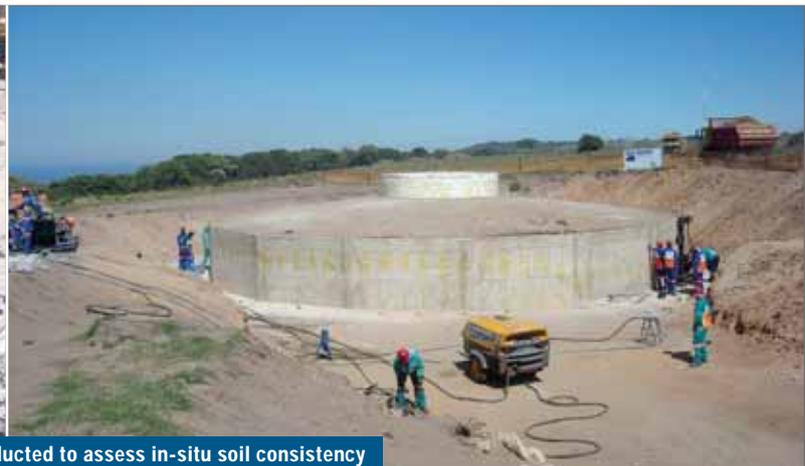
Figures 8 and 9: DPSH tests were conducted to assess in-situ soil consistency

A system was detailed in which DPSH tests were conducted around the edge to a depth of 6 m at 600 mm centres. The 50 mm cone at the tip of the DPSH was welded to the rods, which were jack-extracted to enable re-use. The blow count per 300 mm penetration results were

electronically recorded in a spreadsheet and sent to the designer on a daily basis for evaluation. This enabled a much more detailed assessment to be made of in-situ soil consistency. The holes were then pressure-grouted on a grout-one-skip-one

basis under 100 kPa using an initial mix of 60 litres of water to 50 kg of cement. If grout takes exceeded 20 litres, the mix was progressively thickened to 40 litres of water, and then in a final step to 20 litres (see Figures 8 and 9).

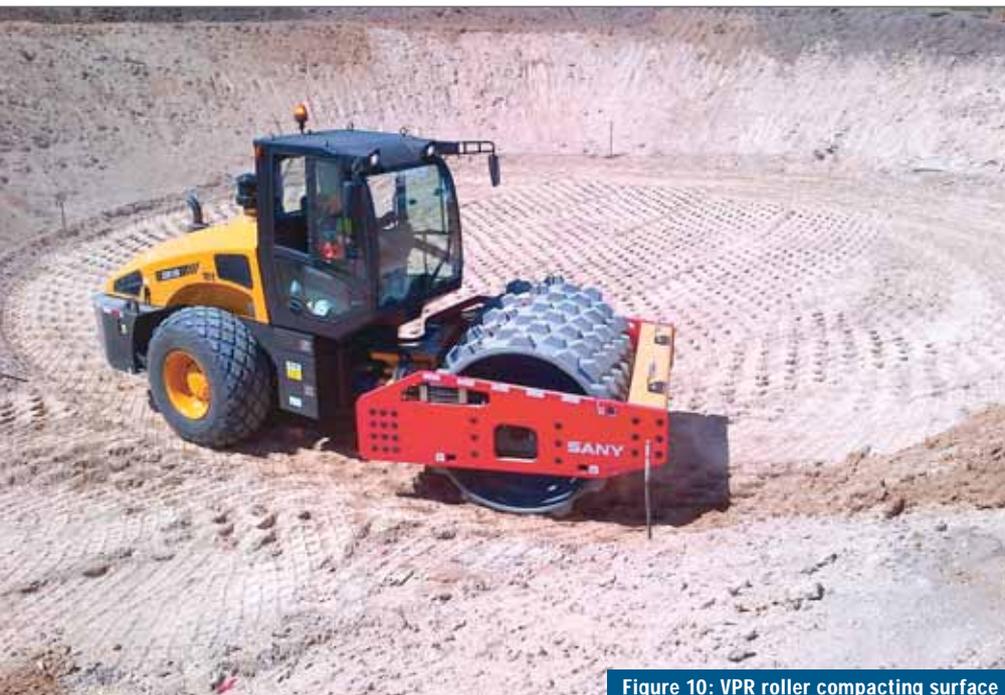
Figure 10: VPR roller compacting surface

In many of the bases, the CSW testing only indicated non-compliance in the top 2 m or so. In this case it was reasoned that rolling would be sufficient to ensure compliance. Calculations revealed that 55 passes of a 380 kN centrifugal force, 1.9 mm amplitude, vibrating padfoot roller (VPR) would be needed for the required compaction standard. This was conducted as per Figure 10 with a typical CSW result, as detailed in Figure 11. What is obvious from these figures is the effect of the roller on the top 2 m of the profile.
