IN THE PITS

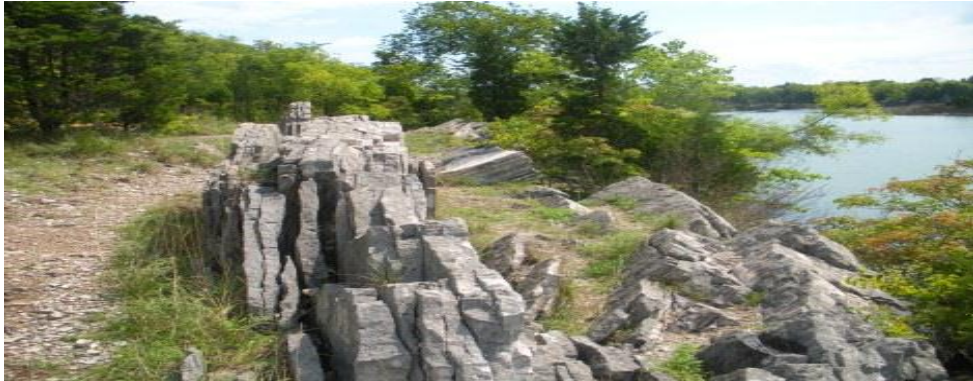
"Clue #3" from the puzzle

You've seen all the pictures and descriptions from the actual puzzle. If you haven't – or if you don't quite remember – here's a quick recap (although I recommend glancing over the puzzle). You were presented with four pictures. The first three were all pictures of rocks with obvious bedding planes with a lake in the back/right of the picture. The bedding planes are near horizontal in the first image, at an approximate 45° angle in the second image, and near vertical in the third. All three pictures were taken facing the same direction and within 100 yards of one another as I walked along a near linear path.

Naturally, if nothing significant had occurred here, the bedding planes would remain horizontal across the board. Therefore, these three images would seem to imply structural deformations (folding, faulting, or something of the sort).

The strange structure, what you should have envisioned as a sort of twisting of the rock, would be difficult to achieve through large-scale tectonic deformations. If this were the case, applied forces would affect the entire region similarly, not uplift and overturn some portions, but leave others alone which existing only yards away.

Faulting is a better explanation. Especially when you consider that rotation could have occurred between the two affected blocks. For example, a vertical fault occurs between blocks three (image three) and two (image two). Block three is rotated about 45° counter-clockwise relative to block two. Then, a second fault ruptures between blocks two and one, causing blocks two and three to rotate 45° relative to block one in the same direction. If you're following this, you'd get the setup we have in the images: block one remains horizontal, block two is at an angle, and block three is now vertical! However, this isn't right, either.

By now, you've probably figured out that this was a trick question. Don't hate me. This was not so much a trick, as a way to show how important it is to understand your surroundings when making geologic interpretations. The images and even the hints were purposefully vague in order to get you to think about all possible explanations. These pictures were taken on Kelleys Island in Lake Erie, along a hiking trail which (nearly) circumnavigates Horseshoe Lake. While many of the folks who left comments were seeing signs that they were not looking at folds or faults, but broken off pieces of rock, one person was able to determine that what we're looking at is the edge of a quarry (good job!).

The East Quarry, where the puzzle pictures were taken, has been abandoned for a long time before this and is now called Horseshoe Lake, due to the shape of the pooled water inside. The “twisted” limestone rocks, as you now know, are a result of broken pieces along the edges of the quarry, and not due to any folding or faulting (sorry structure people!). I hope you found the puzzle challenging and have learned a little more about how geology affects you!

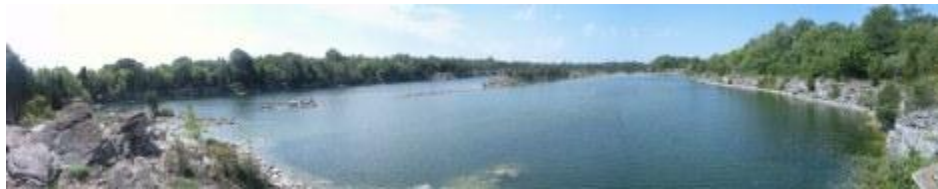
Panorama of East Quarry

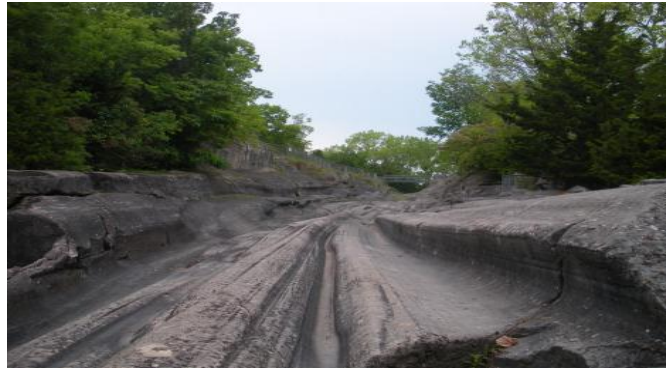
World class glacial grooves on Kelleys Island

Over time, as we can see now, the seas receded and the region was uplifted. Erosion and non-deposition prevailed over the last 200 some million years of Ohio's history, with glaciers up to a mile thick scraping over the northern two-thirds of the state in the last two million years. At Kelleys Island, you can still see the scars of the most recent glacial advance, about 14,000 years ago. The combination of this uplift and erosion allowed the limestone rocks on Kelleys Island to become exposed at the surface.

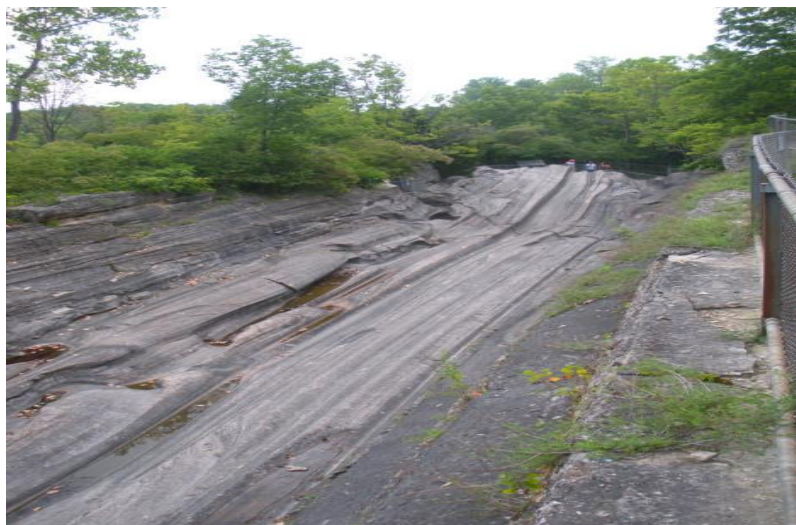
Glaciers carved long grooves into the rock at Kelleys Island, OH

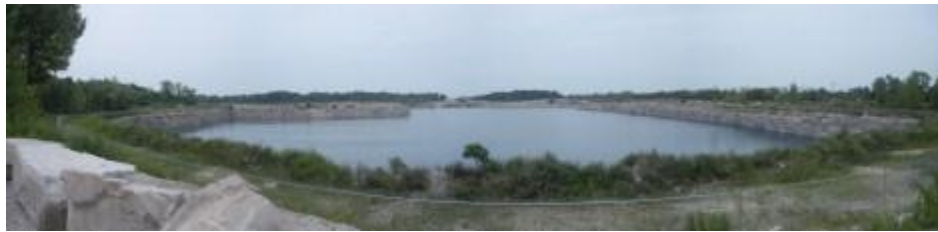
The recently closed limestone quarry has since filled with water.

In order to cut into and extract the rock without the pit filling with water, quarry operators must employ industrial pumps to “dewater” the aquifer in this area. In other words, they lower the water table to below the base of the quarry.

What did this mean for Kelleys Island? Because the water table was lowered, many residents had to go without water because their private water wells went dry. There was also speculation that the water was contaminated by the lime dust created by the quarrying operations. However, this is not true since lime is actually created outside of the quarry (you have to “cook” the limestone at nearly 1,000 °C to create lime). Even without contamination, the lack of water to wash and drink obviously troubled the residents enough to file multiple complaints. Eventually these complaints got the better of the company and operations were shut down in 2009.
