Nelson Mandela Bay Municipality Water Loss Programme

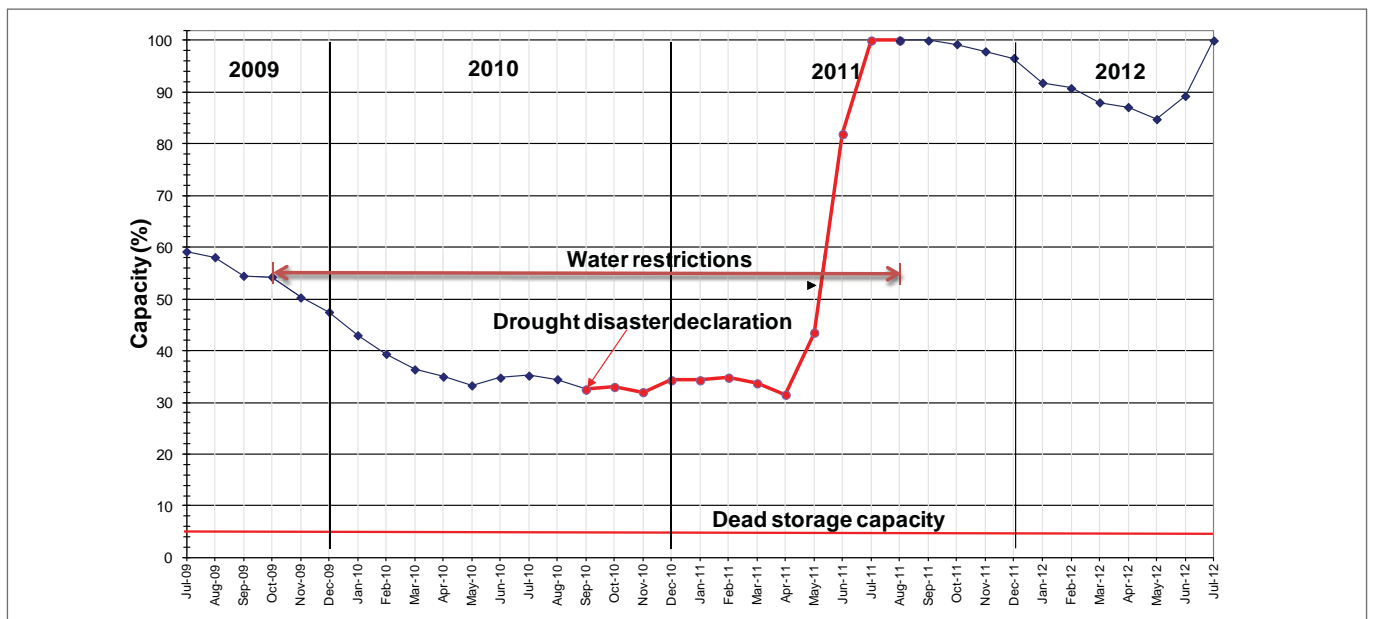
Figure 1: Storage capacity of the Nelson Mandela Bay Municipality dams (2009 to 2012)

water sources. Figure 1 shows the significant fluctuation in the supply dam levels over the last 37 months, highlighting the importance of water resource and demand management for the municipality.

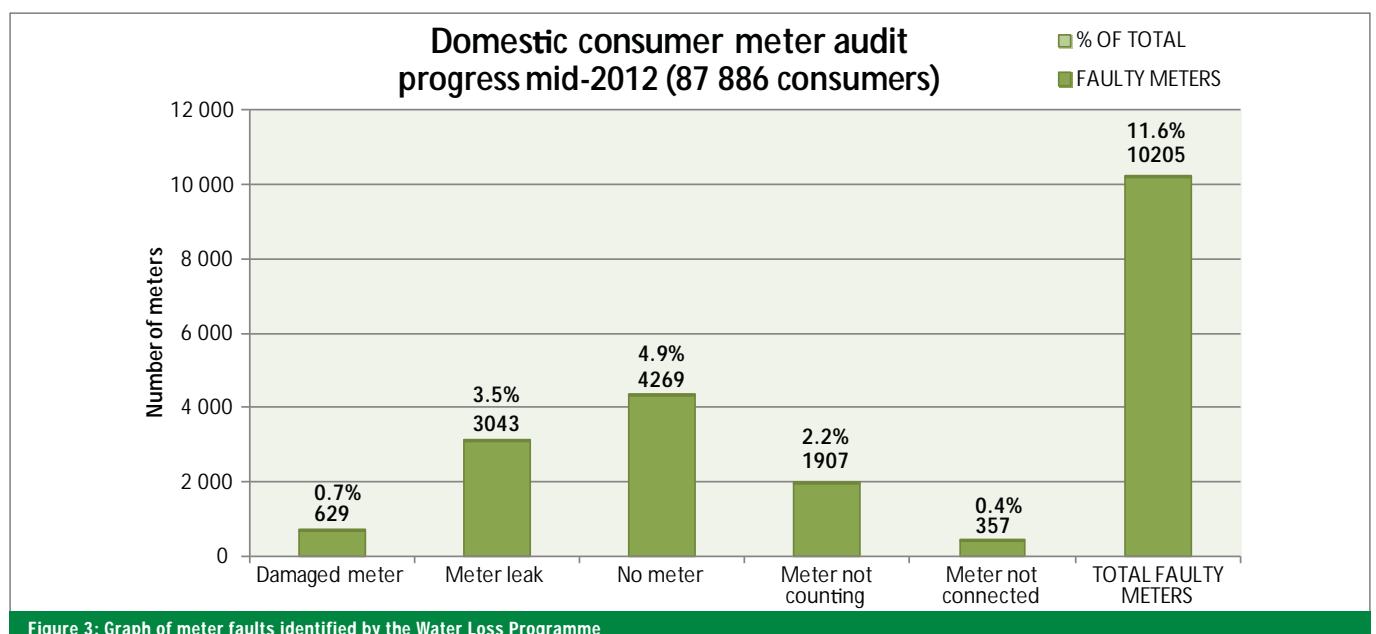
Figure 3: Graph of meter faults identified by the Water Loss Programme

The results shown in Figure 3 and 4 provide a summary of leaks and faults actioned as a result of the Water Loss Services Programme in the domestic supply areas targeted to date.

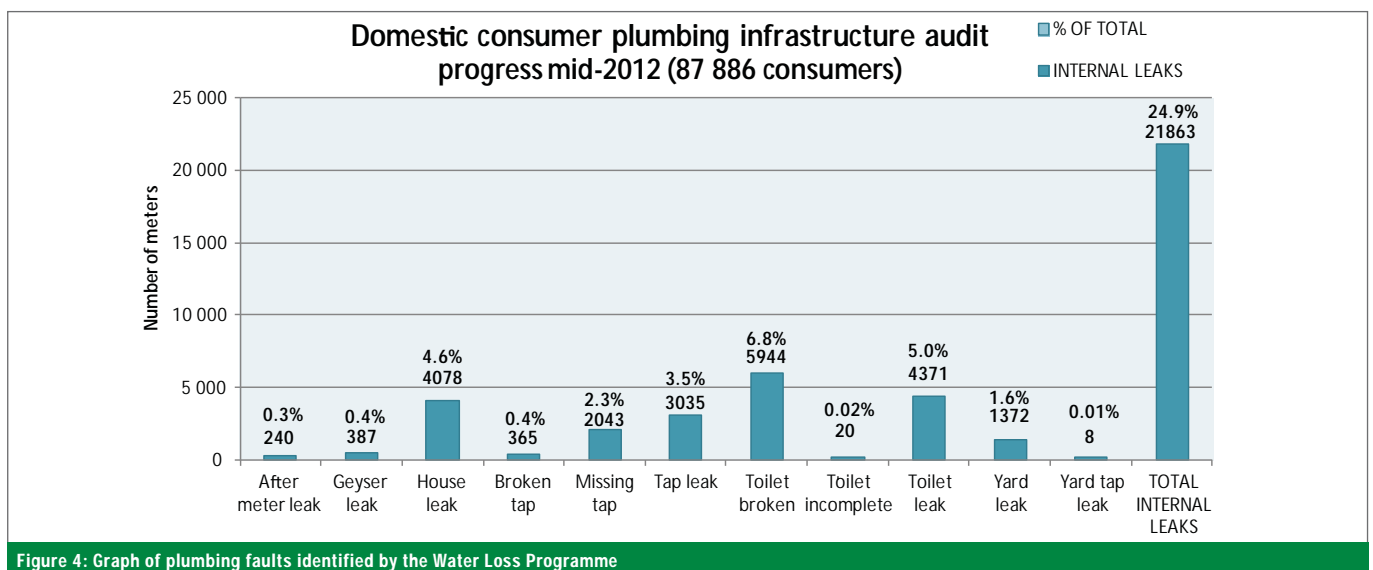
Figure 4: Graph of plumbing faults identified by the Water Loss Programme

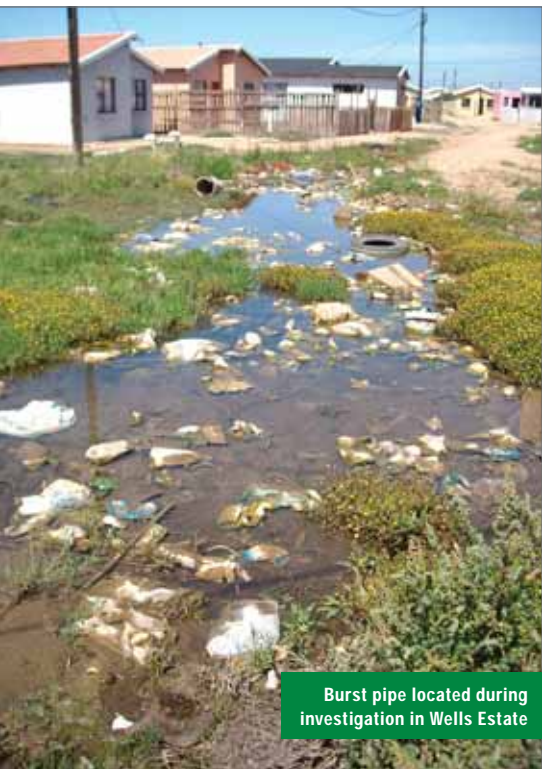
Burst pipe located during investigation in Wells Estate

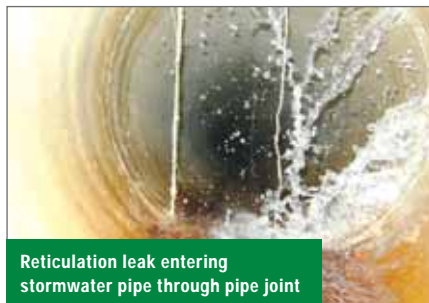
Reticulation leak entering stormwater pipe through pipe joint

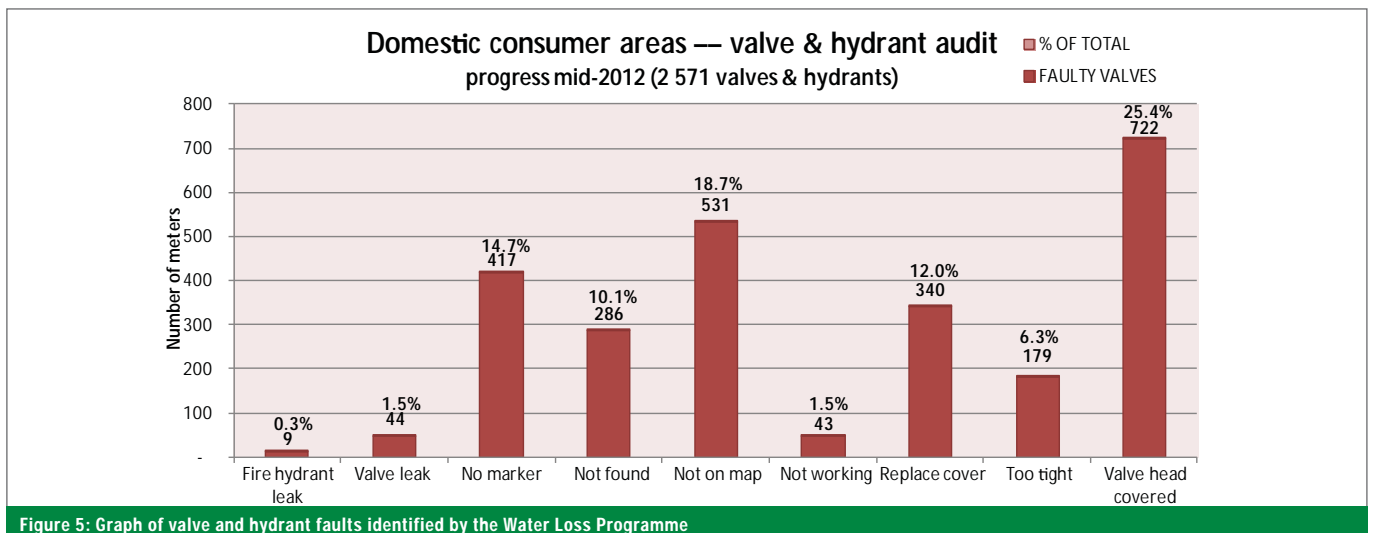
Figure 5: Graph of valve and hydrant faults identified by the Water Loss Programme

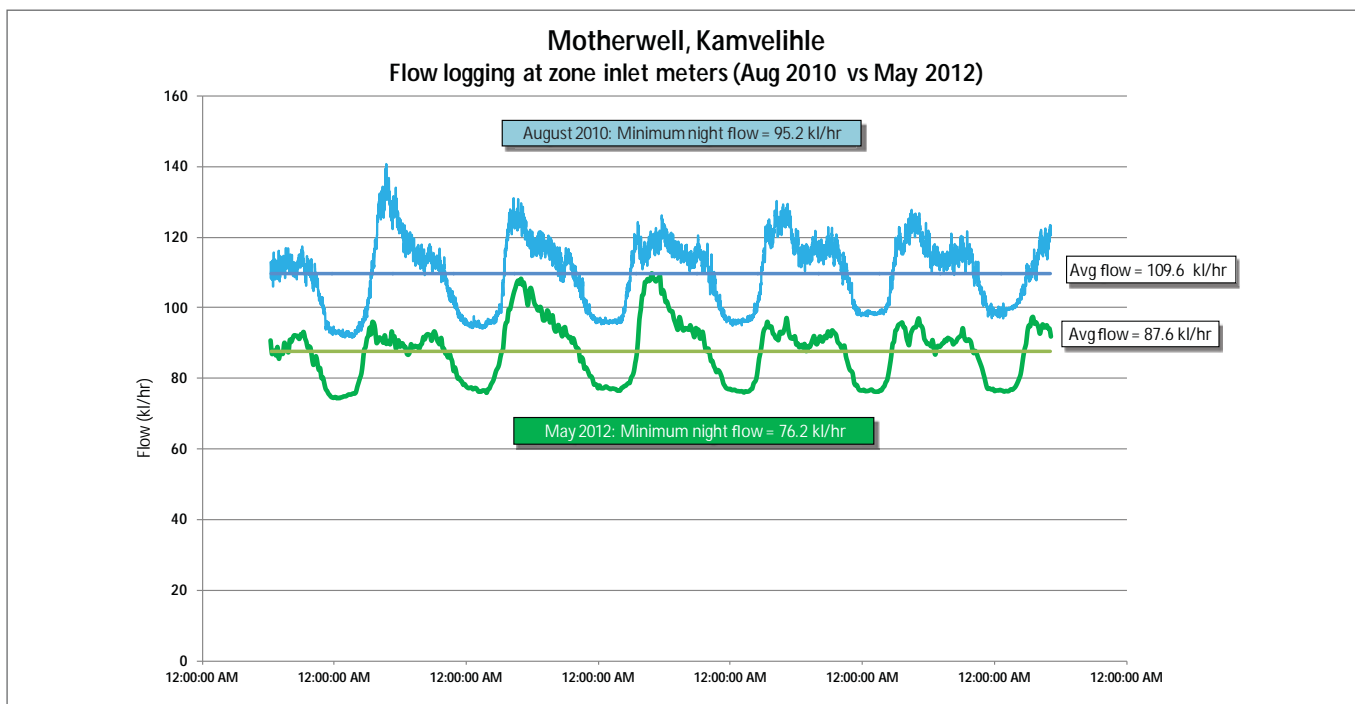
Figure 6: Flow logging results for Motherwell, Kamvelihle (August 2010 & May 2012)

The flow logging results provided in Figure 6 for Motherwell, Kamvelihle, show excessively high minimum night flows (lowest consumption usually between midnight and 4 am) measured in August 2010 prior to the water loss investigations and follow-up interventions. This is compared with a reduced minimum night flow measured in May 2012.

It is noted that the excess night flow for the zone has been reduced by 19.1 kl/hr (22%) as a result of the interventions (excess minimum night flow calculated using the WRC SANFLOW Software). Sewer logging results taken pre- and post-interventions show a reduction in the minimum night flow of 5.1 kl/hr. The minimum night flow (MNF)/average flow ratio was reduced from 83.5% to 67.9%. The logging results also show, however, that there is still significant scope to further reduce leakage in the supply area. The results of the sewer

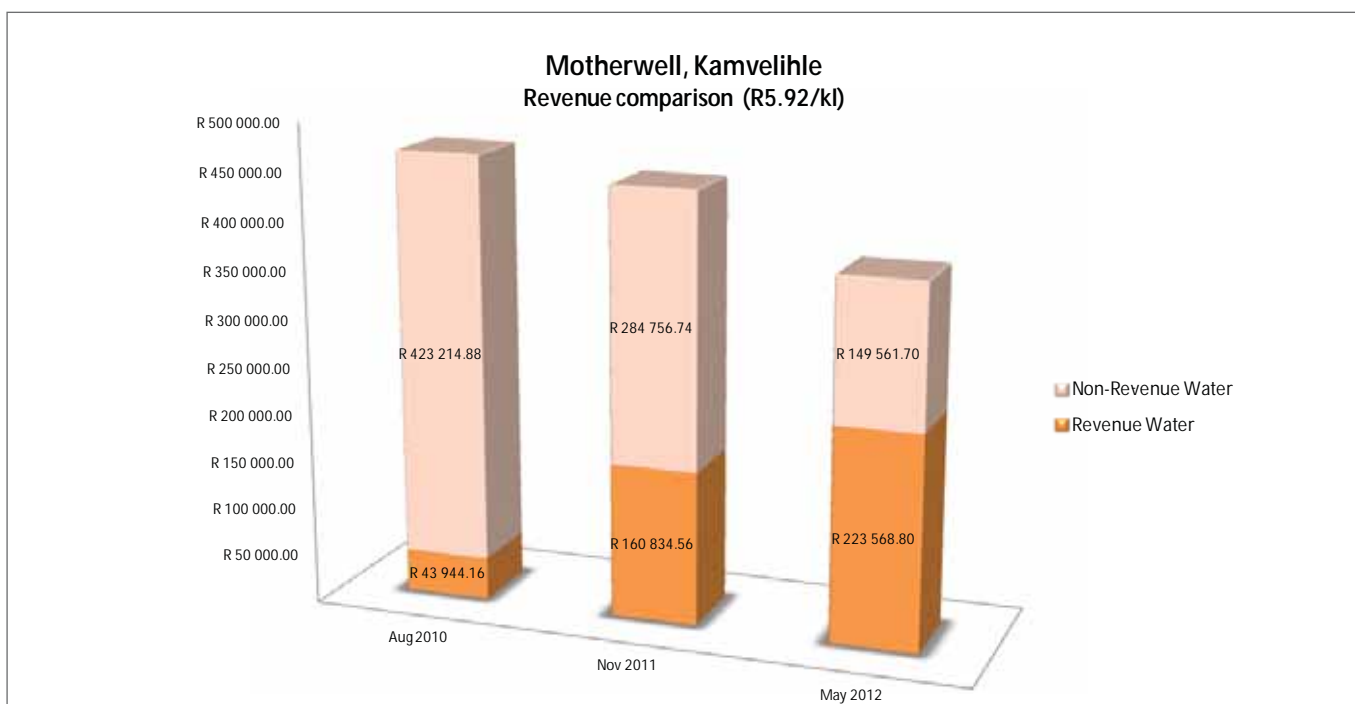
Figure 7: Revenue comparison for Motherwell (August 2010 – May 2012)

logging show a reduction in the minimum night flow of 5.1 kl/hr. The contributing factors to this reduction include the ATTP repairs (indigent household repairs). The revenue comparison in Figure 7 shows the combined impact of the Water Loss Programme in decreasing water losses. Non-revenue water has decreased through the various interventions targeting leakage while revenue water has increased through improved metering, meter-reading and billing. The return on investment has been calculated to be 16 months after the reduction of the MNF.

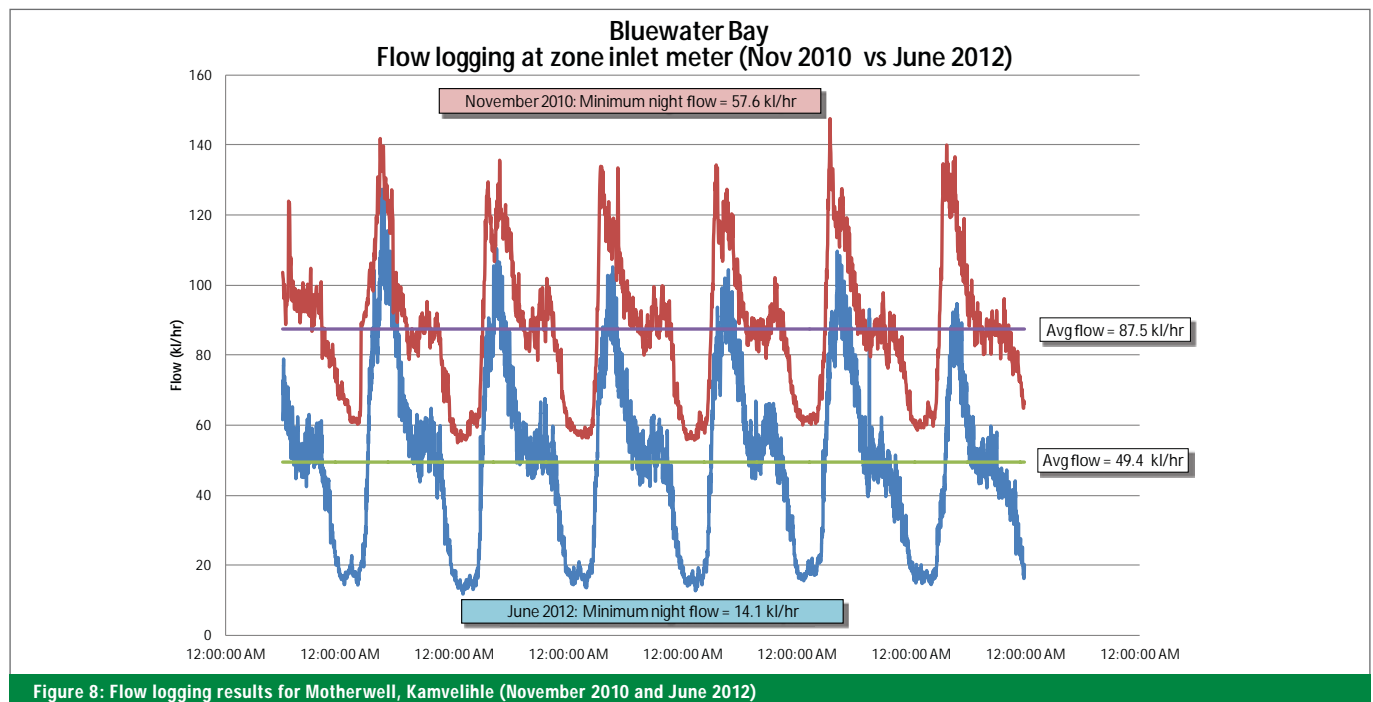
Figure 8: Flow logging results for Motherwell, Kamvelihle (November 2010 and June 2012)

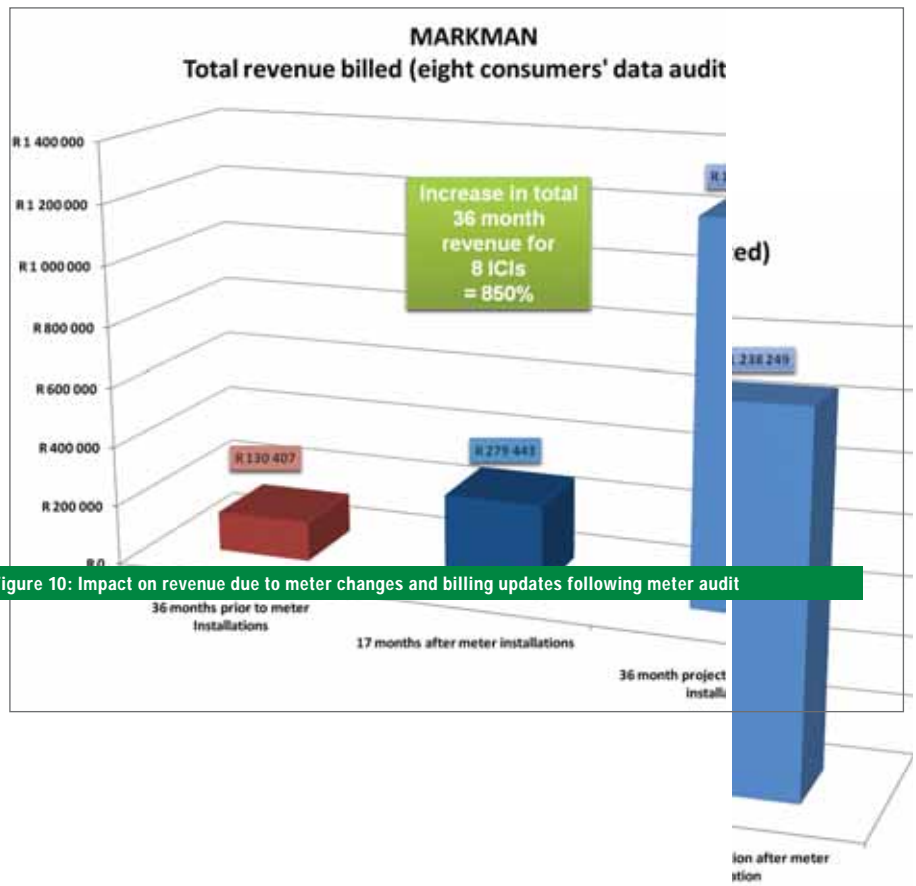
Figure 10: Impact on revenue due to meter changes and billing updates following meter audit
