Northdene Tunnel Pipework Replacement

BACKGROUND

PROJECT DESCRIPTION

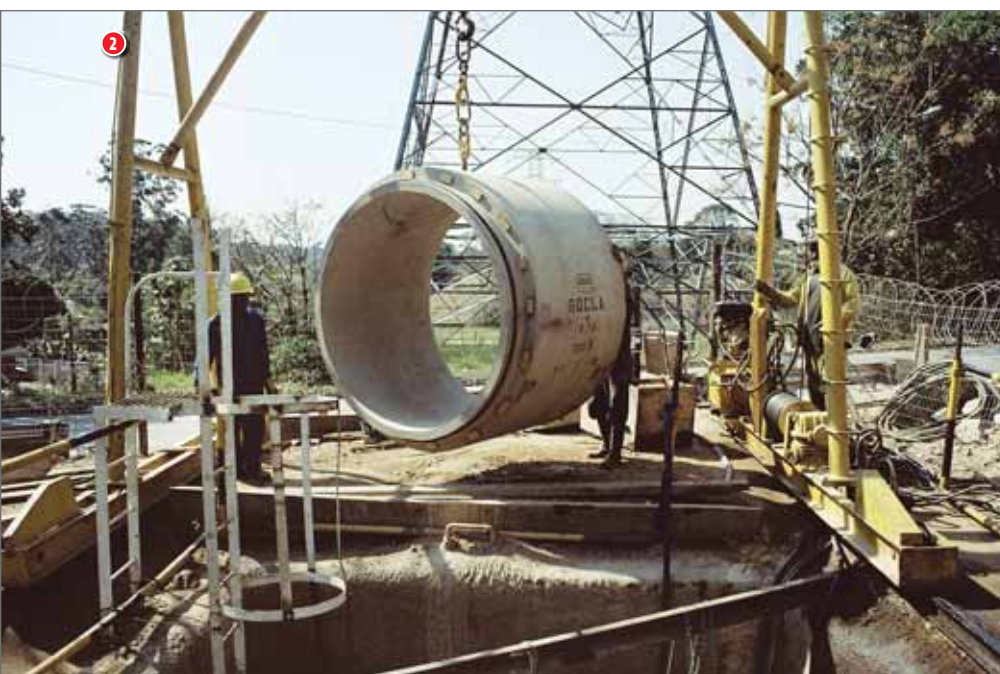
- 1 Two existing pipes in the tunnel showing lack of space for maintenance and repair
- 2 Lowering jacking pipes into the jacking pit with the pylon in the background

The tunnel barely accommodated these two pipes, and the lack of working space made maintenance or repair of either of the pipes virtually impossible. This posed a significant risk to the continuous supply of water to the southern areas of Durban, and a solution needed to be found.

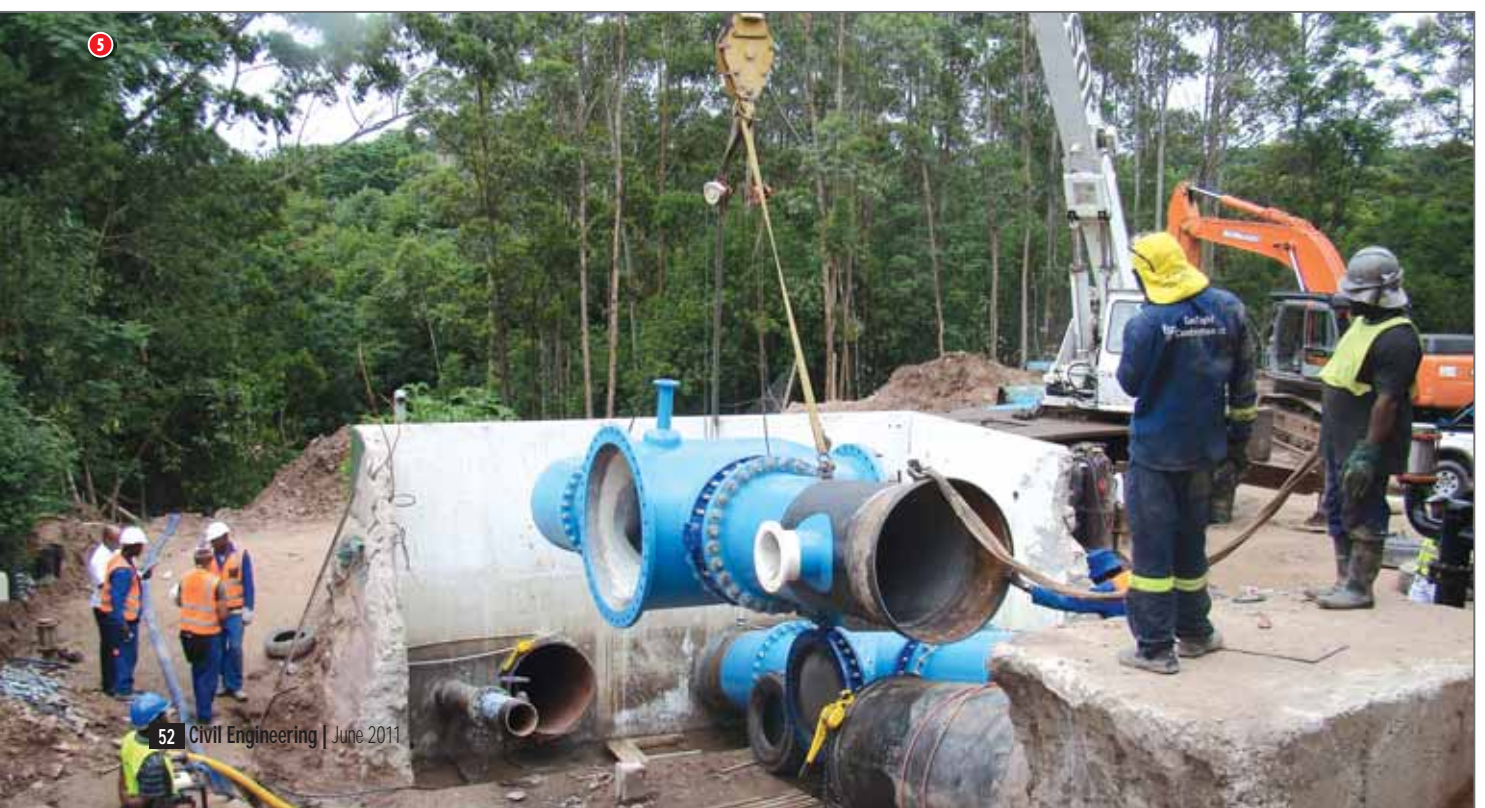
5 The tie-in for the cross connection on the bypass pipeline to the existing pipes downstream of the western tunnel portal
