Rehabilitation of the Pietermaritzburg Airport

FINALIST – Technical Excellence Category

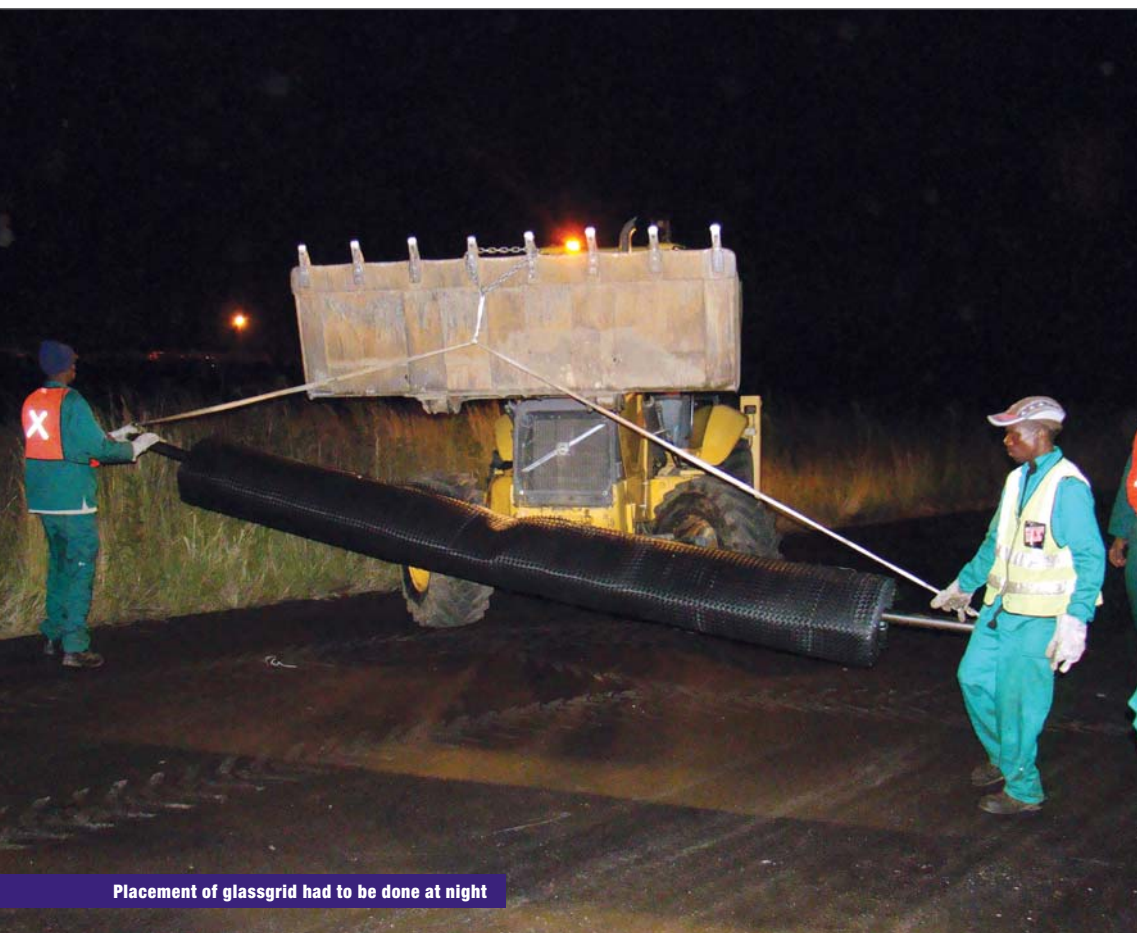
Every day the next 300 m² resurfaced stretch of runway was feathered down to the old level over a distance of 2 m to allow for smooth landing

Work on the runway therefore had to be undertaken at night. A stretch of runway 100 m x 30 m was resurfaced daily, including the placement of the MacGrid. The newly laid surface was feathered down to the old level over a distance of 2 m to allow a smooth transitional surface for landing aircraft. The 2 m section was then milled to the original level before continuing the pavement placement on the following day. The runway was thereafter thoroughly cleaned to remove loose stones which could be picked up by aircraft and could affect their engines. The ultra-thin layer followed in similar fashion.

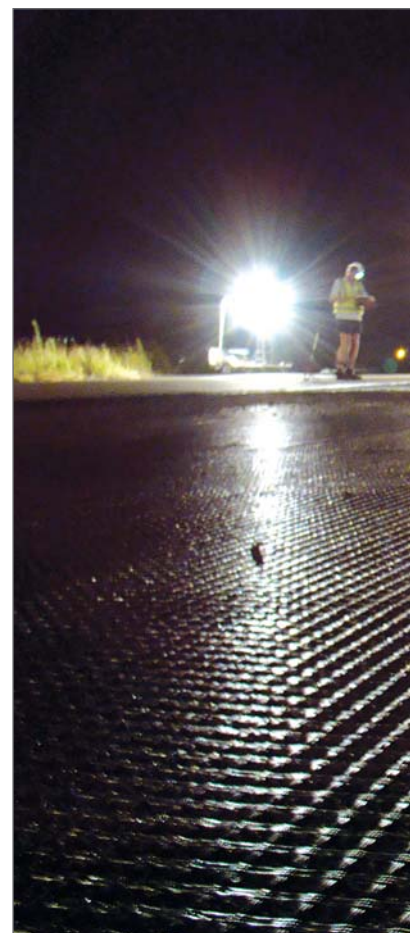
Placement of glassgrid had to be done at night

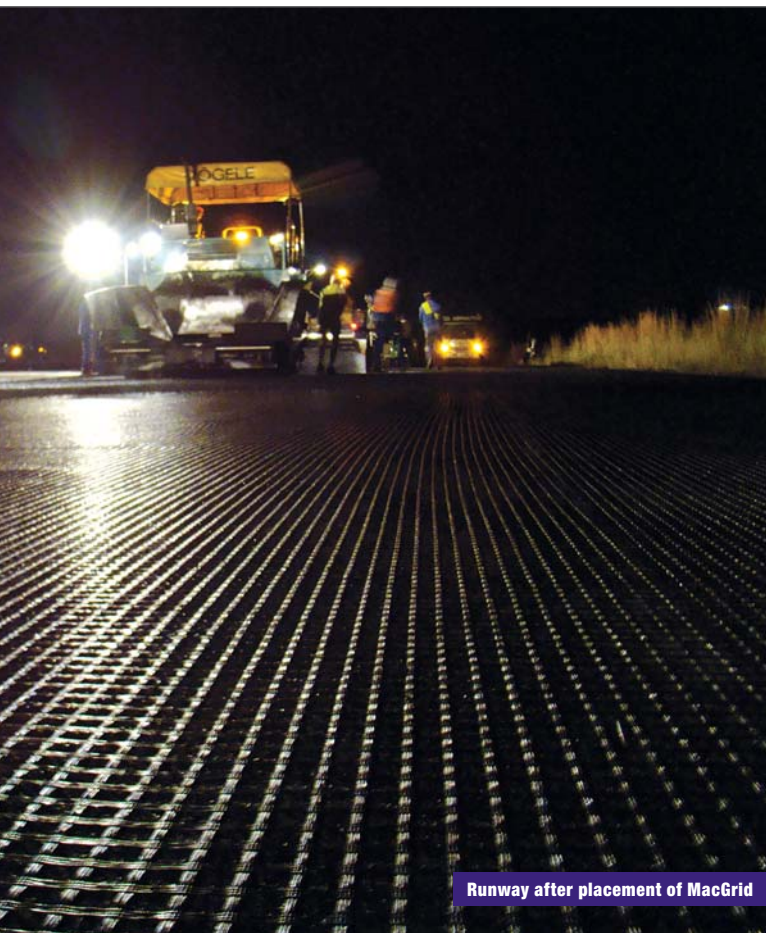
Runway after placement of MacGrid

Approximately 9 000 m of crack sealing was undertaken, and approximately 300 tonnes of bitumen-treated black-base course were used to correct the cross falls on the pavement. The repair work was followed by a tack coat upon which the 66 000 m² of 100 kN x 100 kN fibreglass grids were laid. The cold night temperatures prevented the adhesive from the fibreglass grid to become activated, resulting in the grid lifting up during placement. A 15 mm asphalt blinding layer was therefore placed over the glass grid immediately after placement to prevent movement and to activate the glue admixture, thereby allowing it to adhere to the existing surface. A 50 mm asphalt layer was thereafter placed at a cross fall of between 0.5% and 1%. The asphalt was topped with a 20 mm latex-modified ultra-thin surface which met the design requirements for friction and skid resistance.
