# Rehabilitation of sinkholes on the N14 near Carletonville

## BACKGROUND

This article showcases Aurecon's involvement in the rehabilitation of a section of the N14 north of Carletonville following the occurrence of a number of sinkholes on the road shoulder that resulted in complete road closure. Three sinkholes formed on the road shoulder at some time between late December 2007 and early January 2008. Two sinkholes (each about 10 m in diameter) formed on either side of a box culvert (see Figure 1), and another on the opposite side of the road (about 4 m in diameter). A 15 km section of the road had to be closed and traffic was diverted along existing roads. Sinkhole

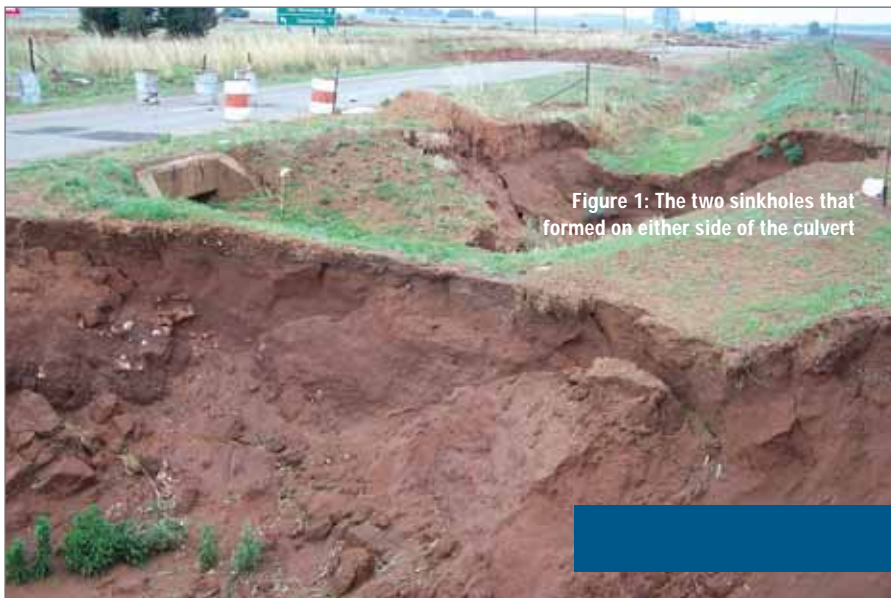
Figure 1: The two sinkholes that formed on either side of the culvert

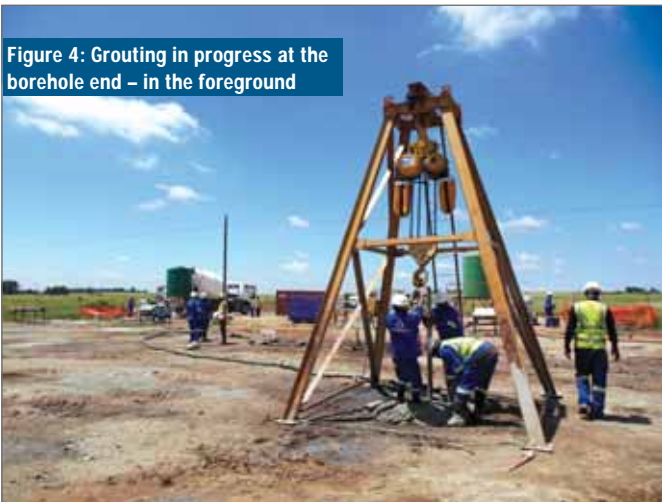
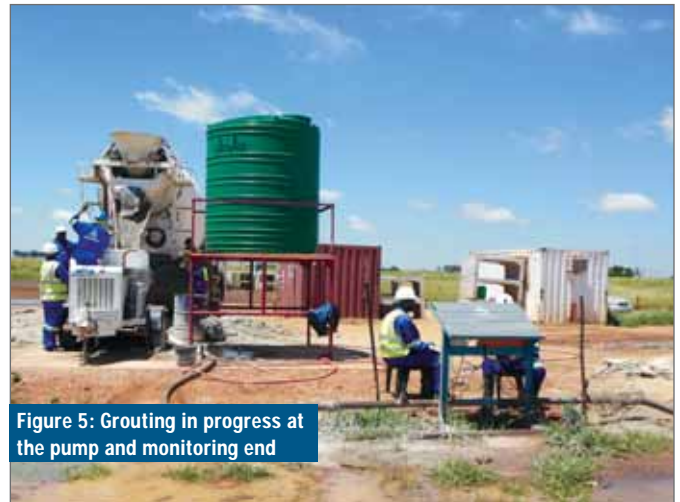
Figure 5: Grouting in progress at the pump and monitoring end

The primary borehole grid of 3.4 m by 3.4 m was designed to allow intersection of any cavity equal to or larger than 5 m in plan dimension. Secondary boreholes were inserted on the diagonals of the original grid where significant grout takes occurred in primary boreholes, especially where the maximum volume criteria were achieved at less than the termination pressure. Figures 4 and 5 show the grouting in progress.
