# SAICE Western Cape Branch Visit to the Tunnels under the Castle

EARLIER THIS YEAR members of SAICE's Western Cape Branch enjoyed a 90-minute tour inspecting the historic drainage tunnels under Cape Town's famous Castle.

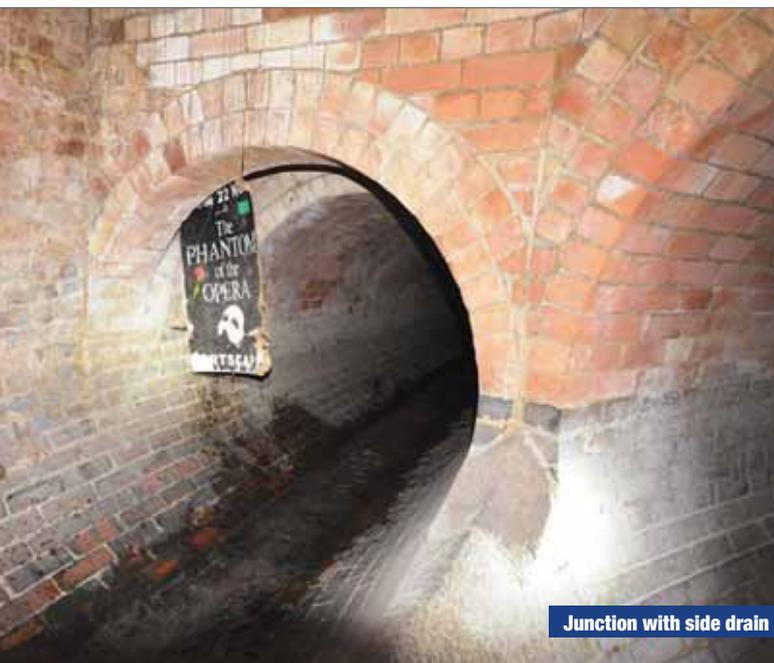
On this reach the tunnel was initially circular, built of bricks – blue engineering bricks for the lower third to half of the section and red hard bricks above. Higher up, stone construction – Malmsbury

Hornfels – made its appearance as the construction material with brick inverts. In this portion, the section had become noticeably elliptical as if it was slowly yielding to the weight above.

The brickwork was generally of good quality and the occasional junctions with side drains presented interesting examples of the intersection of two cylinders at an angle to each other, as executed in brickwork.

Throughout the walk, the invert was running at the order of 0.05 m<sup>3</sup>/sec of clear water without any sign of trash.

Catzenellenbogen bastion, to pass under Strand Street from whence the tunnel debouches into the Duncan Dock. Here the tunnel had been widened and lowered to pass under the roadway which was carried on steel girders.
