Seismic Behaviour of Romanian Orthodox Churches, Modeling of Failure Modes by Rigid Blocks

Marius Mosoarca, Victor Gioncu, Ovidiu Cosma

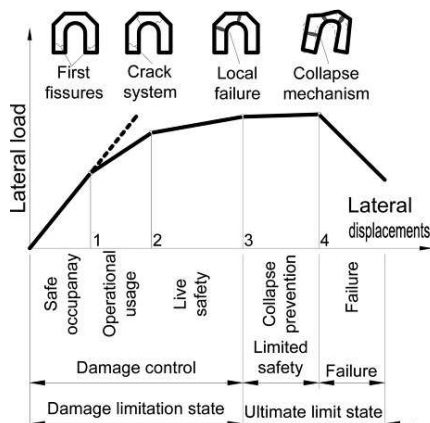
Fig. 1 Behaviour of a masonry triumphal arch

It is well known that masonry structure analysis requires nonlinear modeling accounting for the low tensile capacity and the consequent cracking phenomena. It is well known though that such models cannot be used in the case of very complex structural systems characterized by large number of degree of freedom. In the same time, it is very clearly that the methodologies required for the two limit states differ very much. While for damage limitation state one can use the elastic analysis (with or without considering some fissuration effects), for the ultimate limit state, the methodology must be very different. Therefore, analyzing the behavior of historical buildings, it is need to be adopted a two step procedure as shown in Fig. 1.

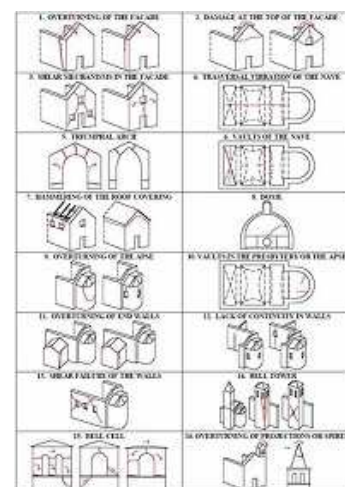
Fig. 2 Romanesque churches. Masonry rigid block [5]

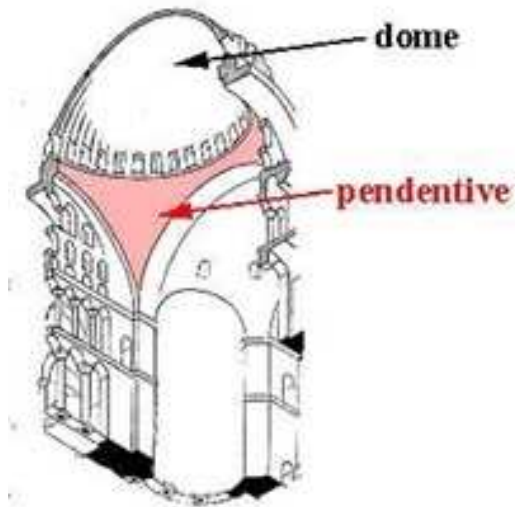
Fig. 3 Pendentive in Byzantine churches

The buildings of Romanian Orthodox churches are based on the Byzantine style, being characterized by the using pendentives and dome on pendentives as in Fig. 3. It must be pointed that the main structural characteristic of Byzantine architecture is the use of pendentive domes, dome on pendentives, and tower on pendentives. This is unique way of adjusting the circular form of a dome or tower to a square plan. The pendentive dome is derived by trimmer the sides of a circular dome over a square plan as in Fig. 4. The pendentives dome enables to transfer the total load of the roof to the four corners of the building.

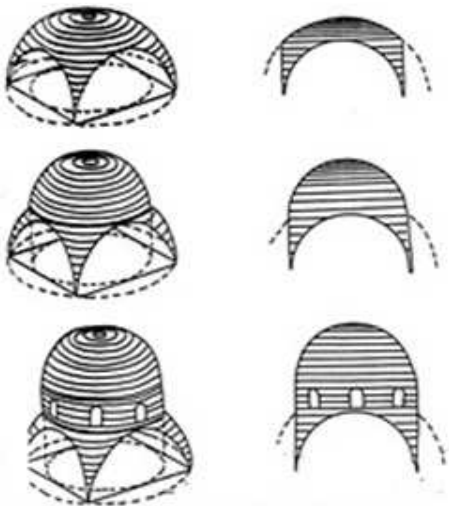
Fig. 4 Pendentives and dome and tower on pendentives

Additionally, the top dome enables to transfer the total load of the roof to the four corners of the building. The top of the pendentive can be trim to introduce another dome on top. The additional dome can further be raised to introduce a cylindrical tower between the pendentive dome and the additional dome.

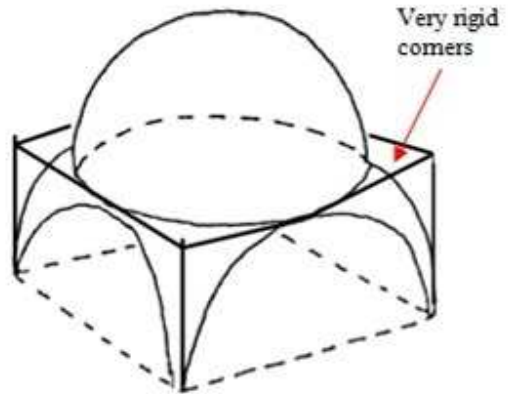
Fig. 5 Rigid corner pendentives, including the surrounding walls

Windows can then be introduced in the cylindrical tower enabling architects to create interior light effects. The surrounding infilled and exterior masonry walls also contribute to carry out the loads, forming very rigid corner pendentives as in Fig. 5.

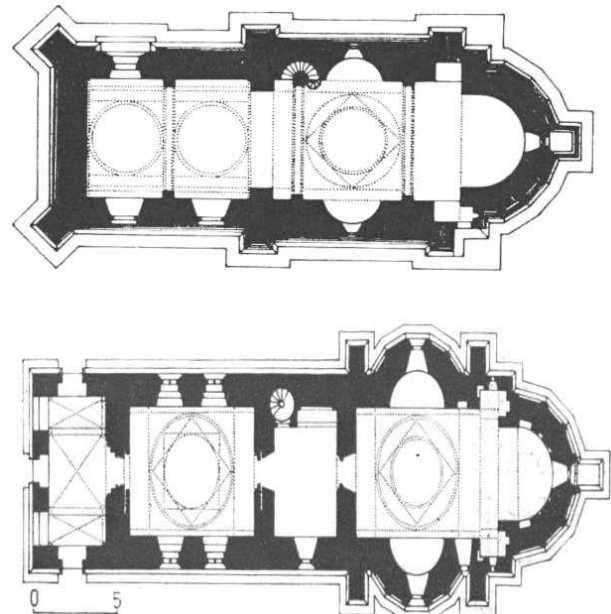
Fig. 6 Typical rectangular and tree-lobed plans [8]

The typical plans of Orthodox churches are presented in Fig. 6: rectangular nave with one lob and three-lobed nave. Unlike the Catholic churches, the Romanian Orthodox churches are relative small in size. The main typical Romanian orthodox churches are the three-lobed plan. This form plays a crucial role in the improving the church behaviour during the earthquakes, because it reduces the distance between stiffness centre and centre of gravity on the longitudinal axis of symmetry [8]. In some cases, some churches were provided with buttresses in order to reduce the distance between these two centers.

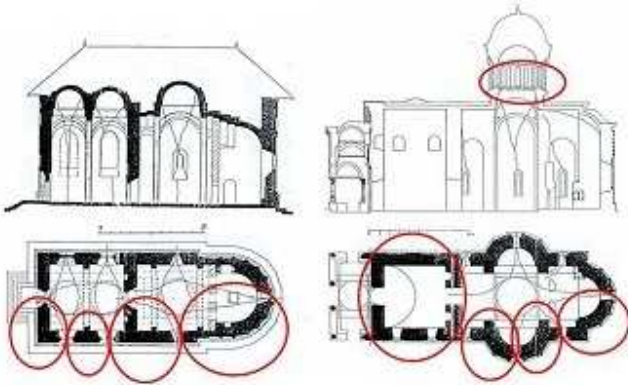
Fig. 7 Damage of Borzesti and Cozia churches due to 1977 Vrancea Earthquake [2]

earthquakes, Fig. 7 presents the Borzesti (rectangular plan) and Cozia (three-lobed plan) churches [2].

Analyzing the occurred system of fissures and cracks it is very clear that the spatial collapse mechanism is formed by a longitudinal fracture and multiple transversal fractures which round the pendentives, due to the great rigidity of these ones.

In addition, cracks occurred at the base of tower. The cracks start always from the windows, due to reduced rigidity in these zones. Considering the system of fractures, it is very clear that, in the ultimate limit state, the churches form a block system, working independently each other's as in Fig. 8.

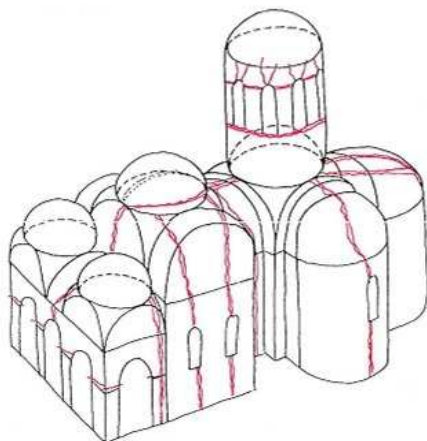
Fig. 8 Blocks system in ultimate limit state [2]

The blocks are formed by the wall delimited by two indows and the corresponding corner pendentives. Due to the seismic actions, the blocks rotate around a basis axis. This rotation is equilibrated by the gravity loads, mainly due to the masonry weight.

- i. The biggest cracks are developed in the eastern wall next to the altar, in full compliance with the structural issues outlined above in Fig.8.
- ii. Next, most important, are the cracks from the southern wall, the northern being much less cracked;
- iii. Asymmetrical turning tendency can be seen on the walls of the western tower, south wall is much more cracked than the northern, while at the western and eastern walls, cracks were insignificant;

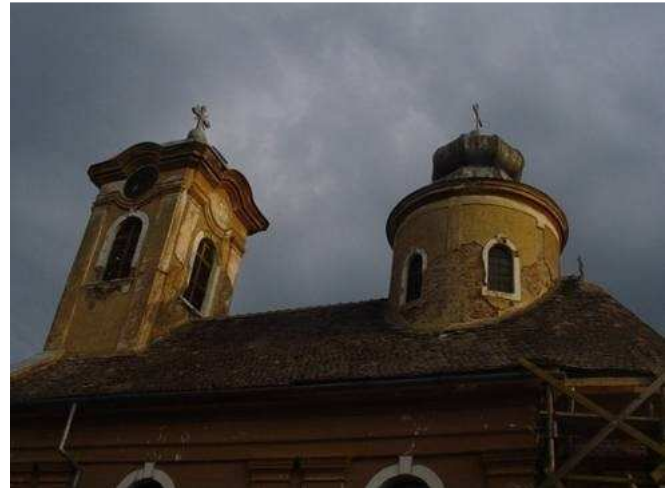
Fig. 9 The two towers of the church

Hall-type church building is covered with brick arches and wood framing. The church has two towers: the West Tower and East Tower in Fig. 9 and Fig. 10.

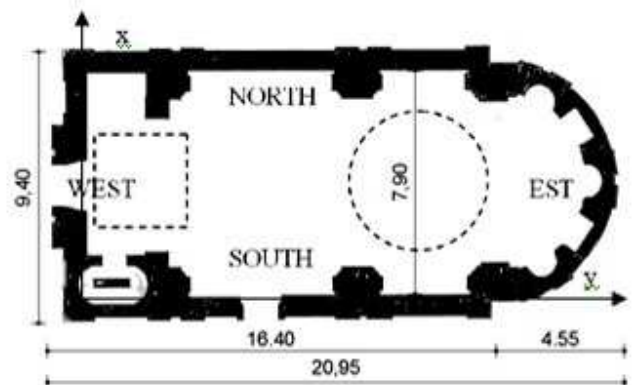
Fig. 10 Horizontal section

- i. The church was divided into rigid blocks based on observations recorded after earthquakes cracks in the Banat area since 1991. Transfer blocks are shown in Fig. 17, based on 3D drawing. Global system of axes is shown in Fig. 10.

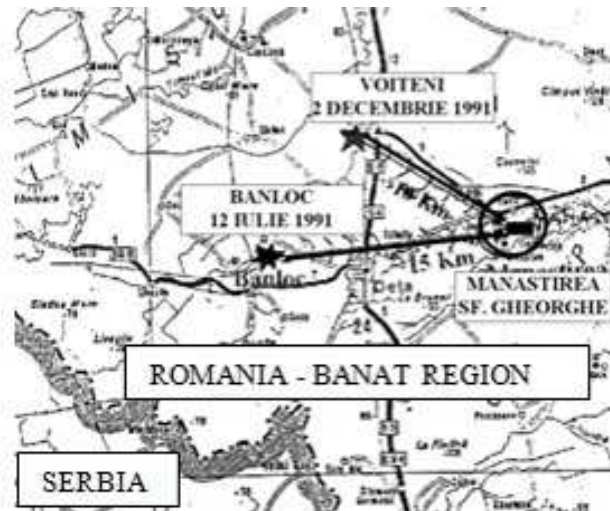
Fig. 11 The distances to the earthquake poles

In these circumstances, taking into account the position of the church to the two poles, the church's main action direction is longitudinal. Given the longitudinal asymmetry of the church, the west is much stiffer than the east. The center of rigidity of the structure is moved to the west. At the same time, taking into account the different stiffness of the stair area on the opposite side, the center of rigidity is moved in north. Rotation of the church from the center of rigidity is shown in Fig. 12. It can be noticed that the round wall next to altar is the most stressed, being the farthest from the center of rigidity.

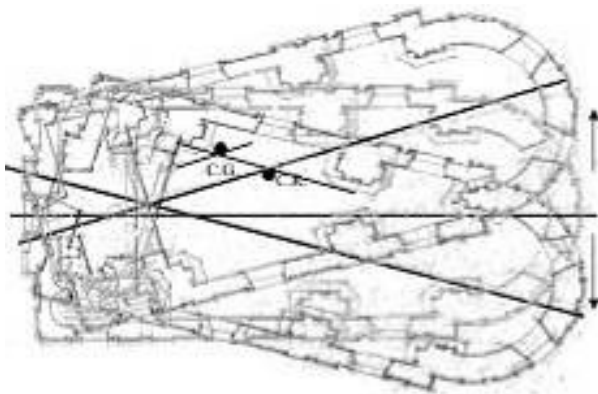
Fig. 12 Rotation of the church

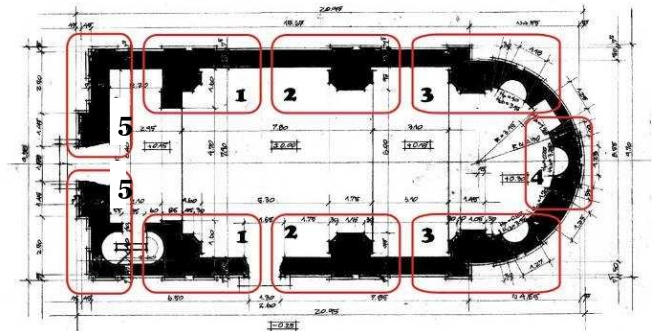
Fig. 13 Mechanism blocks

Under these conditions, considering the presence of openings, masonry has a tendency to separate into blocks by splitting of arches above the openings thus forming nine blocks. The most stressed is block 4 of the eastern wall where are the largest lateral deformations in Fig. 13.

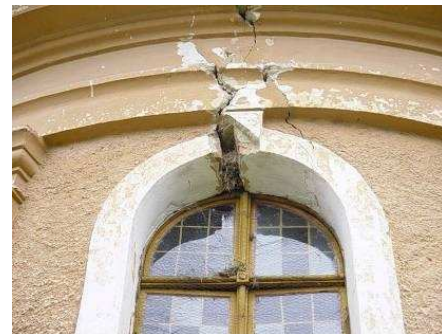
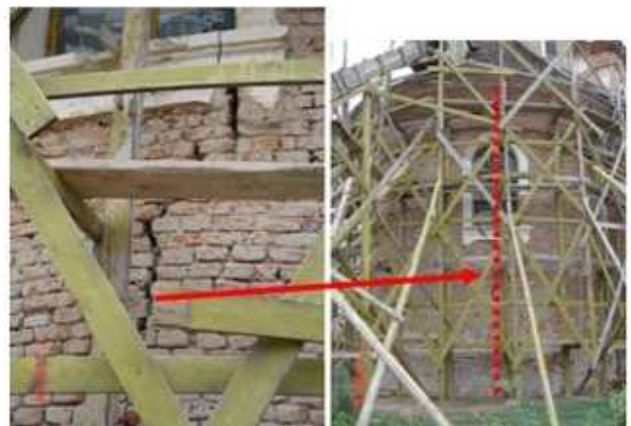
Fig. 14 Cracks at the eastern wall

Brick walls are 75 cm thick, reinforced with brick pillars in front of the roof arches. Masonry structure has a longitudinal symmetry, except the West side where the presence of the stair has introduced an asymmetry characterized by walls with a thickness of 40-45 cm. The window openings on the altar apse and reduced thickness of the wall under the windows have caused cracks in Fig. 14.

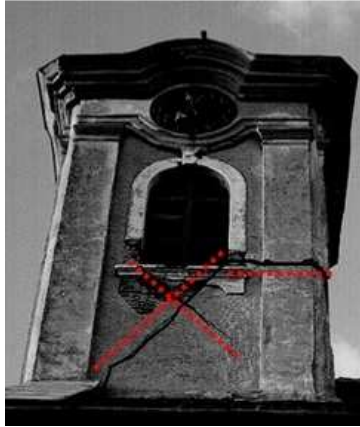
Fig. 15 Cracks at bell tower

The cover in the central area is made of two domes on brick pendants resting on arches. One of the vaults supports a tower with circular section. Rectangular bell tower section is being supported on one side of the church walls, and on the opposite side of a brick arch that has no tie to the beginning and shows cracks. Under the bell tower windows, X cracks were found on the South and North facades, damages characteristic of seismic actions in Fig. 15.

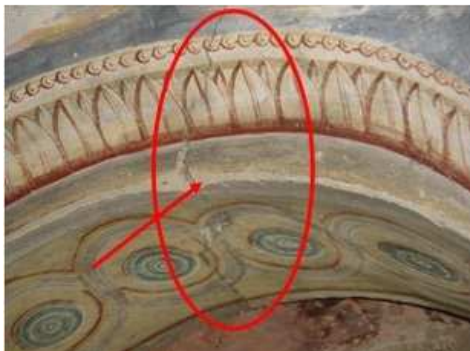
Fig. 16 Cracks at arches

Eastern Tower, not being bounded by land and moving freely with the dome, has minor cracks. Inside the church there are cracks at the top of the vaults because arches don't have ties for taking vertical loads in Fig. 15.

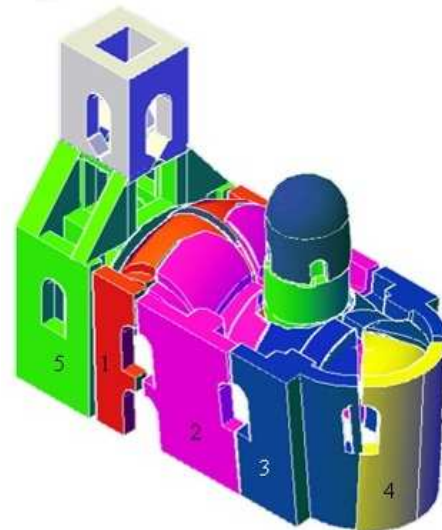
Fig. 17 St. George church, blocks system in ultimate limit state

- ii. Because the greatest damages were recorded in the nave and apse altar, a special attention was given to these areas. They were divided into blocks 1, 2, 3 and 4.

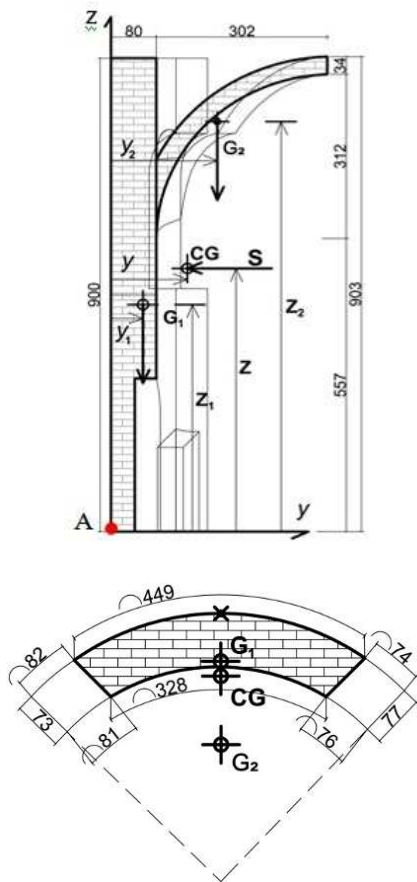
Fig. 18 Dimensions in plan and positions of centers of gravity for block 4

ix. The equilibrium relation between overturning moment and stabilisation moment was written for each failure block in relation to point A from the wall as shown in Fig. 18. It is located at the outer end wall. According to [6] the proportion ratio between the overturning moment and the stabilisation moment of the transfer block is called seismic coefficient and is noted by λ . It has subunit value and represents the maximum value of ground acceleration for which the building collapse that occurs outside of the plan of the failure block. Maximum seismic acceleration of ground in the Monastery of St. George is 0.16g, so $\lambda_{\max \text{ field}} = 0.16g/g = 0.16$. λ values calculated by theoretical modeling for each failure block were compared with this value of $\lambda_{\max \text{ field}}$. Blocks with a value of λ

Because the most damaged transfer block after 1991 earthquakes is block 4, in Figure 18 are presented the dimensions and position of the center of gravity and the point of application of seismic force. There are only two centers of gravity for masonry and bolt and one for the entire block 2. The Name of symbols used in Figure 18 are shown in Table I.

For failure block 4, who was the most damaged after earthquake, λ is determined with (1) [9]. Calculations are presented in Table II. The value of λ is calculated in (2).

No. element	γ kN/m ³	V m ³	G kN	x m	$M_s=xG$ kNm	z m	$M_o=zG$ kNm
1	20	32.5	650	0.7	455		
2	20	3.47	69.4	1.87	129.8		
TOTAL		35.97	719.4		584.8	4.84	3482

$$\lambda_4 = 0,168 \quad (2)$$

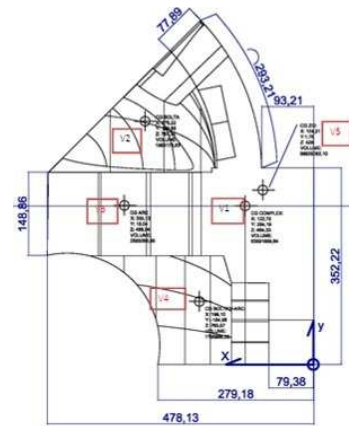
Fig. 19 Dimensions in plan and positions of centers of gravity for block 2

In Fig. 19 and Fig. 20 are shown the dimensions in plan, the positions of the center of gravity and the point of application of seismic force for failure blocks 2 and 3 in 3D coordinates. There are five centers of gravity for each failure block caused by wall, domes and arches. Values of stabilization and overturning moments are presented in Tables III and Table IV. The values are presented in (3) and (4).

No. element	γ kN/m ³	V m ³	G kN	x m	$M_s=xG$ kNm	z m	$M_o=zG$ kNm
1	20	63,60	1272	1.22	1552		
2	20	1,55	31	2.75	8.25		
3	20	2,68	107	3.35	358.5		
4	20	1,80	36	1.98	71.2		
5	20	56.62	1132	1.04	1177		
TOTAL		126.25	2578		3167	4.65	11988

$$\lambda_2 = \frac{3167 \text{ kNm}}{11988 \text{ kNm}} = 0,264 \quad (3)$$

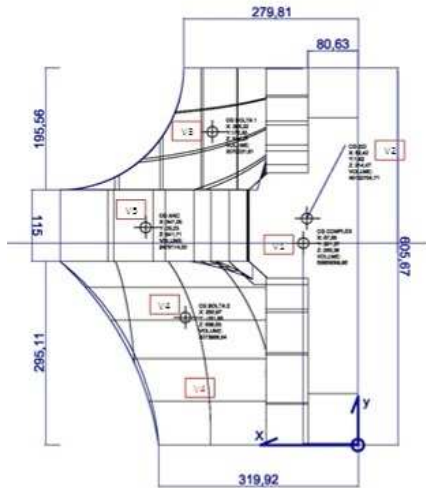
Fig. 20 Dimensions in plan and positions of centers of gravity for block 3

No. element	γ kN/m^3	V m^3	G kN	x m	$M_5=xG$ kNm	z m	$M_0=zG$ kNm
1	20	57	1140	0.87	992		
2	20	49	980	0.62	608		
3	20	2	40	2.65	106		
4	20	3,3	66	2.60	172		
5	20	2.5	50	3.47	174		
TOTAL		113.8	2276		2052	2.66	6054

$$\lambda_3 = \frac{2052 \text{ kNm}}{6054 \text{ kNm}} = 0,338 \quad (4)$$
