# WHEN RAIN FALLS, LANDSLIDES!

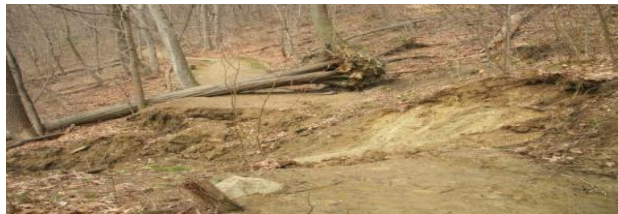
The debris flow cut out approximately 15 feet of trail. The head scarp is visible on the right.

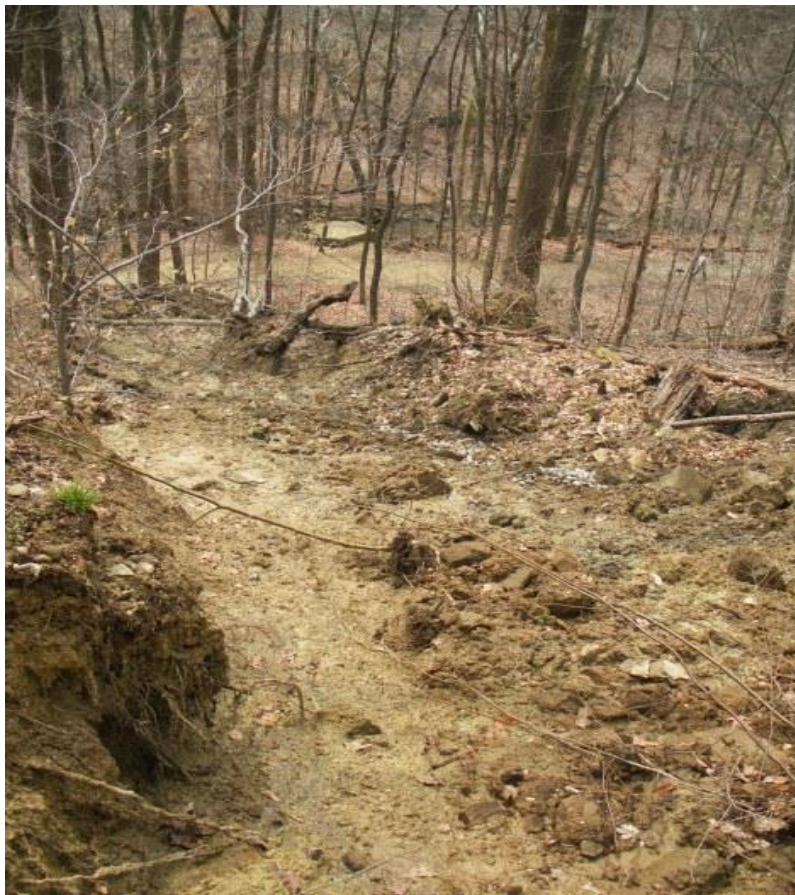
Looking down the debris flow to the lower trail. If you look closely, you can see people walking on the trail for some sense of scale.

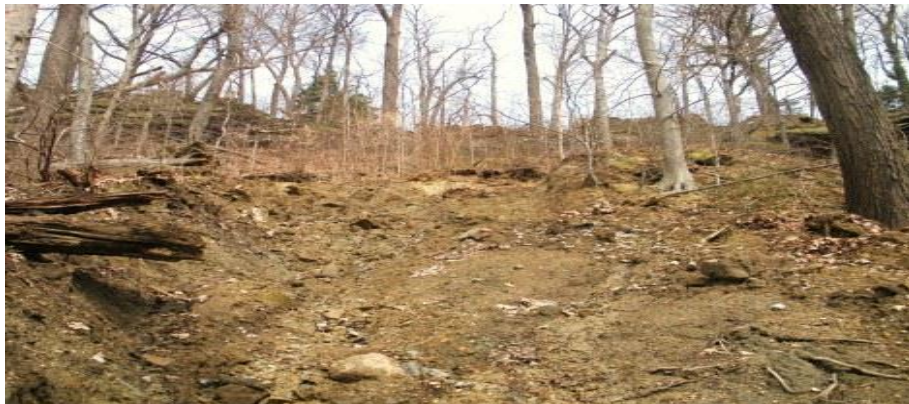
Looking upslope from the midway point.

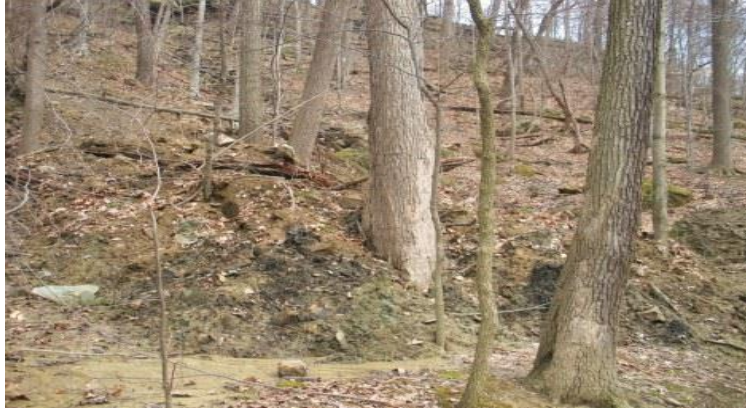
At its base, the debris flow has wrapped around trees.

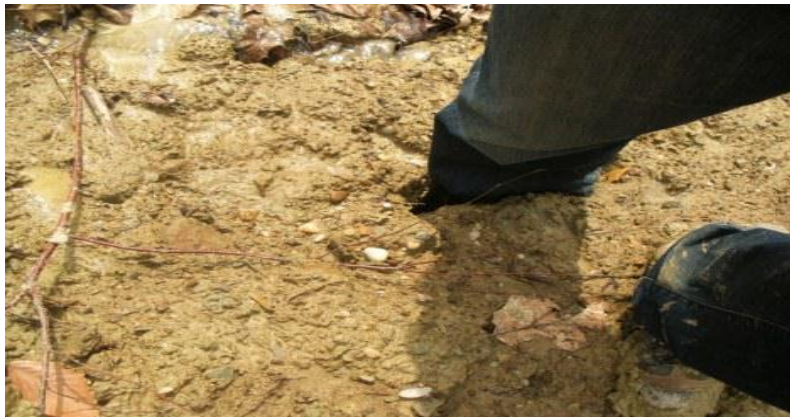
I happened to be visiting during the afternoon two days after the slide occurred and a day after it had last rained, yet the soil in the immediate vicinity was still completely saturated. Water continued to flow out of the ground near the head of the failure, exemplifying how much water must have been present in the ground at the time of failure.

Realizing just how saturated the ground is, still two days after the landslide occurred.
