Integration of geosynthetics into civil engineering

From products to functions

a case study: Hazyview slip repair

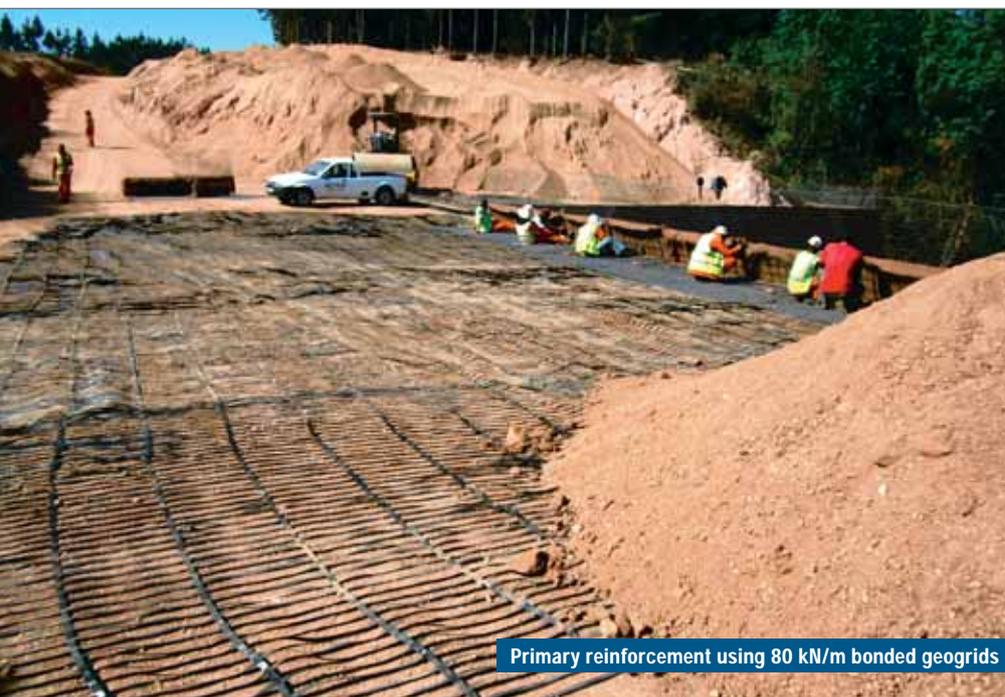
Primary reinforcement using 80 kN/m bonded geogrids

The geogrids used were high-tensile polyester, encased in a LLDPE coating to prevent installation damage, with a strength of 200 kN/m at the bottom and 80 kN/m at the top, all at 2 m spacing, acting as primary reinforcement. A secondary reinforcement in-between was given by a double-twisted mesh of 50 kN/m linked to the facing. For most of the structure a 70° angle was maintained, with surface erosion control. Where hydraulic structures were required, a gabion face was used.

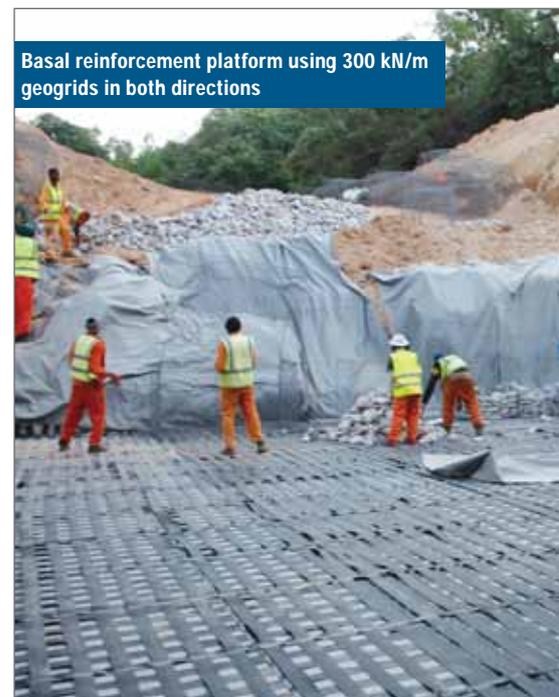
Basal reinforcement platform using 300 kN/m geogrids in both directions

Once the contractor reached the foundation level for the reinforced structure, a standard penetration test revealed the soil's low bearing capacity (between 10 and 60 kPa), which would have caused a failure due to the un-drained shear stress of the foundation. Basal reinforcement was suggested to avoid interruption by construction (standing time would have compromised the entire programme) and to maintain the costs within budget.

Based on the analysis done with Mac.St.A.R.S in-house software, 300 kN/m mono-directional geogrid reinforcement was placed at the foundation in both directions. A mono-directional geogrid, with a creep deformation of less than 1% in 120 years, was selected in accordance with the SANS 207:2006 for embankments on highways. (The use of bi-directional geogrid would have required a 4 m overlap to obtain the same result, and this would not have been cost-effective.)

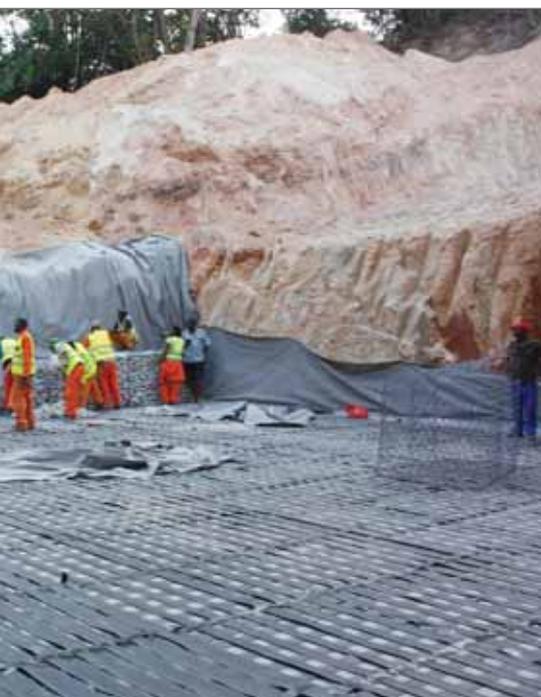
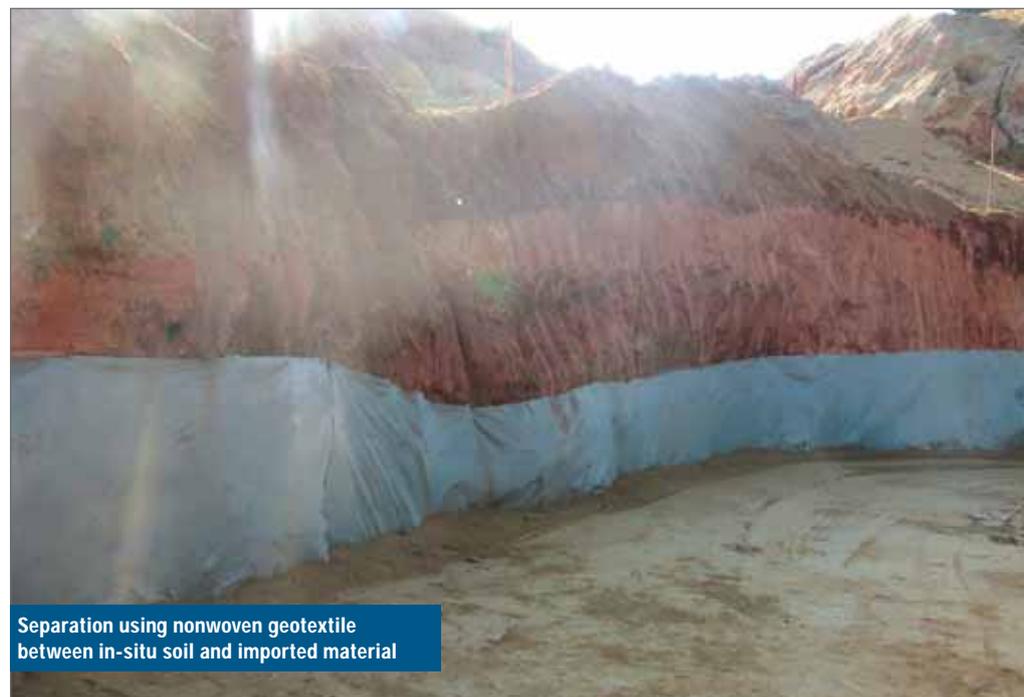
Separation using nonwoven geotextile between in-situ soil and imported material

0.075 sieve) and thereby drastically reducing the mechanical properties of the imported soil, nonwoven geotextile was placed at every interface between the imported material and the in-situ soil. Benching was adopted to prevent a weak interface, and hence a failure zone, behind the reinforced structure and the in-situ soil.

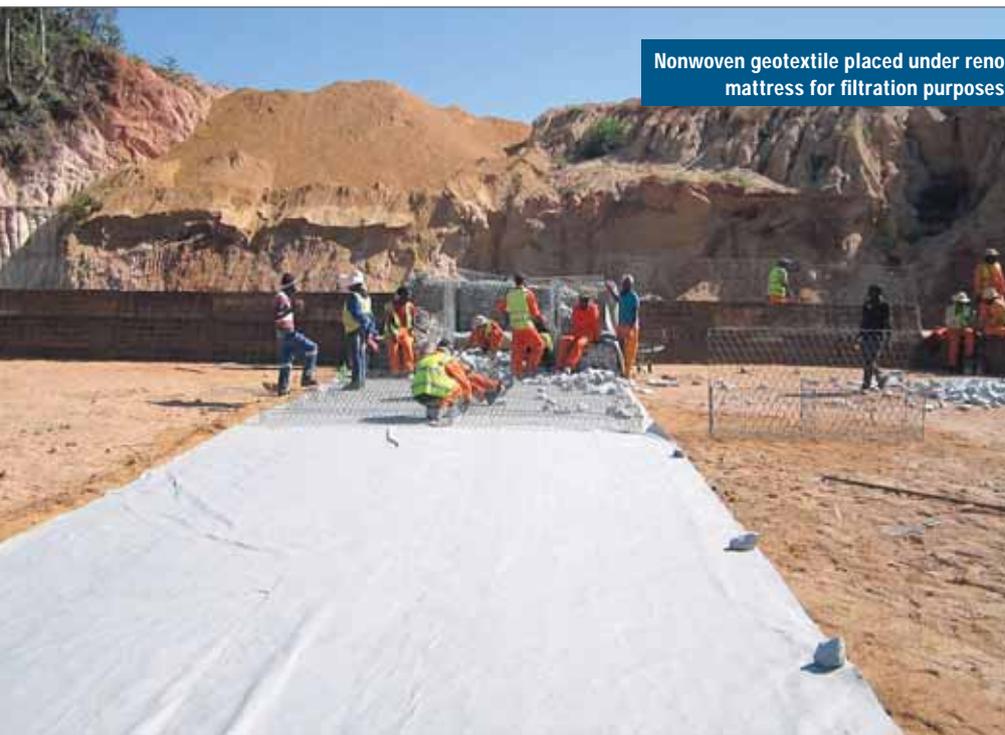
Nonwoven geotextile placed under reno mattress for filtration purposes

It was suggested that a geocomposite clay liner (GCL) be placed underneath all

the hydraulic structures, but this proved too costly. To remain within budget, a 21 mm thick nonwoven geotextile was used instead.

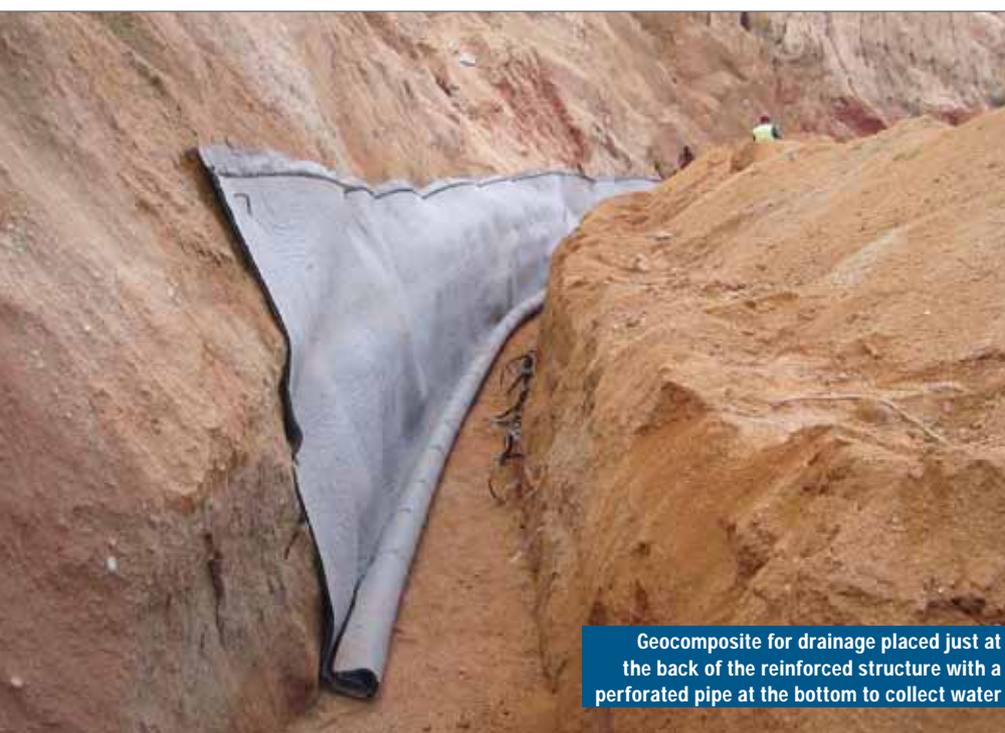
Geocomposite for drainage placed just at the back of the reinforced structure with a perforated pipe at the bottom to collect water

Water that had not been properly contained on the other side of the embankment created a water table in the top 8 m of the reinforced structure. To avoid any pore water pressure in the embankment, which would have increased the reinforcement requirement by about 50%, a geocomposite liner was installed at the back of the reinforced structure with a perforated pipe at the bottom to collect water. The pipe was then connected to the hydraulic structures.

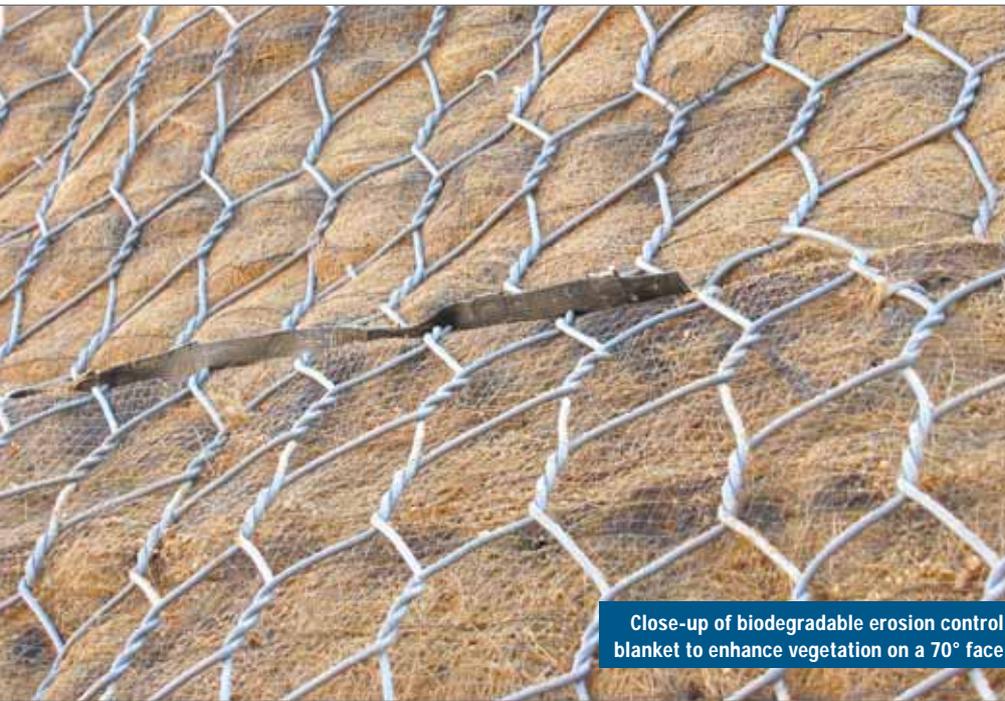
Close-up of biodegradable erosion control blanket to enhance vegetation on a 70° face

It was therefore decided to use a more economical pre-formed unit made of double-twisted mesh to provide primary reinforcement. A synthetic biodegradable erosion control blanket was installed on the 70° front face of the slope, and was held in place by the wraparound double-twisted mesh. The erosion control blanket was then hydro-seeded to stimulate appropriate plant growth on the slope.

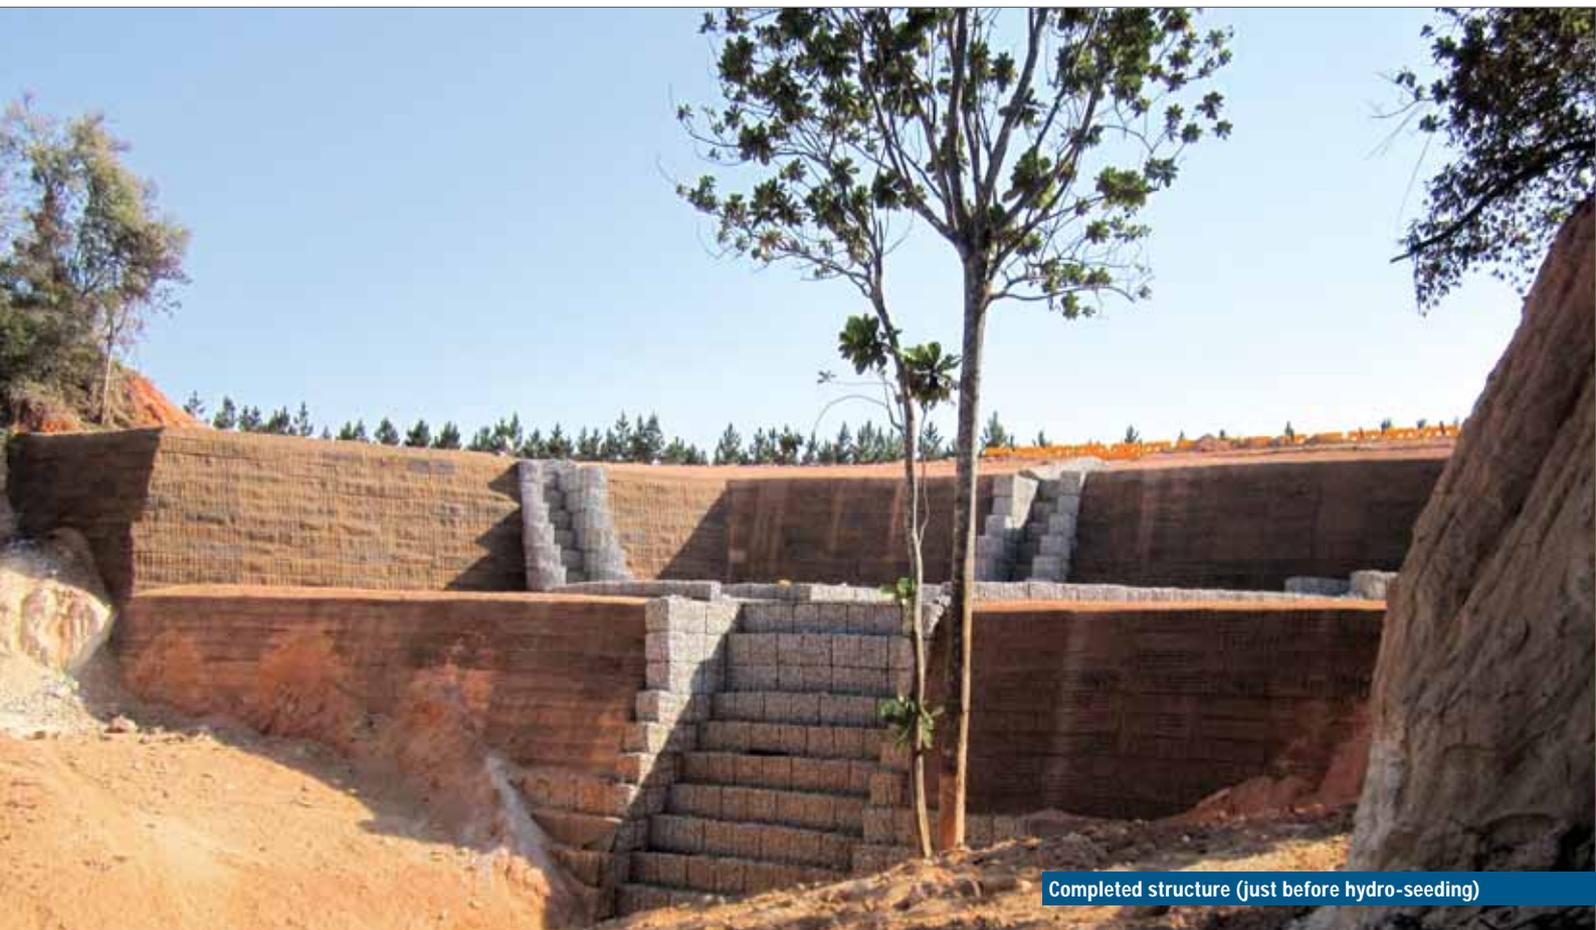
Completed structure (just before hydro-seeding)

The final solution comprised three berms – the first one (to prevent global stability failure) of 11 m high with a foundation

of 4 m in order to intercept the deep-seated instability; the second one closer to the road (in order to save on the volume of imported material) of 8 m high; and the third one a natural slope of 2 m high which restored the previous distance of about 11 m between the road and the edge of the cliff, thereby improving the safety of the road.
