# An investigation into the stability of the Ring Road lateral support system adjacent to the construction of UCT's new engineering building

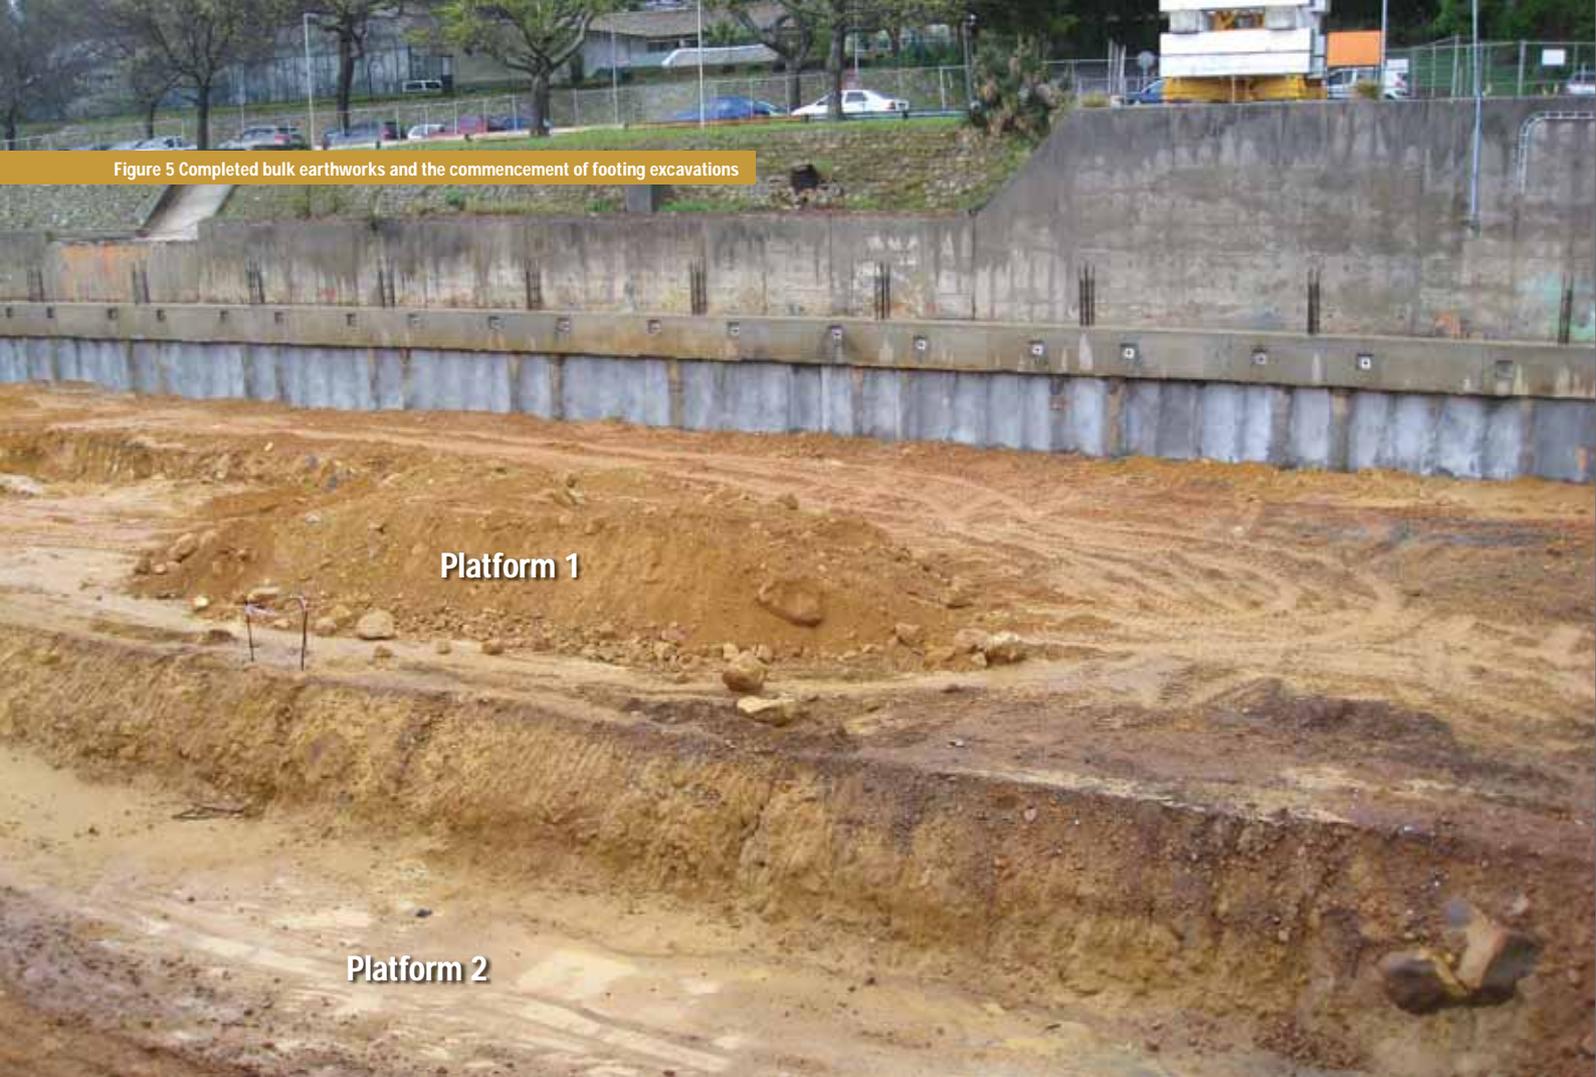
Figure 5 Completed bulk earthworks and the commencement of footing excavations

The excavation works were carried out by Caterpillar 330C excavators. Platform 2 was excavated first as these excavations did not interfere with the installation of the additional lateral support to the western boundary. Excavation processes were carried out on portions of Platform 1, but Platform 1 was only completed after the ground anchors had been installed. Figure 5 illustrates the completed bulk earthworks.

Platform 1

Platform 2

The bulk excavation process involved the establishment of two platforms – Platforms 1 and 2 – over a period of four months. The two platforms were established at different levels in order to accommodate basement levels and the pad footings upon which the NEB was to be founded.
