# Nelson Mandela Multi-Purpose Stadium

## NELSON MANDELA MULTI-PURPOSE STADIUM

### Technical Excellence category

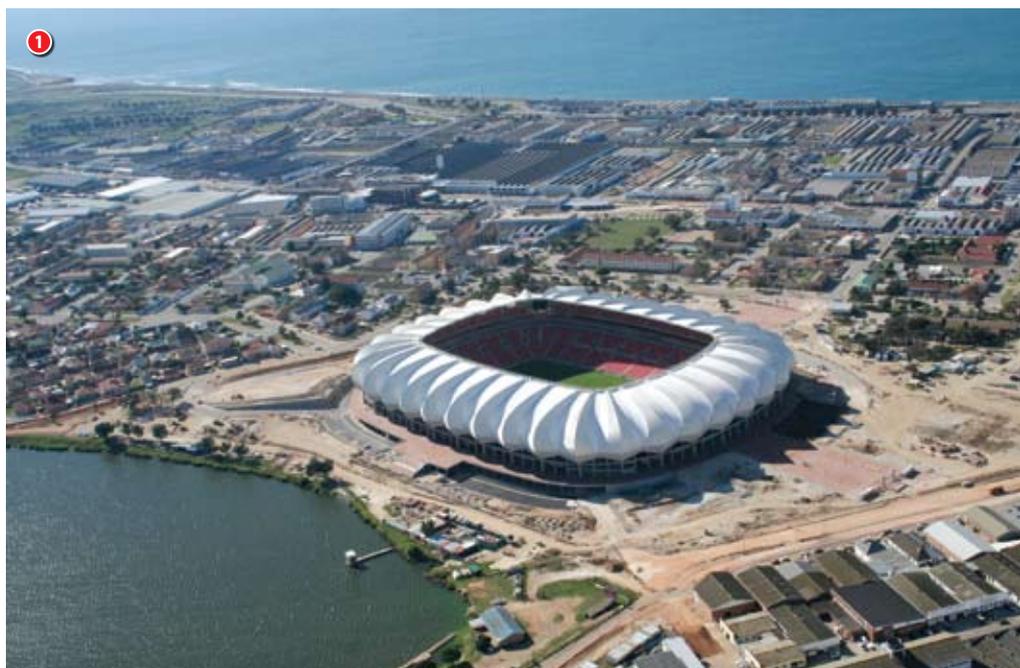
1 The Nelson Mandela Multi-Purpose Stadium is located about 50 m from Port Elizabeth's North End Lake, and within 1 km from the sea

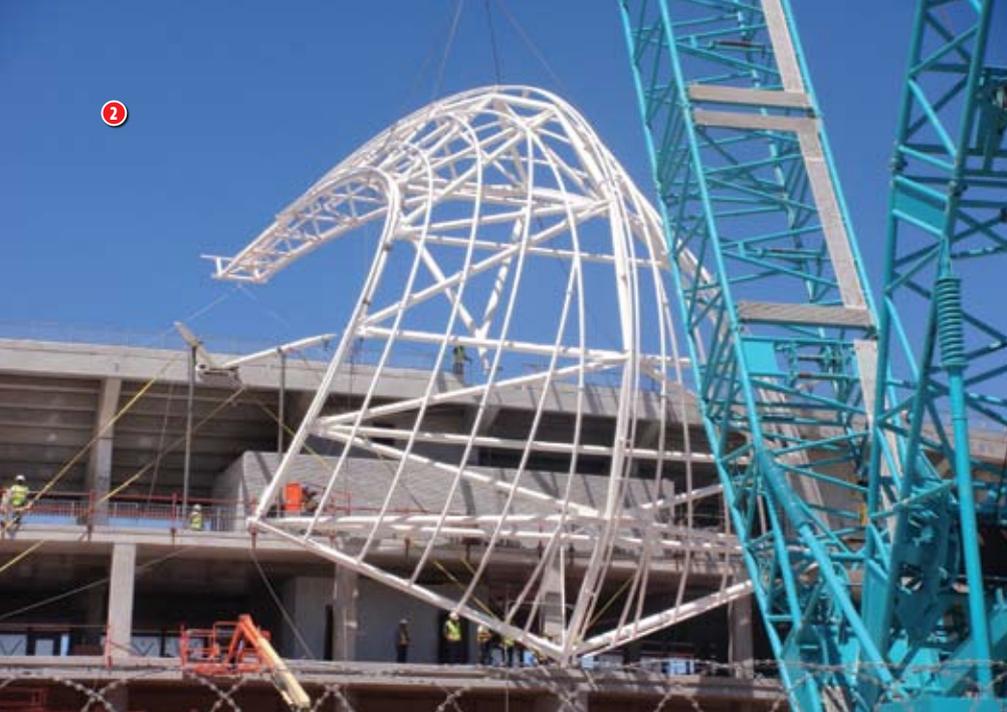
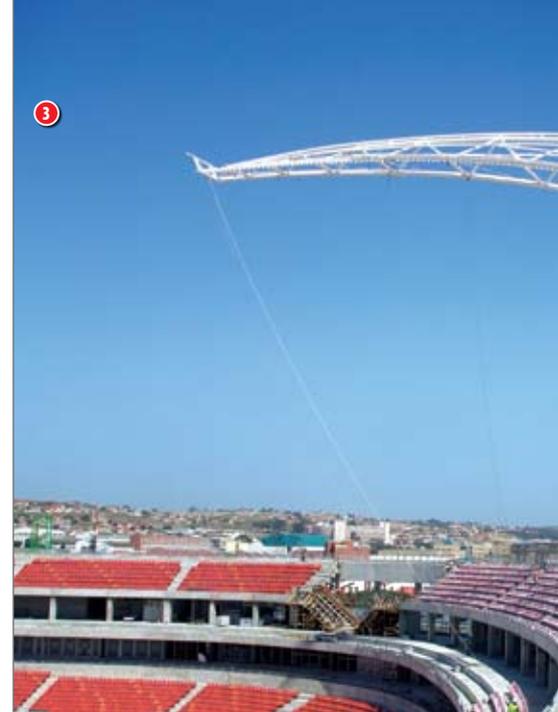
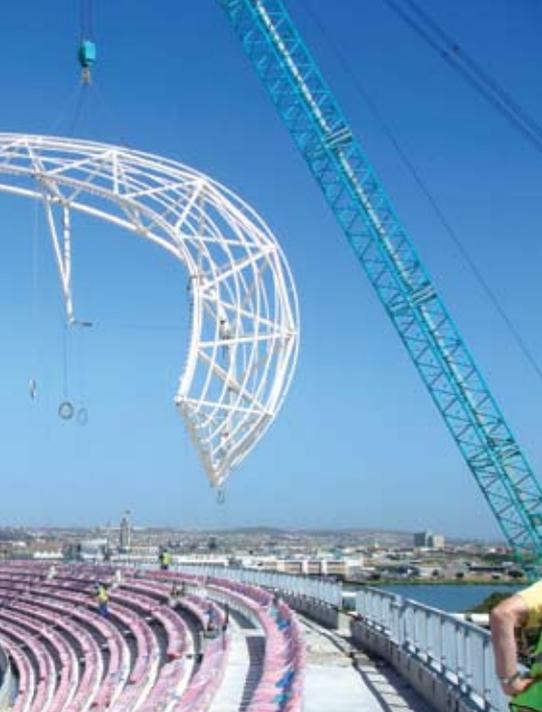
- 2 and 3 and 4 The roof girders were installed entirely from the outside of the stadium. The window of operation for the 500 t caterpillar crane was limited by the notorious Port Elizabeth winds, resulting in the erection of the girders occurring mostly in the morning
- 5 The initial programming sequence required the roof to be erected in a clockwise direction only, but it became necessary to change this sequencing to 30% clockwise and 70% anti-clockwise, resulting in a time-saving of several months
- 6 The roof acquires its remarkable form from the alternating arrangement of the girders and the membrane surfaces spanned in-between

In order to not interfere with the work on and around the playing field, the pre-fabricated girders had to be installed entirely from the outside of the stadium. The pre-fabrication of the girders was performed on scaffolding, which was equipped with individually adjustable clamping saddles to accommodate the different girder geometries. After the calibration of the scaffolding, mobile cranes lifted the pre-fabricated units into place, where they were bolted. The tip of the girder was set in place as a single unit at the end. To compensate for the tolerances from fabrication and the bolt-hole clearance of the connections, the girder tips were initially set in the specified

The window of operation for the 500 t caterpillar crane was limited by the maximum wind speed of 10 m/s. As such wind speeds occur daily in Port Elizabeth, often already before noon, the erection of the girders occurred mostly in the early hours of the morning. The installation of the aluminum cladding proved equally challenging in these windy conditions.

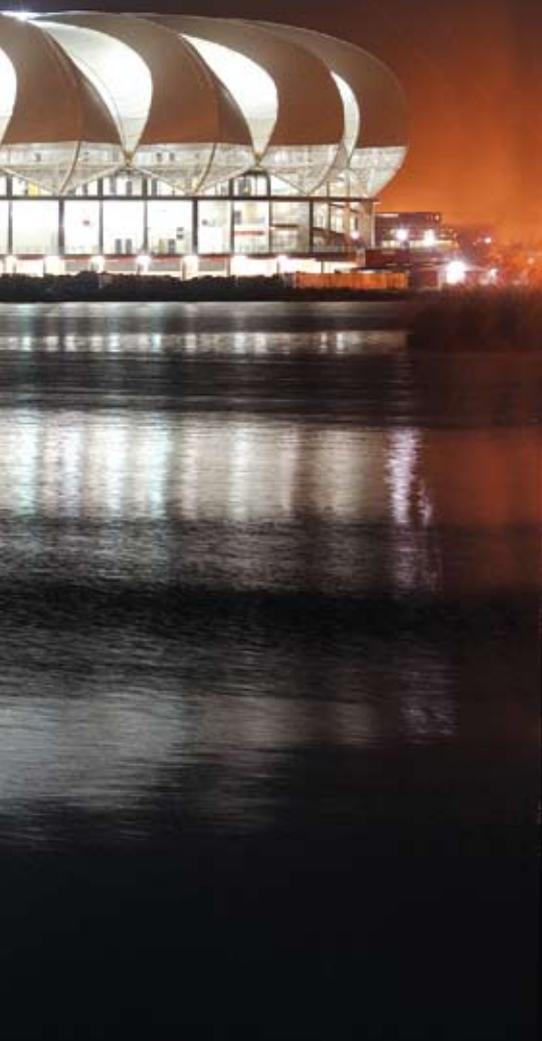
7 The backlit membrane surfaces of the roof make the stadium widely visible at night
