## ENVIRONMENTAL

# Old sand quarry makes way for golf estate

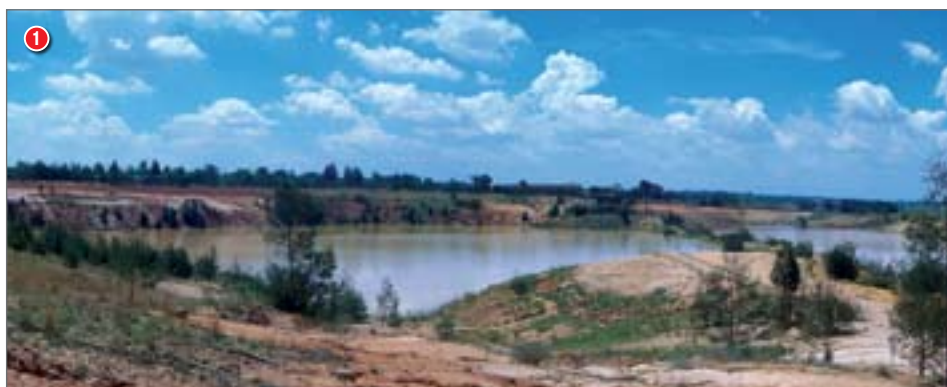
- 1 Final void before rehabilitation
- 2 Booster pumps for hydrosluicing
- 3 End tipping of material. The bulk of the void has already been filled by hydrosluicing

A few years ago, however, this now pristine site was not nearly such a sought-after property. A large portion of the estate is being developed within the property of a decommissioned sand quarry. Before rehabilitation the site consisted of a large final void, split into an eastern and western compartment, several smaller holes where sand were mined out, and a large slimes dam, all covered with wattle trees. The slimes dam comprised 975 000 m<sup>3</sup> of kaolin clay material (the clay fraction of the sand that was washed out of the sand when the quarry was still in operation).
