While Jo'burg sleeps ...

O R Tambo gets a facelift

The next time you land or take off from O R Tambo International Airport, spare a thought for the contractors, Rand Roads and Black Top Surfacing, who have been working through the night rehabilitating the main runway and Yankee taxiway for a year. Planning and timing each night's shift was critical to ensure that not even the tiniest pebble remained on the runway at sunrise when the night's work had finished

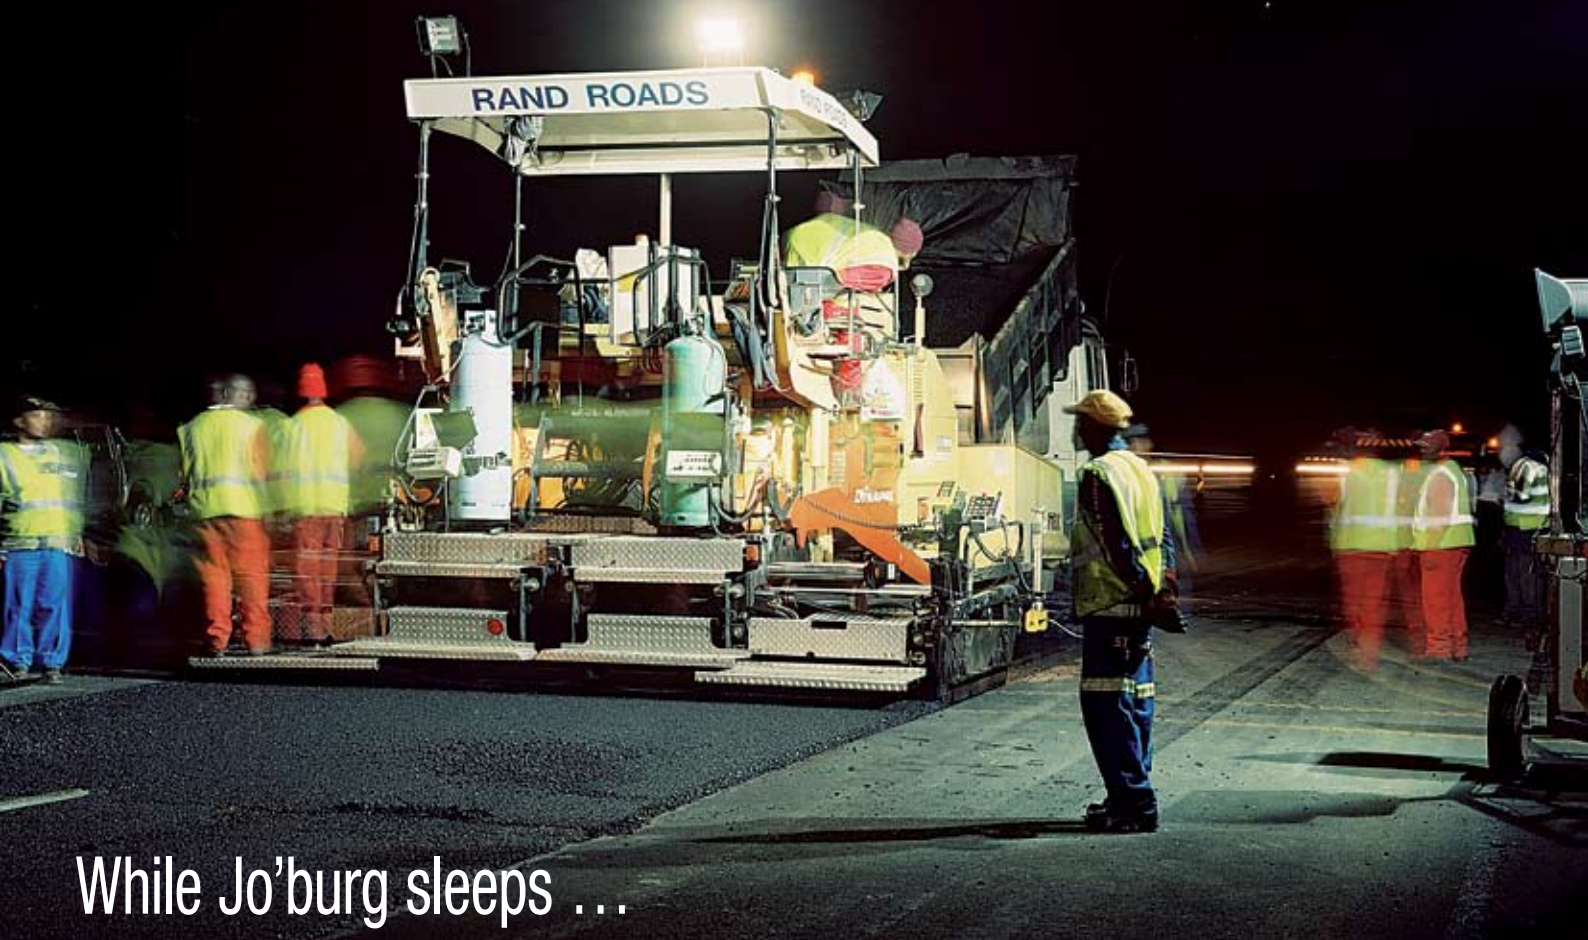
► Operations for secondary runway strengthening had to be carried out at night so as not to disrupt normal air traffic movements

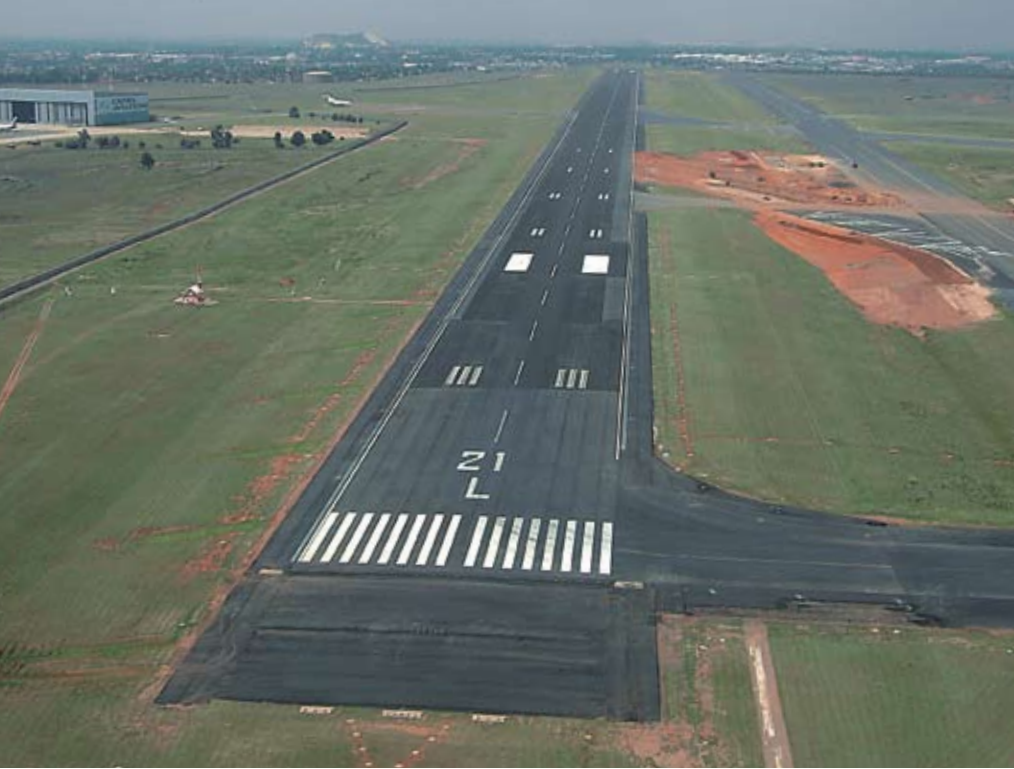
► An aerial view of the main runway with the Yankee taxiway on the right and a rapid exit taxiway being constructed

This R63,5 million project comprised doubling the width of the taxiway from 30 m to 60 m, as well as repairs to the Delta apron. The taxiway is 3,6 km long and runs parallel to the 03R/21L runway.

The two new rapid exit taxiways (RETs) are located on the western side of the runway and are approximately 2 000 m apart. They will allow more planes to land as those which have just landed can leave the main runway more quickly.
