# uThukela Water taking the first step towards proactive pipeline integrity management

uThukela Water (Pty) Ltd recently completed a series of investigations as part of a programme to assess the condition of two critical raw water supply pipelines

**Project** Integrity survey of two raw water mains from Ntshingwayo Dam to the Ngagane Water Treatment Plant

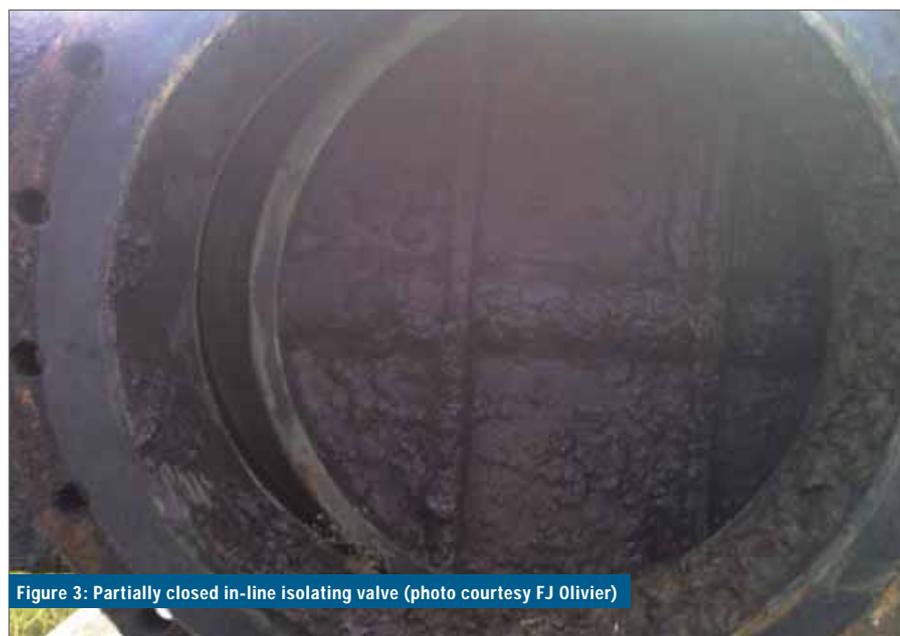
Figure 3: Partially closed in-line isolating valve (photo courtesy FJ Olivier)

The hydraulic modelling of both pipelines yielded interesting results. Whereas the hydraulic performance of the Steel/FC pipeline was as expected, the hydraulic analysis of the PCP produced results that were not representative of the expected condition of the main pipe barrel. Entrapped air, the presence of some large leaks along the pipeline and an isolating valve that was stuck in an almost closed position (see Figure 3) are the most likely causes of the anomalous hydraulic behaviour of the pipeline.

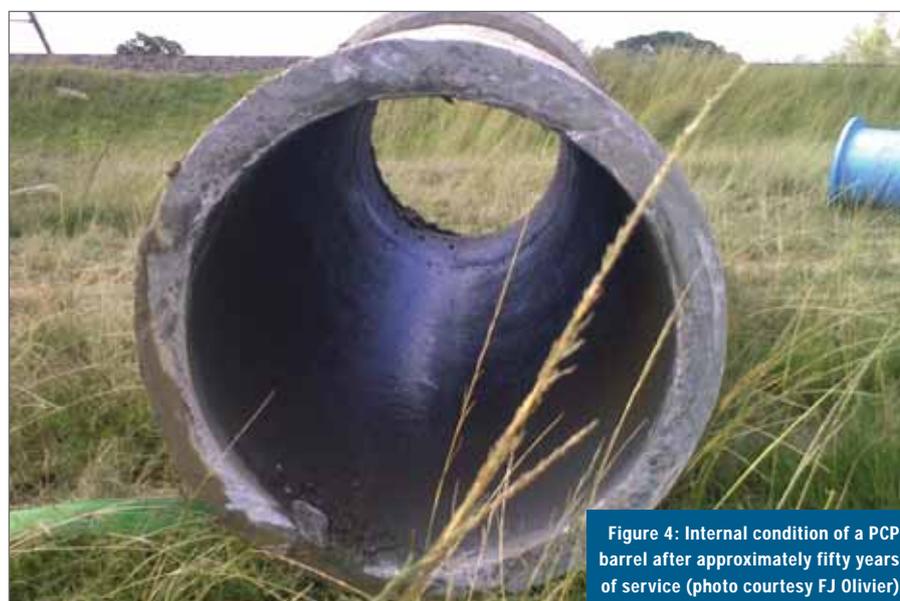
Figure 4: Internal condition of a PCP barrel after approximately fifty years of service (photo courtesy FJ Olivier)

Based on the findings of the surveys performed on the PCP and Steel/FC pipelines, and given the relatively low operating pressures that the pipelines are exposed to, it is believed that rehabilitation or selective repair methods could be a cost-effective alternative to overall pipeline replacement. This was confirmed when sections of the PCP were removed to install a by-pass connection, offering the opportunity to inspect the internal condition of the pipeline and finding it to be in better than expected condition after almost fifty years of service (see Figure 4).
