# Failure analysis in locomotive Bogie Brake-Hanger

## Abstract

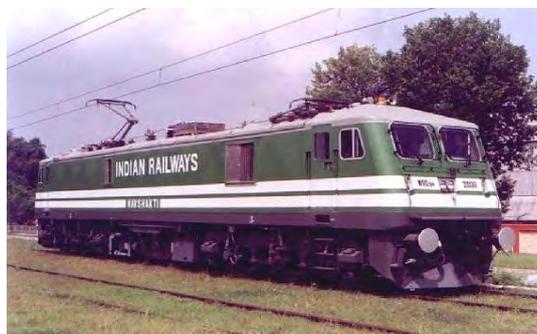
Figure 1: WAG-7 type Electric Locomotive

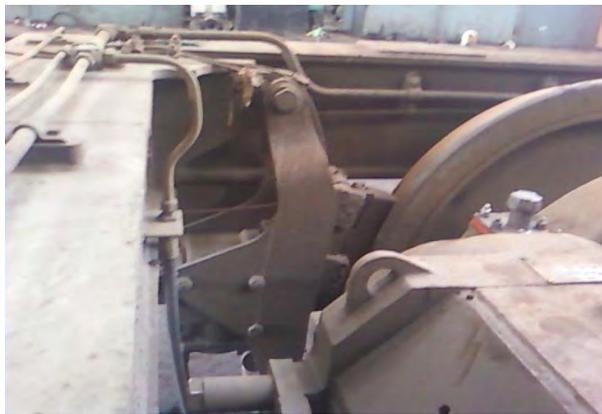
Figure 2: Brake hanger assembly

During a brake application, the brake beam on either side of a wheel set are moved by the brake cylinder through the brake rigging so that the brake block holders are pulled towards the wheel treads. The brake beam however only controls the movement of brake blocks in horizontal plane and provides no vertical restraint. The upper part of the brake hangers are connected brackets on bogie frame by the upper brake hanger-pins.

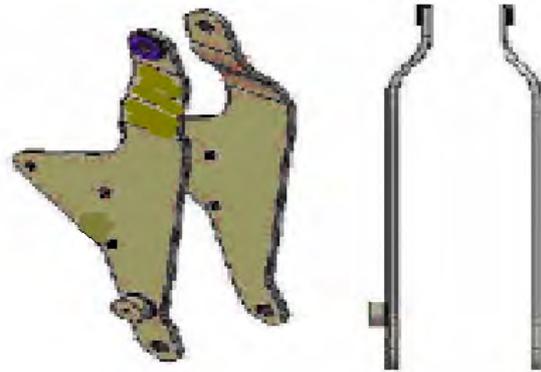
Figure 3: Brake hanger

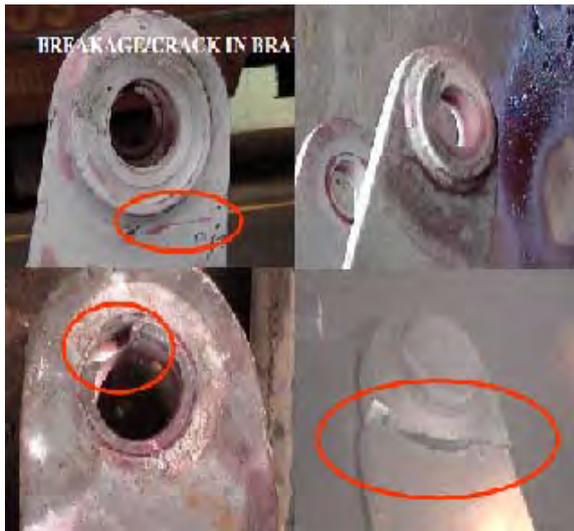
1. The brake-hanger usually fails during running condition after certain period.
2. 100% breakage at the top of the hanger plate
3. The initiation of crack begins near the bush welding which progresses and breaks the hanger plate into two pieces.
4. Both the inner and outer hangers are breaking but the breakage of inner hanger towards bogie frame is much more with 80% of total failure.
5. Failures in PBU (weight of 150 kg) are more compared to TBU (weight of 130 kg).  
(It should be noted that, the material report confirms the brake-hanger material as per requirements.)

Figure 4: Various types of failures in Brake hanger

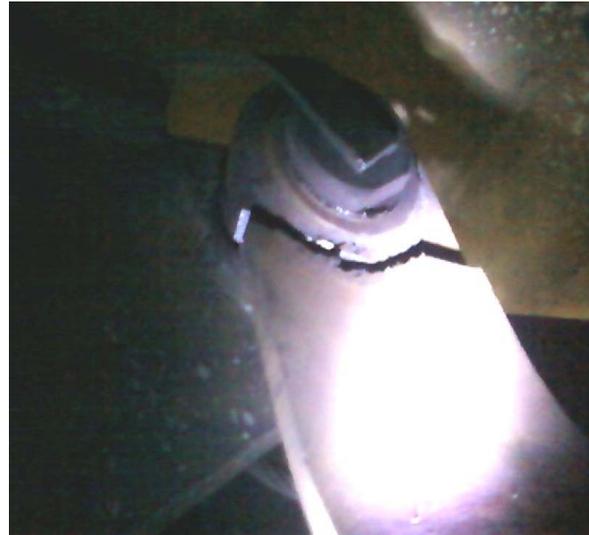
The problem identified in the assembly of brake-hanger of WAG-7 railway engine is that the brake-hanger fails under fatigue. Following are the observations on failed brake-hanger.

Figure 5: Present failure in Brake hanger

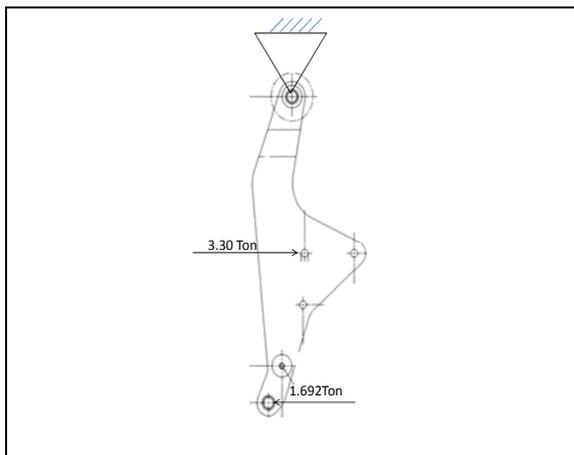
Figure 6: F.B.D. of Brake Hanger (for WAG-7)

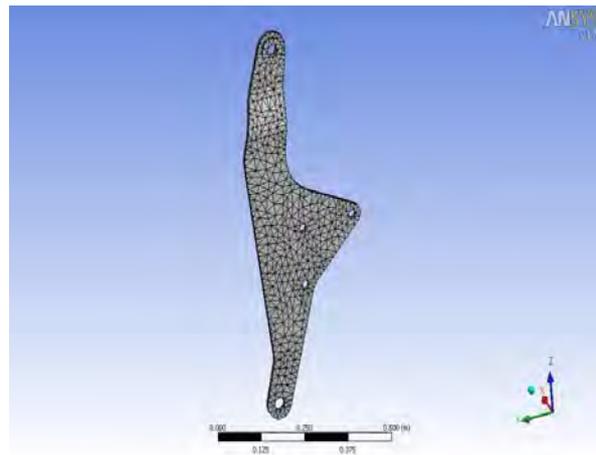
Figure 6: Meshed Model of Brake hanger

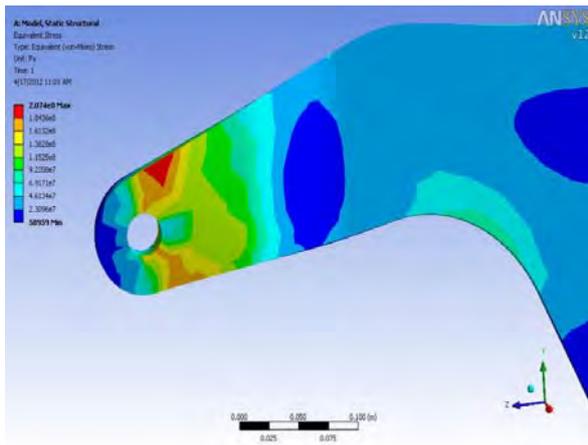
The above observed failure in brake hanger could be analysed by using ANSYS. The following are the outcomes for existing model. It shows the Equivalent (Von-Mises) stress and Maximum Shear stress.

Figure 6: Von-Mises(Inner side) Stress in Brake hanger

Since with the analysis of present brake hanger using ANSYS 12.0, the critical points were observed where high stress concentration is present, and the values of respective stresses are calculated. From these locations of critical zones only the fracture may start and it confirms to the present failure occurring in the brake hanger.

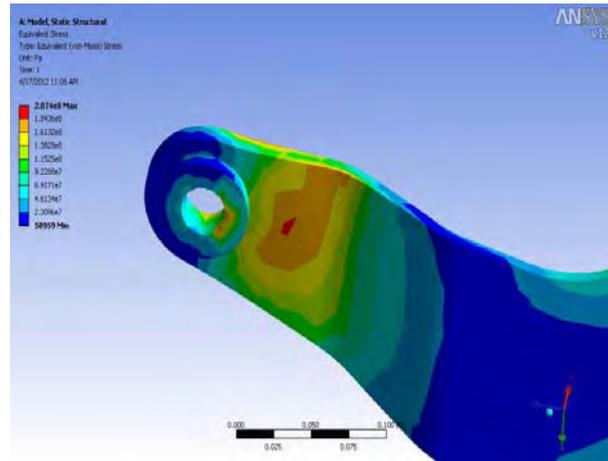
Figure 7: Von-Mises(Outer side) Stress in Brake hanger

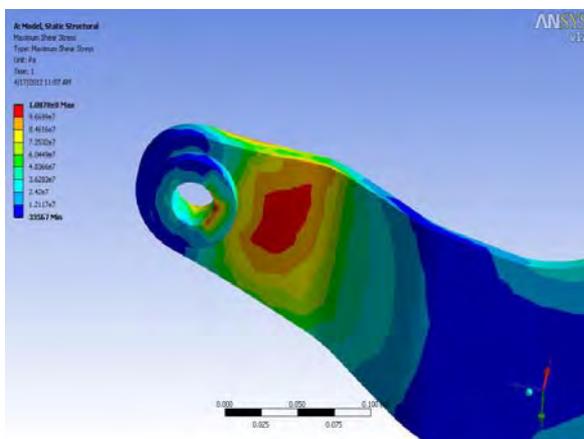
Figure 8: Max. Shear stress (Outer side)

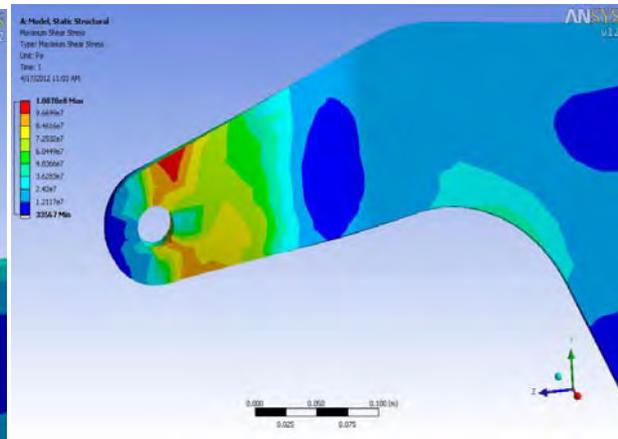
Figure 9: Max. Shear stress (Inner side)
