A Study on Evaluation of Strut Type Suspension Noise Caused by Rubber Degradation

Gugyong Kim, Sugnsu Kang, Yongjun Lee, Sooncheol Park, and Wonwook Jung

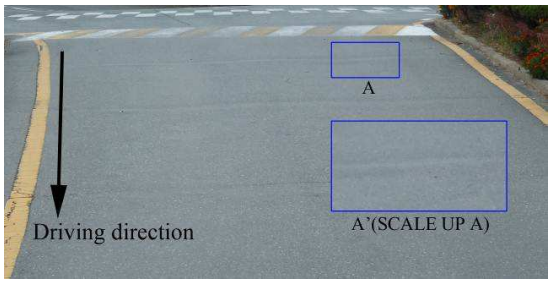
Fig. 1 Road surface generating strut noises

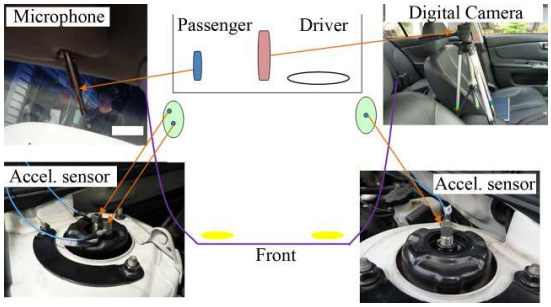
Fig. 2 Sensor installation position

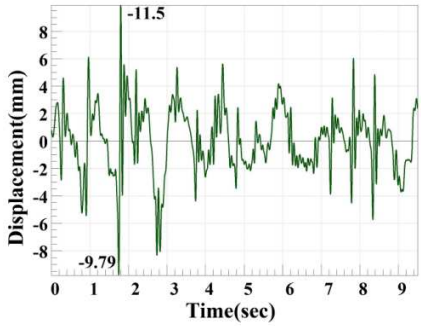
Parts which went through calibration were assembled into a strut module and this module was installed on the car (Fig. 3) to measure the profiles of the noise-generating road surface (Fig. 4). Sensor-attached springs were installed on the car before conducting the experiment. Fig. 4 indicates the strut movement profiles measured on the noise-generating road surface.

Fig. 4 Profiles of the noise-generating road surface

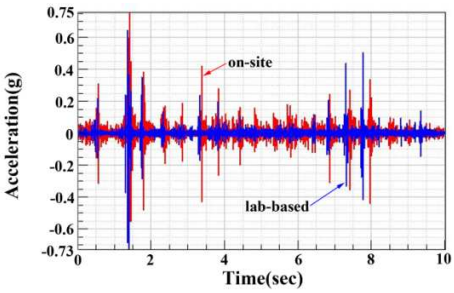
Fig. 7 shows the data measured by the accelerometer attached to the upper end of the insulator. It represents the size of acceleration measured on-site and in a lab-based experiment. It can be seen that the lab-based experiment properly reproduces the acceleration size measured on-site.

Fig. 7 Comparison of acceleration data measured on-site and in a lab-based experiment

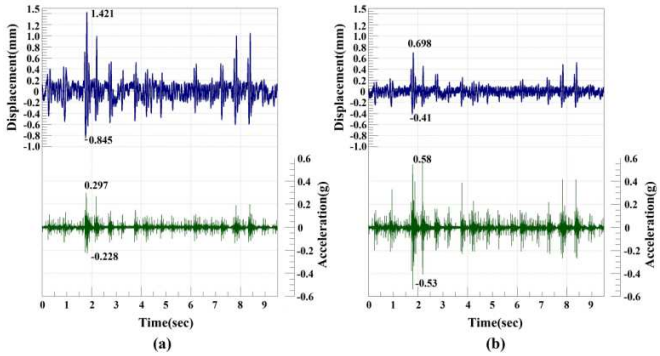
Fig. 8 Comparison of displacement and acceleration data for the insulator noise section: (a) new insulator; (b) used insulator generating noises

In Fig. 8, (a) represents the experiment with the combination of a new damper and a new insulator and (b) indicates the experiment with the combination of a new damper and a used insulator (82,000 km; 4 years). It can be seen that the new product displacement (2.266 mm) is greater than the used product displacement (1.108 mm). Natural rubber (NR) is mostly used for the rubber material of the insulator. To find out the difference between the initial-state (new) insulator and the used insulator, the strut insulators were disassembled and the rubber shapes were compared. The rubber thickness of the initial-state insulator was 37.8 mm and that of the used insulator was 30.9 mm, showing a difference of 6.9 mm (Fig. 9).

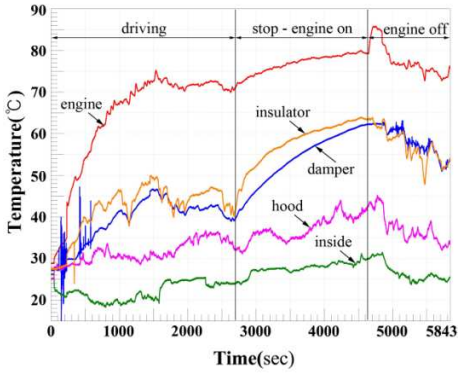
Fig. 10 Insulator during driving in summer (30 °C) and damper temperature data

To compare the rubber hardness, the hardness was measured using the durometer (KS M 6518 Shore A type). The hardness value of the initial-state insulator is Shore A 55 and that of the used insulator is Shore A 69, indicating a difference of +14. The insulator degradation was caused by the heat (of the engine and the air) and the repeated loads [8-10]. An experiment was conducted to measure the insulator's temperature changes during driving and stopping. The experiment's conditions included 30 °C in the summer and downtown driving and stopping (Fig. 10). It can be confirmed that the insulator temperature rises up to 50 °C during driving and up to 63 °C during stopping as there is no air circulation and the car iron plate temperature increases due to the engine temperature and the solar heat.

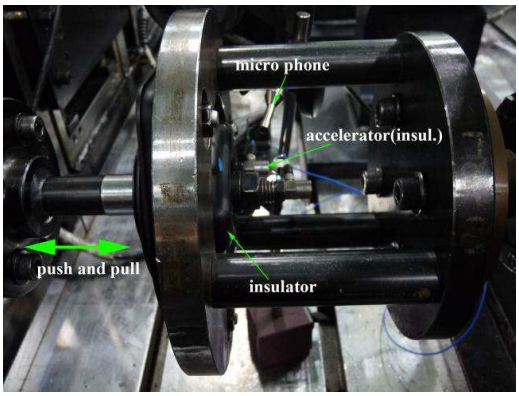
As shown in Fig. 11, the insulator rubber is compressed by the upper and lower metal sheets to prevent vibrations and noises from reaching the car body. The compression amount can be expressed as in (2).

It can be confirmed that the rubber compression height, which represents the height difference between the disassembled rubber and the compressed rubber, changed from 9.8 mm (the new product) to 2.9 mm (the used product).

Fig. 11 Composition of insulator noise confirmation experiment devices

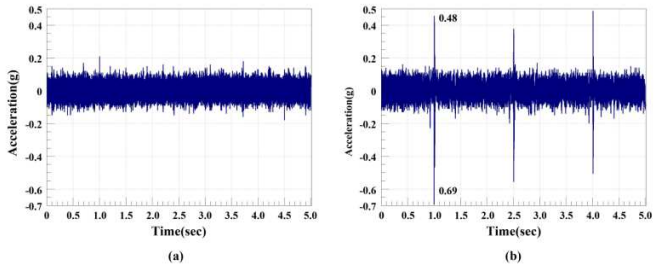
Fig. 12 Comparison of insulator noise generation degrees: (a) new insulator; (b) used insulator generating noises

With the newly developed noise confirmation test, the acceleration data of the new insulator and the used insulator generating noises were compared (Fig. 12). The insulator noise confirmation test was conducted in a general lab, not in an anechoic room. Accordingly, both the new insulator and the used insulator generated additional ±0.15 g of noises due to the noise occurring during the hydraulic operation. In the case of the used insulator, the noises were generated at positions with greater operation loads and frequencies. As a result, the new test method developed in this study could reproduce the noises generated by the used insulator in the field.

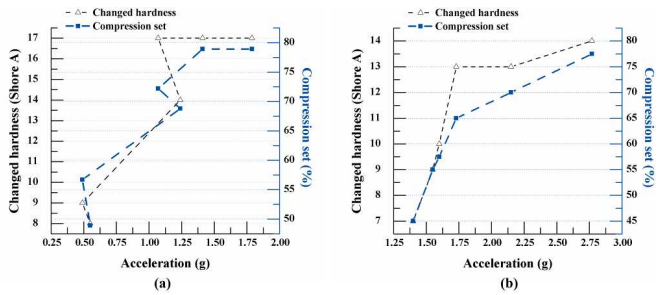
Fig. 13 Comparison of hardness and compression set: (a) Type A; (b) Type B

Fig. 13 shows the results of comparison between the rubber hardness change and the acceleration change depending on the compression set. The experiment results indicate that the acceleration, that is, the noise increases as the rubber hardness changes and the compression set increases.

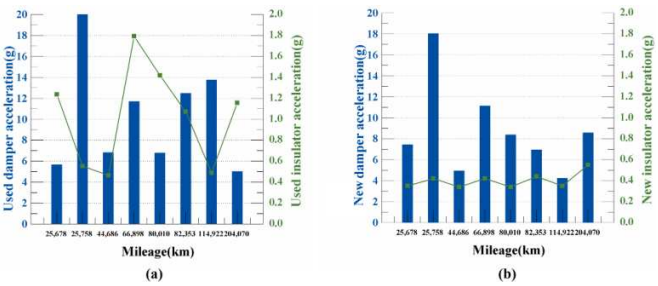
Fig. 14 Effects of insulator performance on noises: (a) used insulator; (b) new insulator

To see how the state of the damper and insulator which constitute a strut affects noises, an experiment was conducted with use of a used part of Type A. A module-state lab-based noise evaluation test was performed using new strut parts except the damper and insulator so that the effects of the parts other than the damper and insulator can be excluded. In the experiment using a used damper and a used insulator, five out of eight samples showed 1 g or greater vibrations which were delivered to the car body through the insulator (Fig. 14(a)). In an experiment using the same damper and a new insulator, even when the damper generated vibrations with great deviations between 5 g and 18 g, only vibrations between 0.35 g and 0.6 g were delivered to the car body through the insulator (Fig. 14(b)). The experiment results show that the insulator performance has greater effects on the vibrations and noises conveyed to the car body than the damper performance.

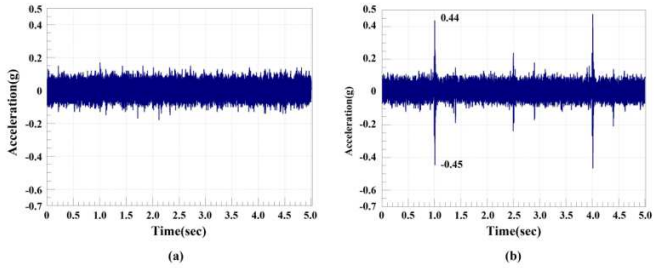
Fig. 15 1Comparison of insulator noise generation degree: (a) existing durability test; (b) cyclic durability test

Existing insulator durability tests are carried out by applying certain repeated compression and tension loads to the insulator at room temperature. In this case, rubber softening takes place due to the repeated loads, failing to reproduce rubber hardening which occurs in the field. In addition, noises are not confirmed even with the insulator noise confirmation test (Fig. 15(a)). To resolve these problems, a cyclic reproduction test was developed by considering the insulator's use environment condition, that is, the temperature condition. The data obtained through the newly developed reproduction test can confirm the noise reproduction as shown in Fig. 15(b).
