# Bridge reinstated to its

**Bridge No 422 over the Orange River near Zastron in the Free State was constructed in 1934. It is a magnificent feat of engineering and concerted efforts should be made to preserve it for posterity. The bridge, which was seriously damaged by vehicular impact, was recently repaired. Innovative answers were found for the challenging demands of structural stability, safety and economy**

## BRIDGE NO 422 REPAIRS

### Category Technical Excellence

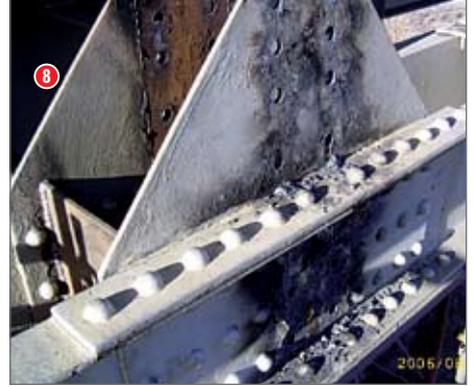
- 8 Damaged member removed
- 9 Repair of diagonal member
- 10 Finished diagonal member
- 11 Temporary adjustable ties
- 12 Adjustable nuts on tension tie
- 13 'Repair in the air' scaffolding
- 14 Safety was not negotiable
- 15 Vehicle 'terminus'

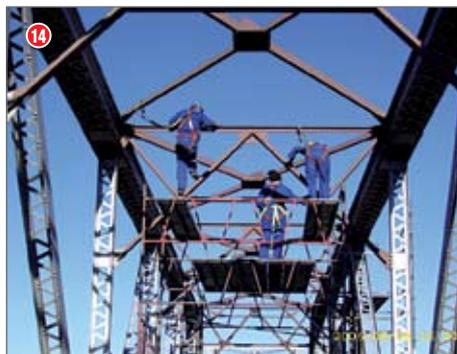
The contractor designed a functional and unique moveable scaffolding system suspended from the deck to make possible the 'repair in the air' solution.
