Mike Chemaly
Associate
WSP Africa Coastal Engineers
mike.chemaly@wspgroup.co.za

Failure of the Gansbaai leeward breakwater

Civil Engineering | December 2011

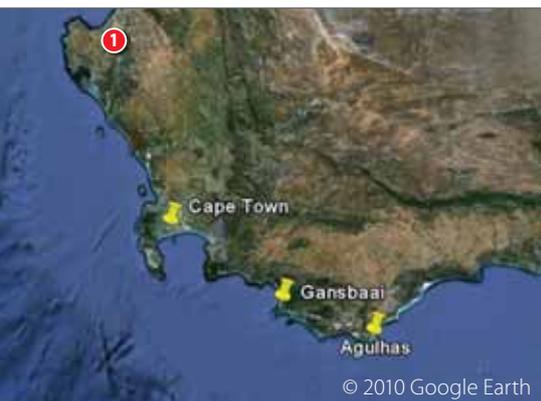
- 1 Gansbaai – South Africa
- 2 Gansbaai – New Fishing Harbour and location of damage
- 3 Existing typical section (Ch 66 – Ch 126)
- 4 1 000 mm deep by 30 m long entrance under structure
- 5 Shear crack running for 30 m along structure length
- 6 Rock armour defence collapsed
- 7 Breakwater founded on rock reef

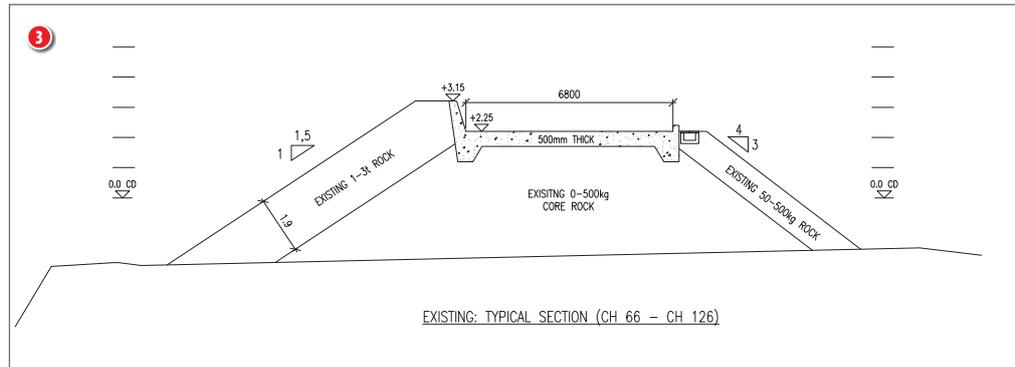
In the 60 m of damaged area (Ch 66 m and Ch 126 m) the existing breakwater cross section was made up as follows: The core consisted of 0–500 kg material. The grading distribution of the core was unknown at the time of tender. The core was overlain by a 500 mm thick x 7 m wide concrete roadway. The sea-facing roadway edge had a 900 mm high parapet wall. The core slopes were shaped to 2V:3H and overlain by a double layer 1-3 t armour rock.

plane of bedrock. This bedrock profile has a final ground level on roughly +0,3 m CD. This level coincides with the Mean Low Water Spring level of +0,27 m CD. This horizontal plane of bedrock extends roughly 2 m past the armour rock toe, after which it dips steeply to form a vertical reef-like edge.

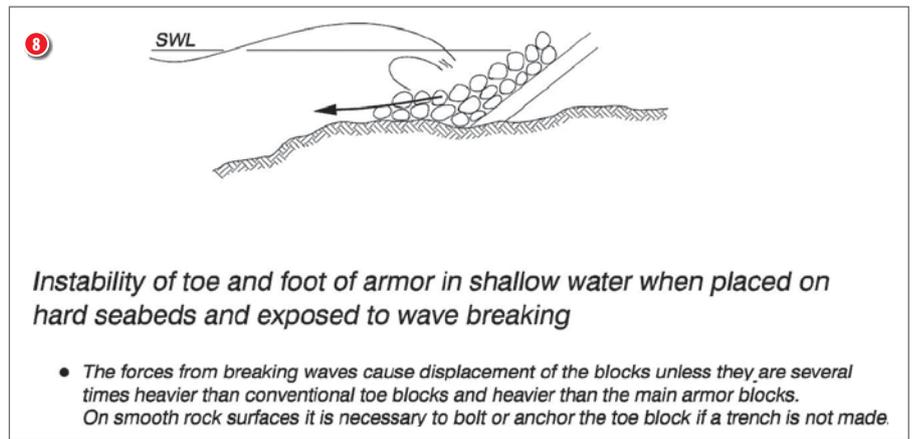
Along the first 30 m (Ch 66 – Ch 96) of the 60 m section of failed breakwater, rock armour had been displaced over a distance of 30 m from the breakwater, due to severe wave action in May 2010. Wave-breaking along this section of the breakwater is in the form of plunging breakers on a hard rock bed (resulting in Failure Mechanism 1 – see Table 1). In addition the original core that predominantly consisted of fine material, unprotected by a geomembrane, had washed out from the

Along the second 30 m (Ch 96 to Ch 126) stretch of this 60 m section of failed breakwater, armour rock was displaced downwards from the toe, slope and crest areas of the breakwater. This in turn exposed the underlying core. In addition the parapet wall was exposed and had to absorb direct wave impact.

- 8 Illustration of Failure Mechanism 1. Source: Coastal Engineering Manual (CEM) EM 1110-2-1100 (Part VI), 1 June 2006, Figure VI-2-39
- 9 Proposed typical section (Ch 66 – Ch 96)

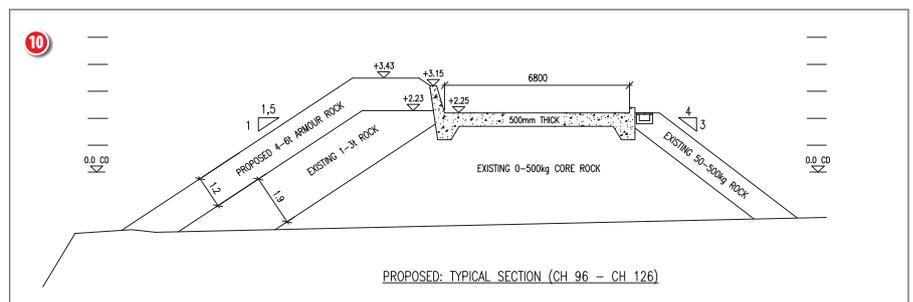
- 10 Proposed typical section (Ch 96 – Ch 126)
- 11 After removal of concrete deck: test hole at 1 m deep
- 12 After removal of concrete deck: test hole at 1,5 m deep

- The original 1-3 t double-rock protection was salvaged and reconstructed.
- A new single layer of 4-6 t armour rock was constructed.

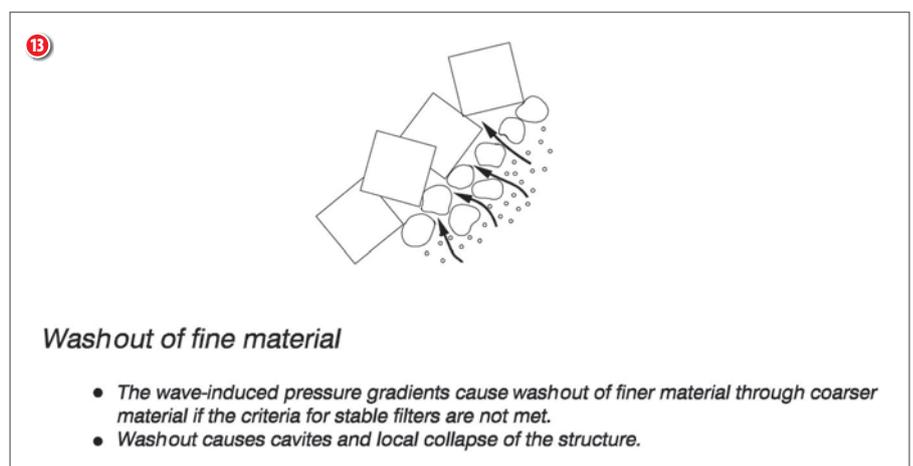
breakwater core (Failure Mechanism 2). This resulted in a massive cavity 30 m long by 0,5-1 m deep forming under the concrete roadway. Subsequently the concrete roadway started to collapse into this cavity.

- 13 Illustration of Failure Mechanism 2. Source: Coastal Engineering Manual (CEM) EM 1110-2-1100 (Part VI), 1 June 2006, Figure VI-2-40
- 14 Proposed typical section (Ch 66 – Ch 96)

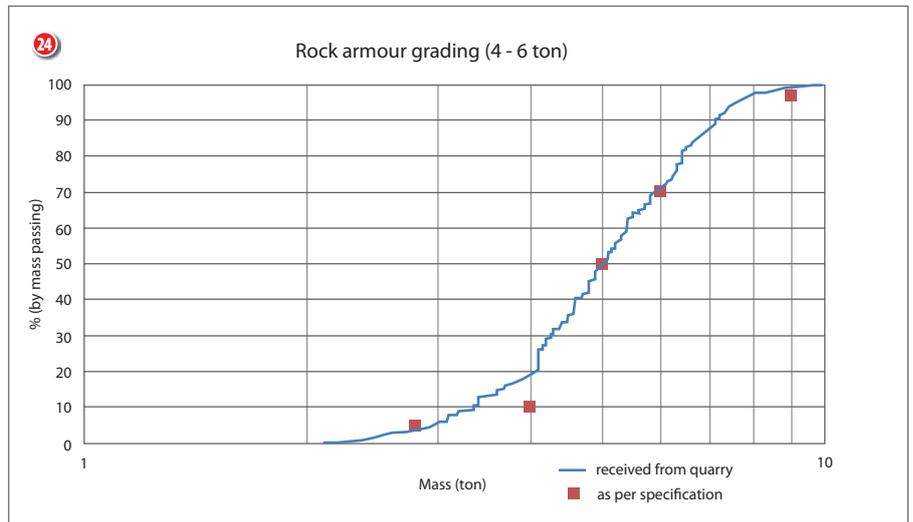
- 24 Rock armour grading
- 25 1,5 m high drop test – crushed rock onto steel plate

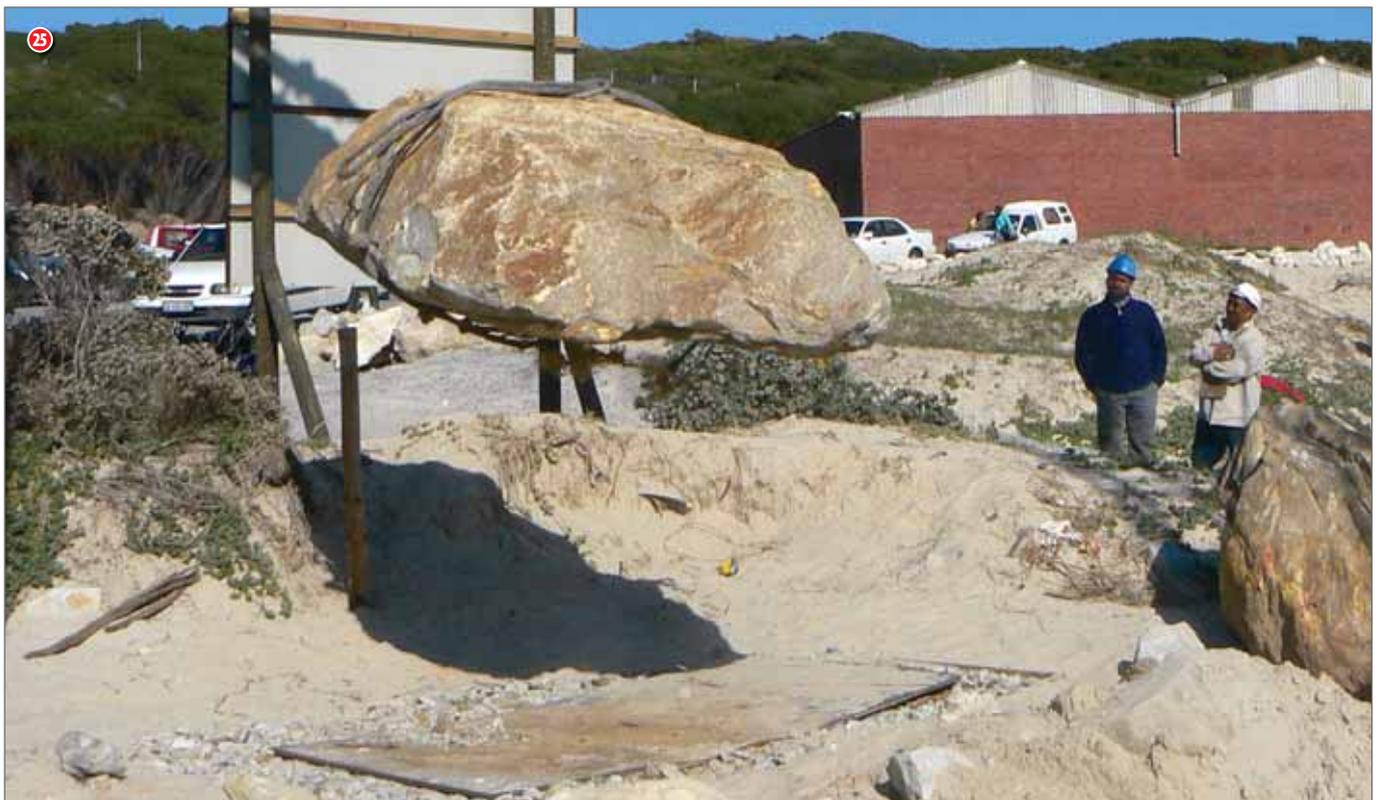
Specification requirements (avg)	QC test result (avg)
Rock dry density	> 2 600 kg/m ³	2 650 kg/m ³
LA abrasion value	< 22%	11,9%
Drop test @1,5 m onto steel plate	Bn < 10% (armour rock)	< 1%
Water absorption	< 2% of dry weight	0,53%
Shape of armour	Cubicle to rectangular	Cubicle to rectangular
Greatest to least dimension GTL	Less than 5% should be > 3:1	Average 2,35; 13% was less than 3:1
Grading armour	M50 = 4,5 t; NUL 6 t; NLL 4 t	See graph (Figure 24)
Grading core	M50 = 250 kg; 0-10 kg = zero; NUL = 500 kg	M50 = 250 kg; 0-10 kg = zero; NUL = 500 kg
Crushing strength core	Hard, sound, durable, 80 MPa	Hard, sound, durable, 111 MPa
Block coefficient armour	> 60%	Approximately 65%
Testing frequency quarry	20%	10%
Testing frequency site	10%	20%
Rock type	To Rock Manual or as agreed	Quartzite
