RAILWAYS AND HARBOURS

Innovative investigation and repair of the Overvaal railway tunnel

THE 4 KM LONG Overvaal railway tunnel on the Coal Line between Ermelo and Piet Retief was constructed in 1974 by blasting into dolerite of the Ecca Group and Dwyka formation. After serving more than 30 years as the only permanent single line section on the Coal Line, foundation problems dictated the need to investigate and rectify the movement of the tunnel slab and supporting foundation.

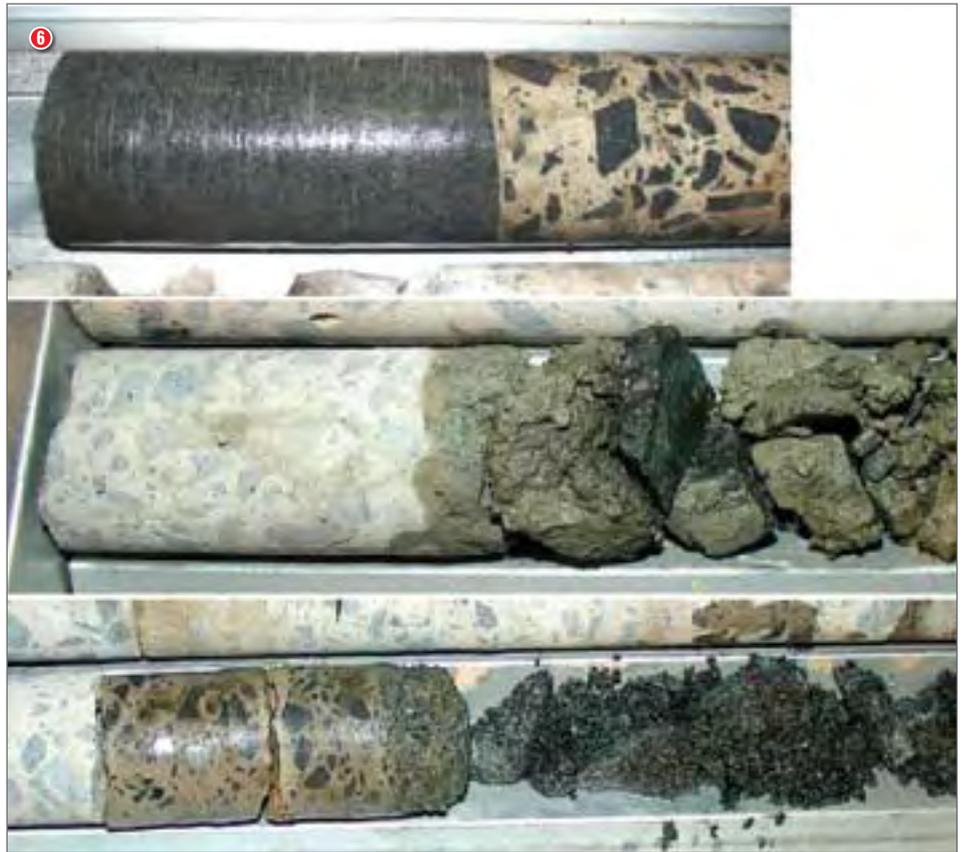
Figure 5 Typical examples of voids or cracks at the interfaces

- Cracks or voids were present at the interfaces, namely between the slab and mass concrete, between different layers of mass concrete, and between the mass concrete and in-situ rock
- The occurrence of cracks or voids varied

considerably along the length of the tunnel and only short distances of the tunnel had no cracks or voids
