Optimization of maintenance, diagnostic technique and design of substation equipment based on analysis of service experience

C. Neumann, B. Rusek

RWE Transportnetz Strom, Dortmund

G. Balzer

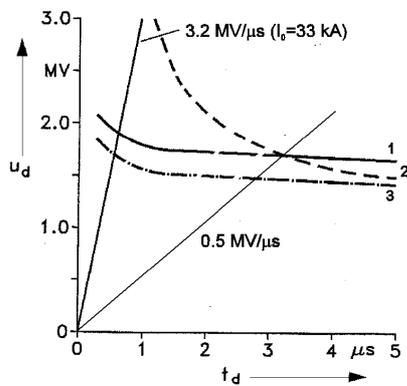
In cases of steep front overvoltages with a steepness above $0.5 \text{ MV}/\mu\text{s}$, as they occur due to first and subsequent lightning strokes to the overhead lines in the vicinity of the substation, the lightning withstand voltage of the instrument transformer as well as of the switching gap of the CB will be exceeded (Fig. 3.2). The problem could be solved by improved overvoltage protection measures by installation of arresters at the line entrance of the feeder. Due to the lack of space in the substation the arrester was integrated into the line disconnector [7]. This integration was verified using the arrester as one post insulator of the two column disconnector. A sufficient mechanical strength of the arrester for this function was proven by tests of the bending strength of the porcelain hollow insulator. The grading electrode turned out to be necessary for a sufficiently uniform voltage distribution had to be adjusted for this special application (Fig. 3.3).

Fig. 3.2: Voltage-time characteristic
 (1) switching gap of CB (2) spark gap
 (3) instrument transformer

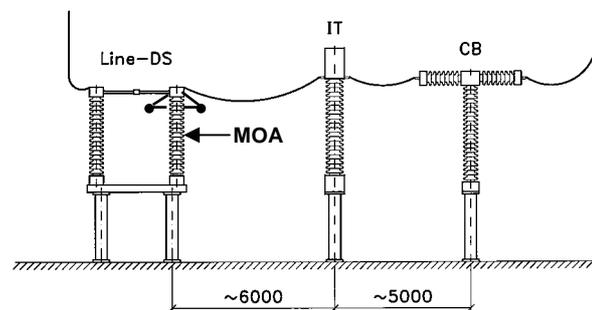
Fig. 3.3: 380 kV feeder arrangement consisting of line disconnector, instrument transformer and two unit circuit breaker

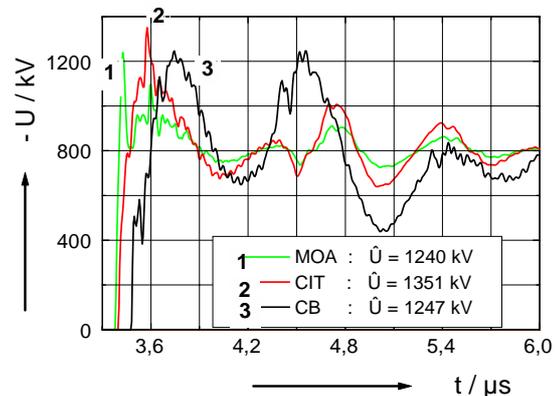
Fig. 3.4: Overvoltages at metaloxide arrester (MOA), combined instrument transformer (CIT) and circuit-breaker (CB) due to a subsequent stroke with $\sim 90 \text{ kA}/\mu\text{s}$

The results given in Fig. 3.4 demonstrate that the overvoltage protection measures considered are suited to protect the instrument transformer as well as the switching gap of the circuit-breaker even in case of steep front overvoltages. Since the strength of SF6 gas insulated systems at lightning overvoltages is strongly affected by protrusions even in the mm-range, it was decided to test the SF6 gas insulated instrument transformers with lightning impulse voltage as routine test.
