# New berth 306 expands capacity of Richards Bay Coal Terminal

The construction of berth 306 at Richards Bay Coal Terminal, involving 11 caissons, has increased the capacity of the terminal from 72 to 82 million tons per annum. Extensive monitoring of the dredging operation was carried out, and it appears that the construction had very little negative effect on the environment

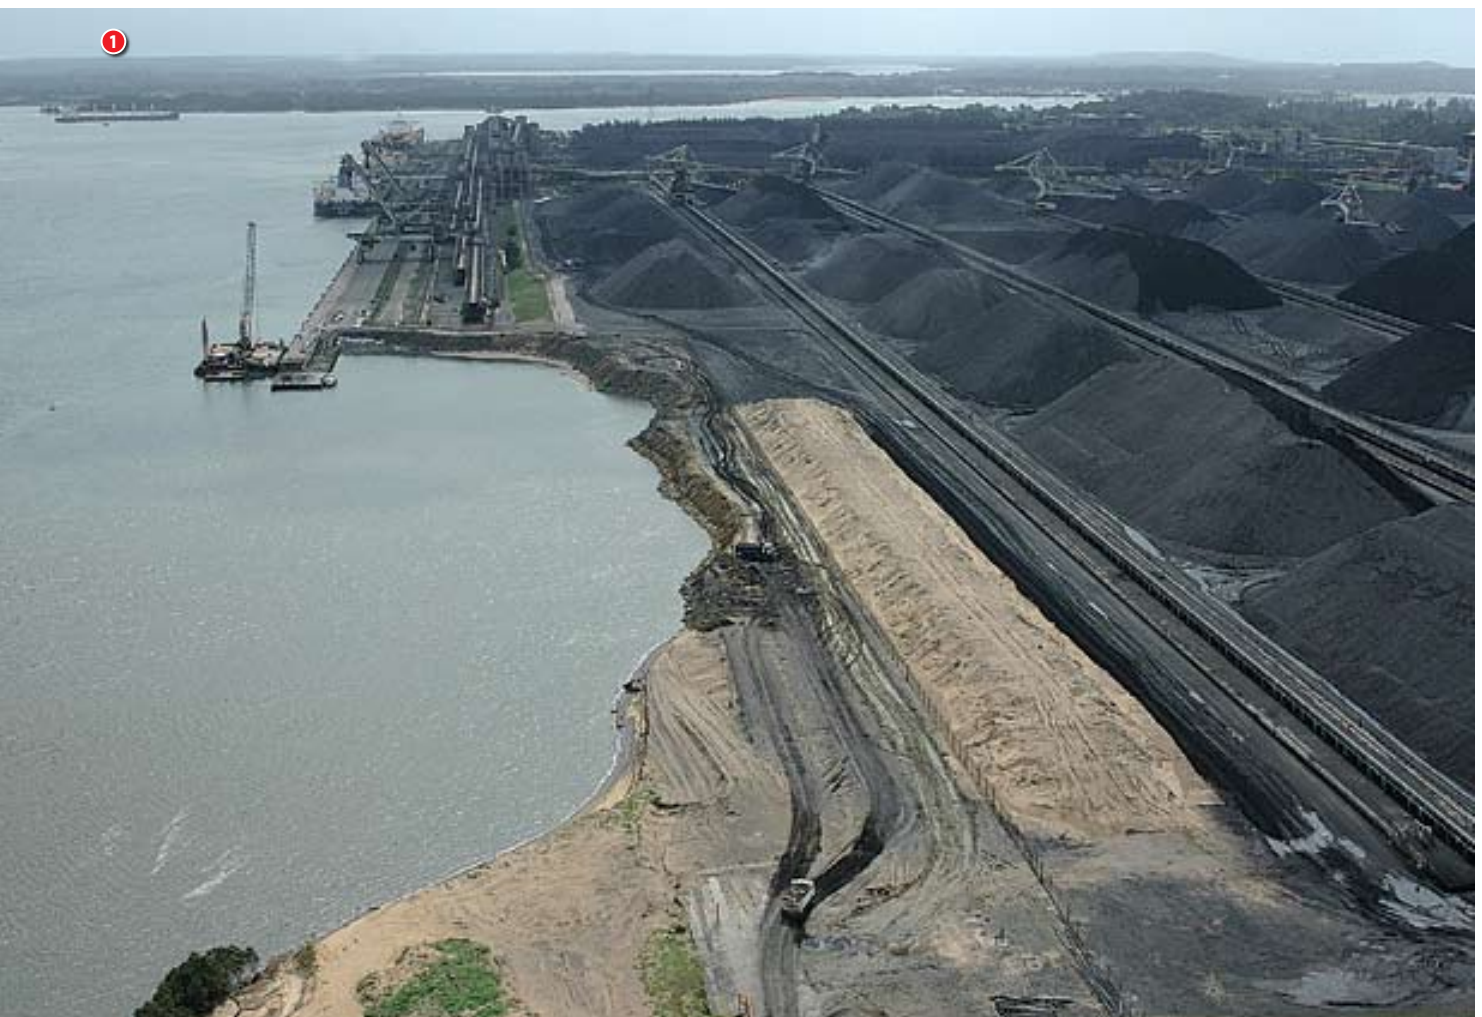
① Quay wall site before construction

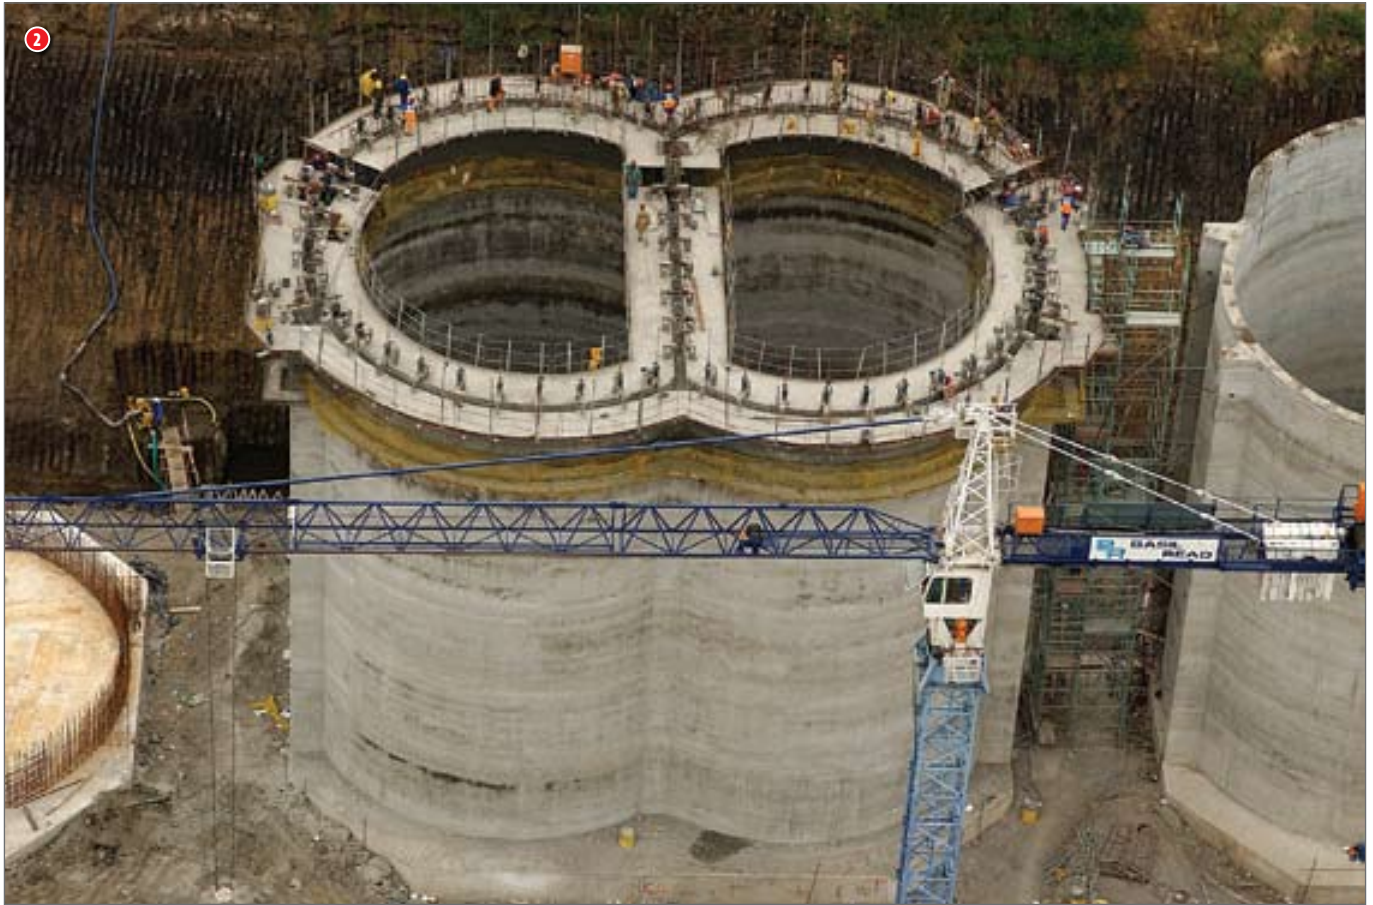
② Caisson under construction

Eleven caissons were required to construct the quay wall. Each caisson had a base which measured 27,9 m by 19,8 m and was 1,5 m in depth. Onto these bases the caisson walls of 22,7 m in height were cast. Each caisson consisted of two circular cells which were joined by a dividing wall and required 2 130 m<sup>3</sup> of concrete. Casting the eleven caissons took 8 months to complete. Once the caissons had been cast, the basin was flooded which allowed them to be floated. Flooding of the basin was carried out by inserting three pipes of 900 mm in diameter into the berm wall with an invert level of +0,5 m, which allowed the variations in tidal levels to fill the basin in a controlled manner within five days. Once the basin had been flooded, the berm wall was excavated, allowing the caissons to be towed from the basin.

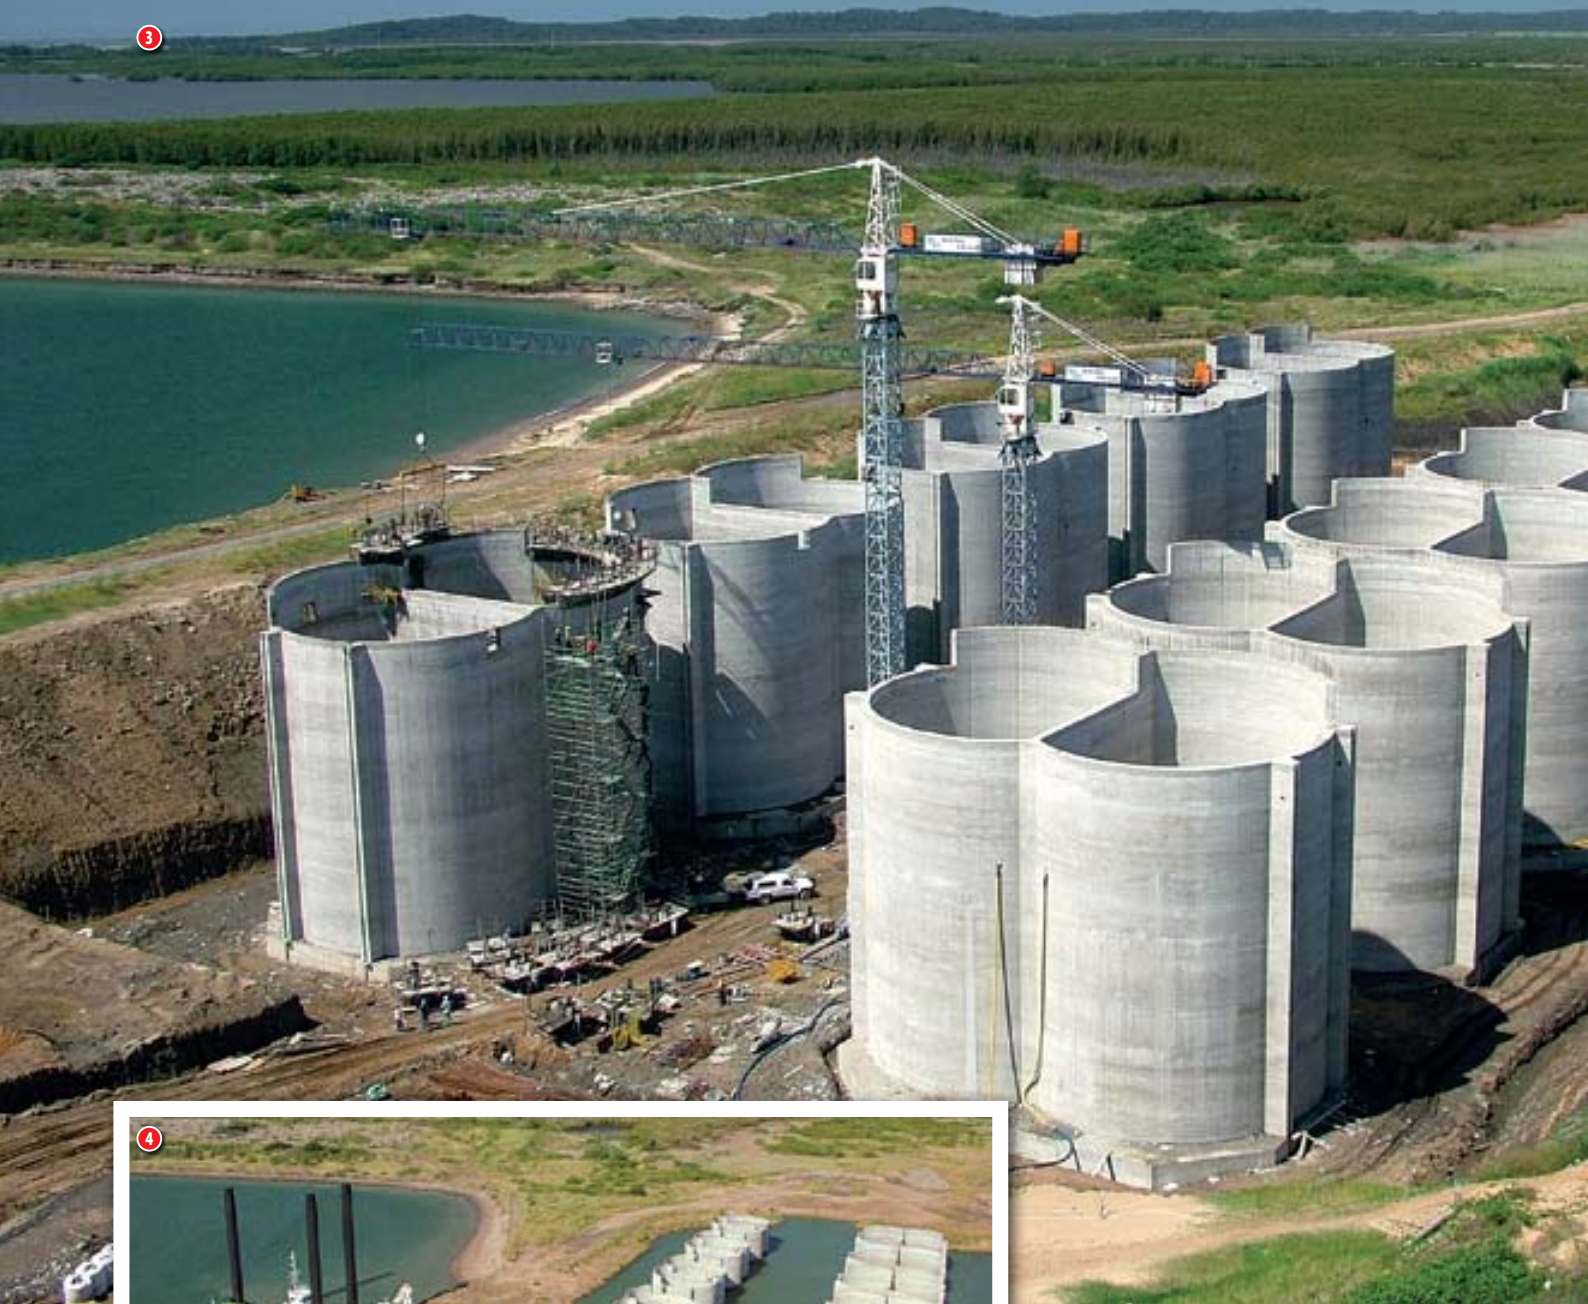
- 3 Constructed caissons in excavated pit
- 4 Caissons in flooded pit
- 5 Caisson listing 25 degrees in flooded basin
- 6 Caissons being placed at quay wall site
- 7 Heavy reinforcing of mass capping

It was decided to construct the caissons in a pit because land was available in the port, port operations would not be adversely affected and this method had been used successfully in the past. The internal dimensions of the pit were 185 m long, 85 m wide and 15,5 m deep. Groundwater seepage into the pit was contained by creating a trench along the sides of the pit from which seepage water would be removed since the only source of seepage water was along porous layers found in the sides of the excavation. As a portion of the pit had been used as a caisson pit in the past, the pit first had to be closed off by constructing a berm

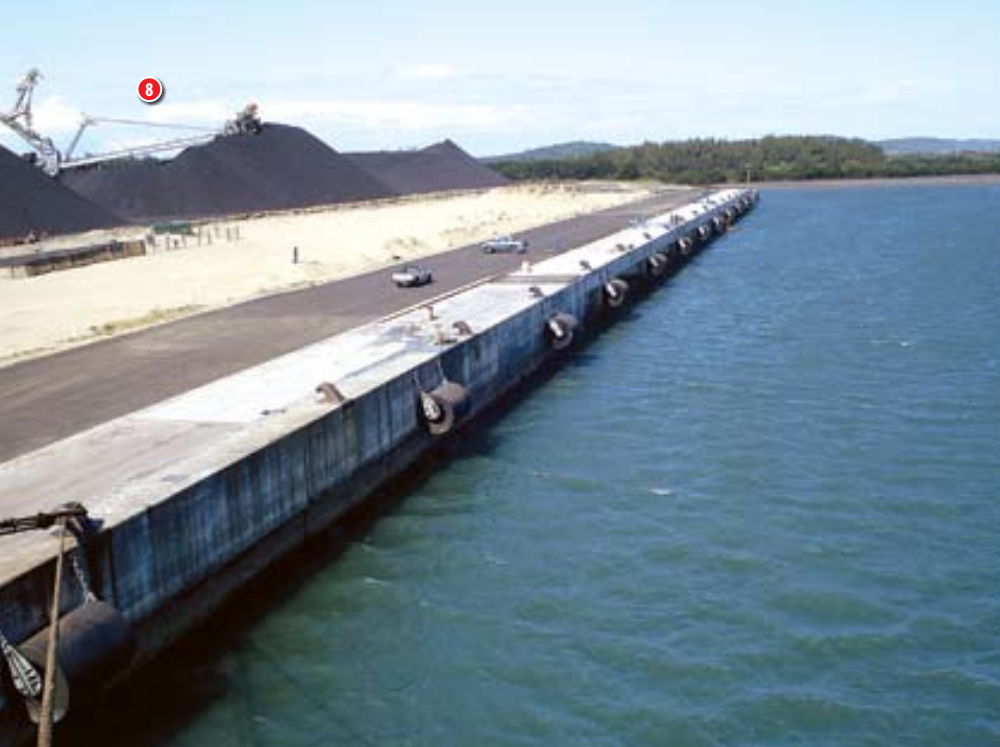
8 Completed quay wall and basin
