## Printed circuit boards-Conductor finishes: nickel-gold

### Introduction

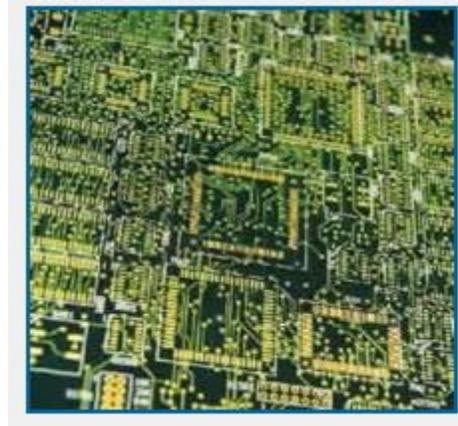
A PCB finished with electroless nickel/immersion gold (ENIG)

Where a flatter surface finish is needed, many companies use 'nickel/gold', more properly referred to as 'ENIG' (Electroless Nickel, Immersion Gold), in which a 3–5 $\mu\text{m}$  layer of electroless nickel is given a thin gold 'flash' coating by immersion plating, an ion exchange process which coats the whole of the nickel surface.
