Board Failures

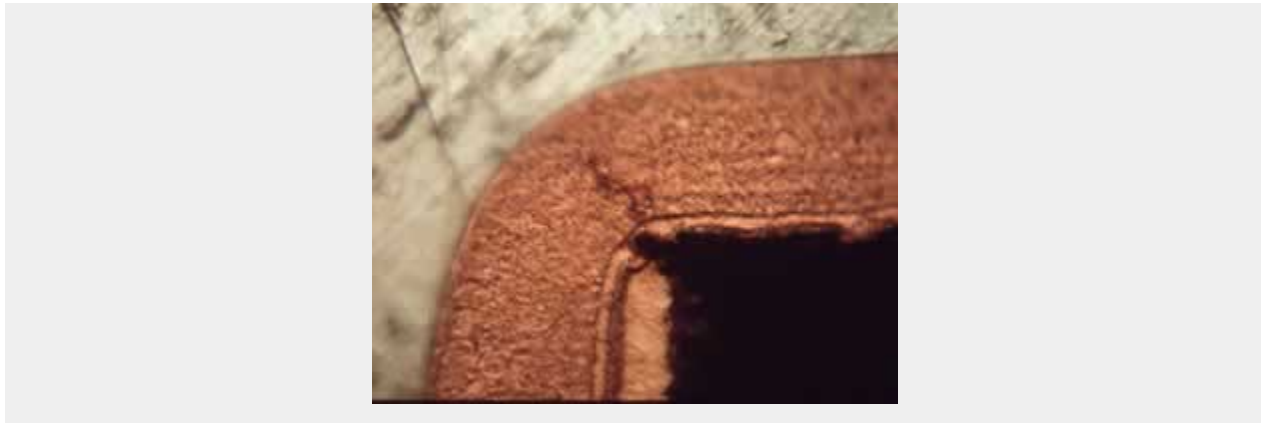
Cracking on corner of PTH

Illustrated in photographs are typical examples of corner cracking and inner layer cracks. Notice particularly that corner cracking starts from the stress point in the inside, rather than the outside, and can be relatively harmless in appearance. However, given that cracks tend to propagate, intermittencies and open-circuits can be created in a number of places within the through-hole structure.
