DEFECTS - METAL WORKING AND ROLLED PRODUCTS

Defects in Rolled Products

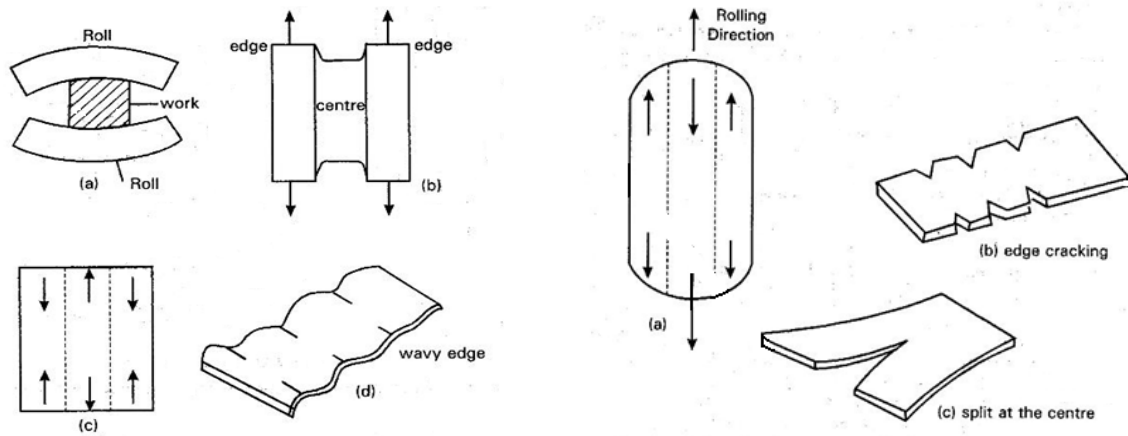
ii) Edge Cracking

The length of the center portion increases but the edges are prevented due to frictional force. As a result the material gets rounded off (a).

The edges are strained in tension leading to edge cracking along the width of the slab (b).

When the difference in the strains become excess i.e. under severe condition, split at the center of the slab occurs (c).
