# INTEGRITY OF GLASS/EPOXY AIRCRAFT COMPOSITE PART REPAIRED USING FIVE DIFFERENT METHODS.

Aircraft repairs are considered permanent repairs. This type of permanent repair is time-consuming and needs to be accomplished in a well-guided specification and precise accuracy. The critical demand for aircraft repaired part is to meet the integrity of the original parent body while in-service, which does not give room for trial and error. Similarly, the cost of discarding parts that have minor to medium surface damage is very high. In this work, an experimental work was carried out to find other viable repair method that could be applied to surface repair of an aircraft. It was found that the pre-preg method is still the most preferred. The infusion process, if performed under well-controlled environment, can be good substitute for wet layup.

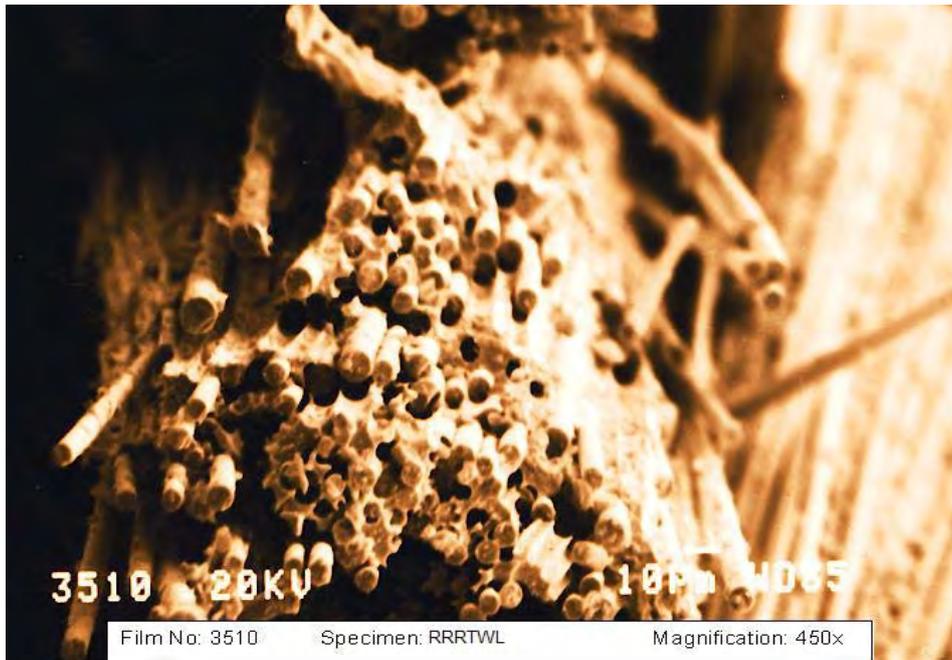
Fig. 3: SEM micrograph of 450-x magnification of the RRRTWL repair method showing resin rich laminate with exposed glass fibres.

This was a different observation for the 121-infusion repair of figure 5 that show good clean break in some areas and fibre pull out in other areas. The 121-infusion repair, show good comparative strength to the preferred pre-preg repair method. The room temperature resin rich laminate of figure 3, displayed neat breakage on one side and fibre pull out on the other side. The pre-preg exhibit neat breakage.

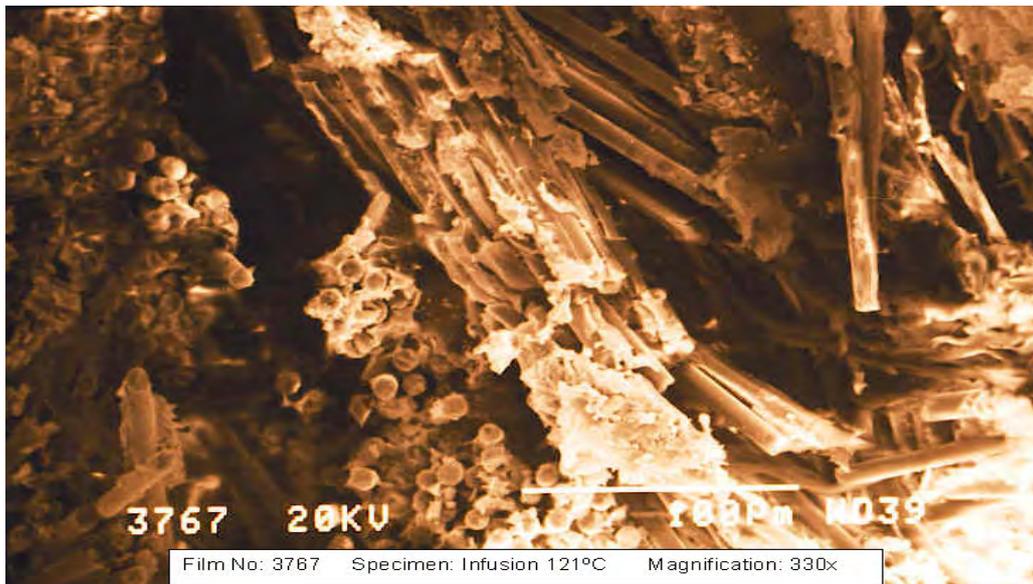
Fig. 5: SEM micrograph of 330-x magnification of 121 infusion repair showing partial uniform breaking and delamination on one side of the laminate
