Concor Civils completes innovative Newclare road-under-rail underpass

Dr Roger Barker Chief Engineer Murray & Roberts Construction roger.barker@murrob.com

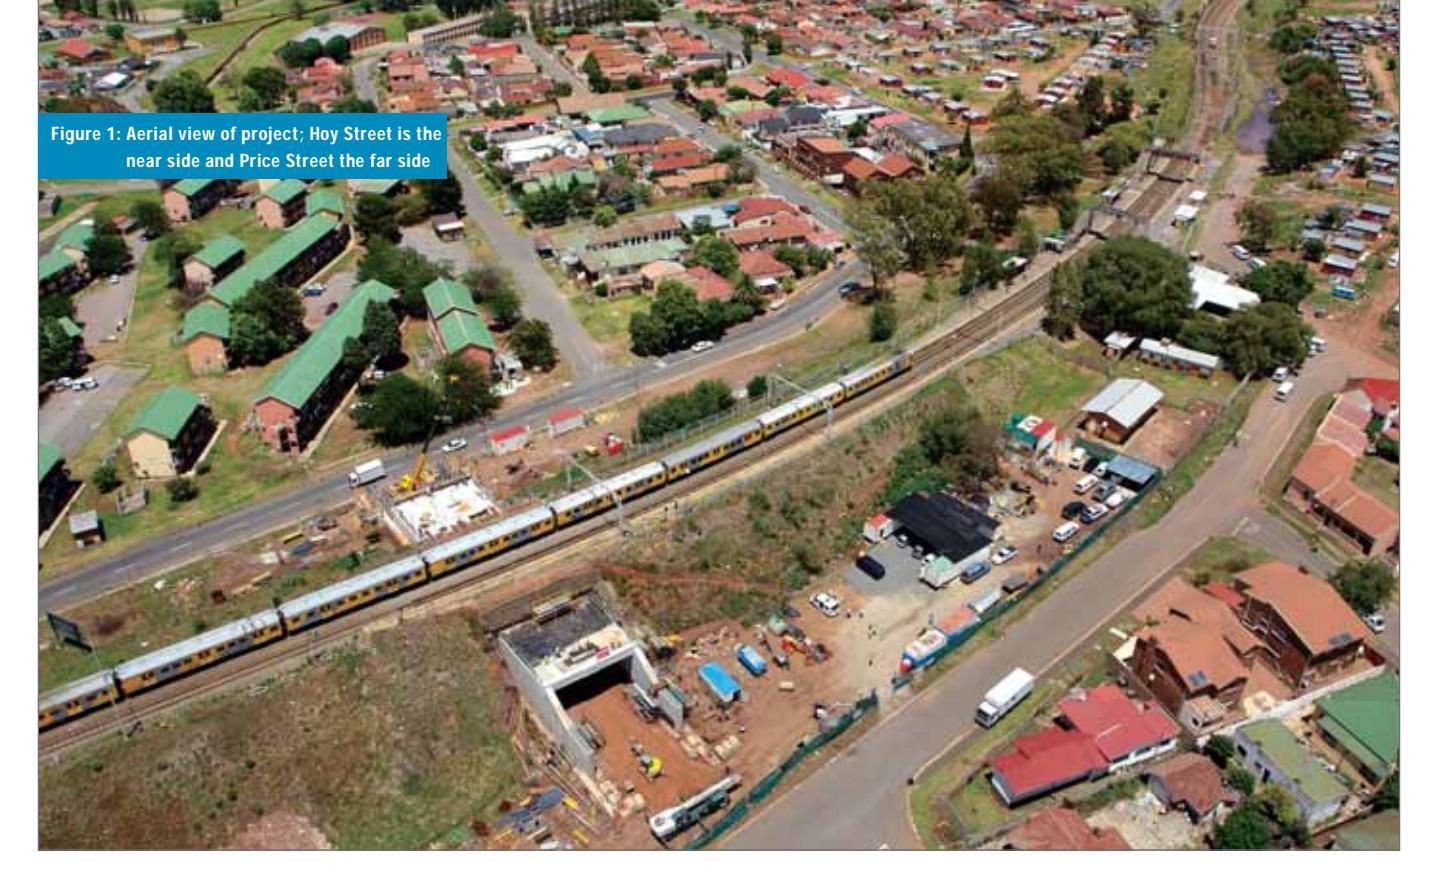
The structure in its final form is an underpass having a total length of 52.5 m. The width is 12.0 m, sufficient for two road lanes of 3.7 m and two sidewalks of 2.3 m. The structure was constructed in two halves – one 28.0 m in length and the other 24.5 m. The difference was necessitated by the 2% site slope and the requirement that the two structures meet on the centre line of the railway. The Price Street side is the longer of the two. Figure 1 shows an aerial view of the project.

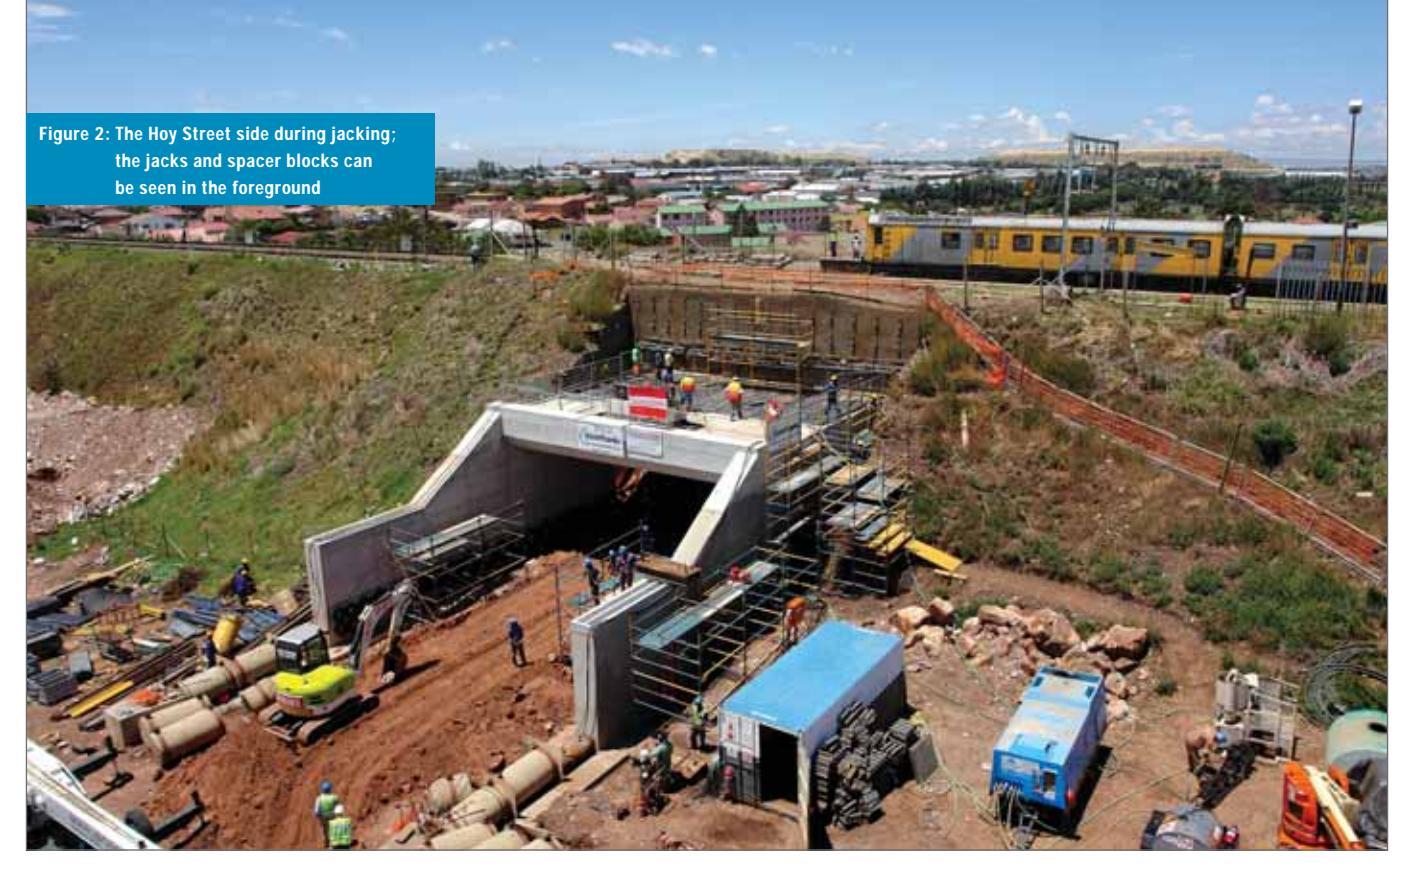
The Price Street side weighed 1 140 tons and required a jacking force in excess of 1 000 tons. The jacking arrangement is best seen in Figure 2. Both walls were jacked simultaneously, often with differing pressures in an effort to maintain the desired directional heading.

anchor the back of the structures. The installation of one set of anchors can be seen in Figure 2.

The last 5.0 m of all four walls were constructed parallel with the sliding surfaces. This can also be seen in Figure 2. The concept was to anchor the back of the structures during the last 5.0 m of jacking by placing rock anchors on either side of all four walls and constructing a steel cross-head over the top of each wall, and anchoring the structure down. Double steel sliding plates were built into the top of each wing wall, as can be seen in the photographs.

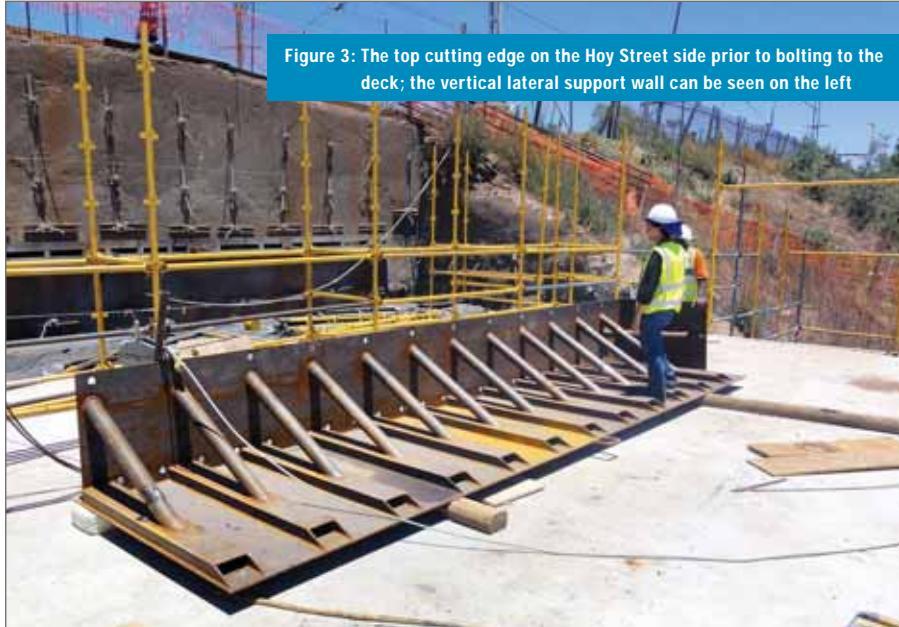
A special requirement of this project was the reported nature of the embankment material. The material was thought to be mine sand from the nearby mines. This necessitated special cutting edges which would keep the excavation beneath the railway lines stable at all times. As it turned out, the embankment material was found to be well compacted fill with a large clay content and rocks up to 500 mm in size. However, the cutting edges were strong enough to support this material and to keep the embankment stable. Figure 3 shows the top cutting edge on the Hoy Street side.

While the soffits for both structures line up, as well as the inside surfaces of the walls, the design required the Hoy Street structure to have a deck of 100 mm thicker than the Price Street structure, and to have walls that are 100 mm thicker as well. This was required to ensure that the Hoy Street deck cutting edges overlapped the Price Street cutting edges as the two structures met in the centre. Figure 3 shows the Hoy Street cutting edge.

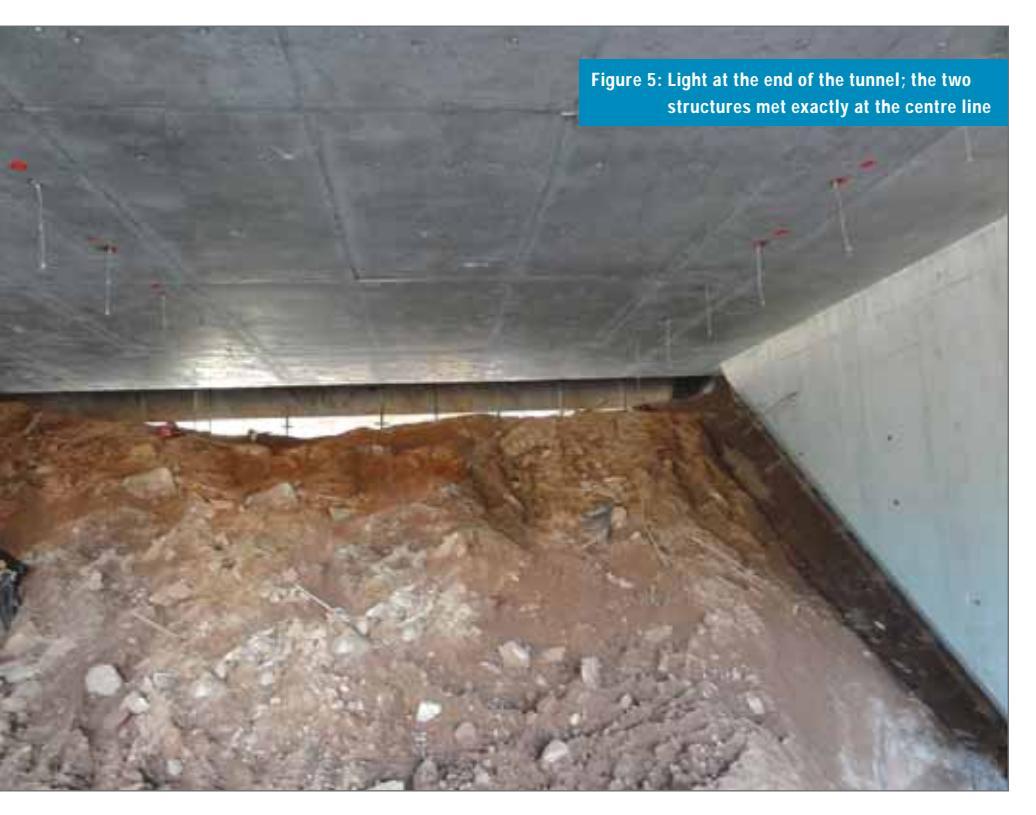
The two structures met exactly as expected on the centre line of the project (see Figure 5). This short-lived relief was, however, totally eclipsed by the unexpected additional volume of quartzite to be blasted and removed for the construction of the triangular in-fill walls – clearly shown in Figure 6. The excavation process for these walls involved working from the top, shotcreting and anchoring the gunited surface to form a stable surface against which the in-fill walls were cast.

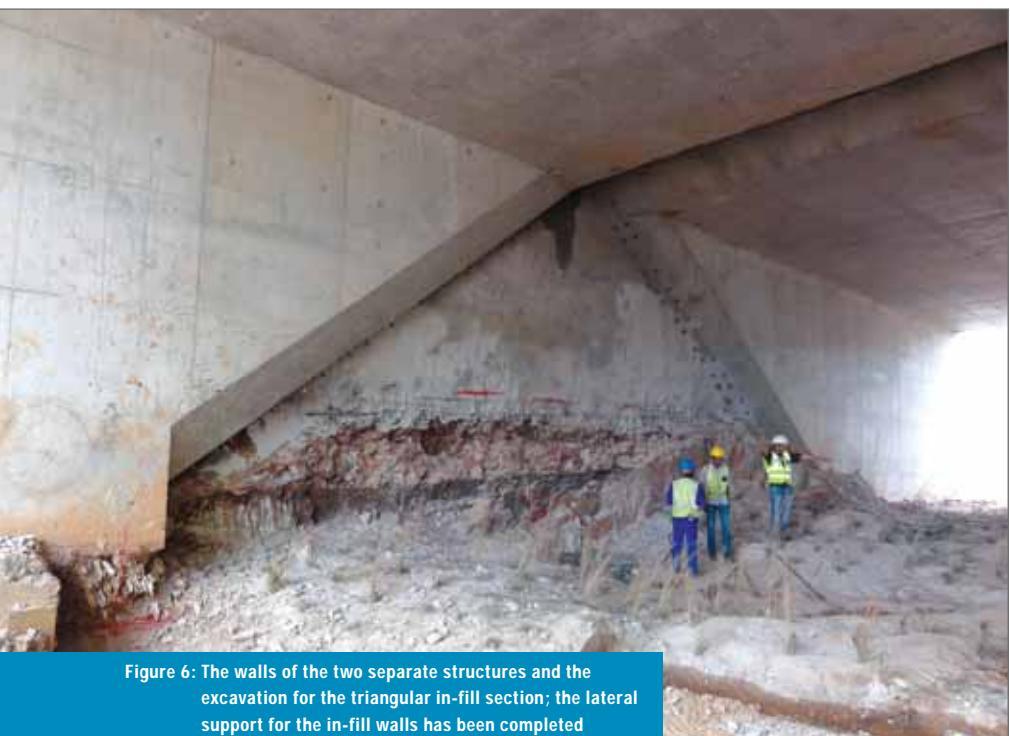
A large volume of very hard quartzite was encountered in the embankment – an unexpected occurrence at a critical time during the construction. This delayed the jacking by close to six months. Drilling and blasting were required to remove the rock, as can be seen in Figure 6.

The side cutting edges were bolted in place using threaded bar cast into the concrete. Once the cutting edges were removed, reinforcing couplers were screwed over the stubs and continuity rebar screwed to the couplers to be part of the wall rebar. The stubs are just visible in Figure 6.

Figure 6 shows an overlap of the sliding structure over the cast foundation of about 1.0 m. Since it was not advisable to construct sliding foundations for the structures once they were moving, an angle of the front cutting edge was chosen as 37 degrees (flatter than the normal 45 degrees), and a 1.0 m overlap over the end of the cast sliding foundation was allowed. This allowed the two structures to meet without having to construct additional sliding surfaces beyond the extent of the lateral support.

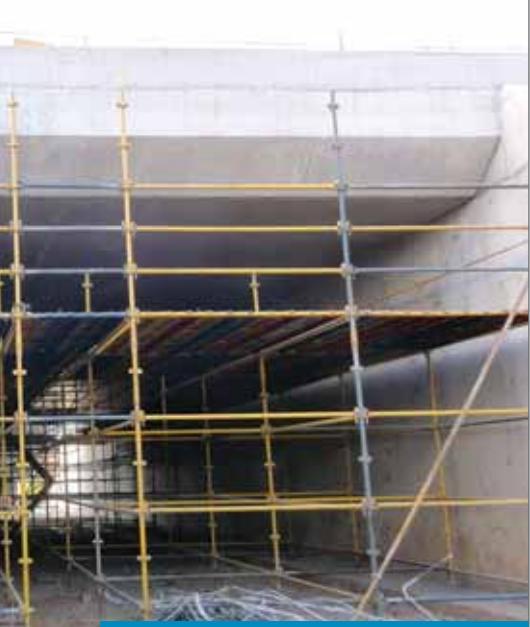
Figure 7: The in-fill walls have been completed and the finishing surface treatment is in progress
