Construction of "Kay Espwa" (House of Hope)

A Prototype Earthbag House in Mizak Haiti, 2010

by Michael Windover

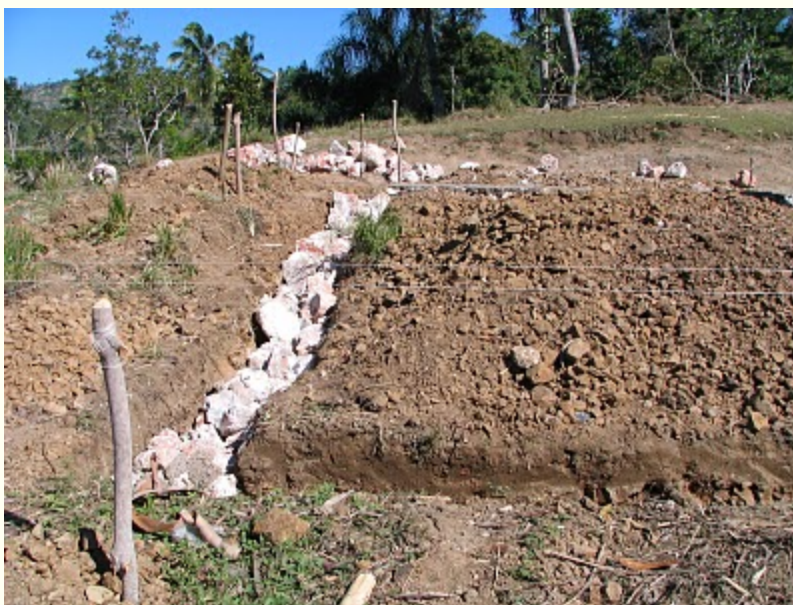
The layout of the house at the site was made based in part on the requirement to leave the old house standing until the new one was done. Also the lack of another level place left little choice. As a result of the slope of the land, the foundation was made higher on one end than the planned 8 inch above grade planned.

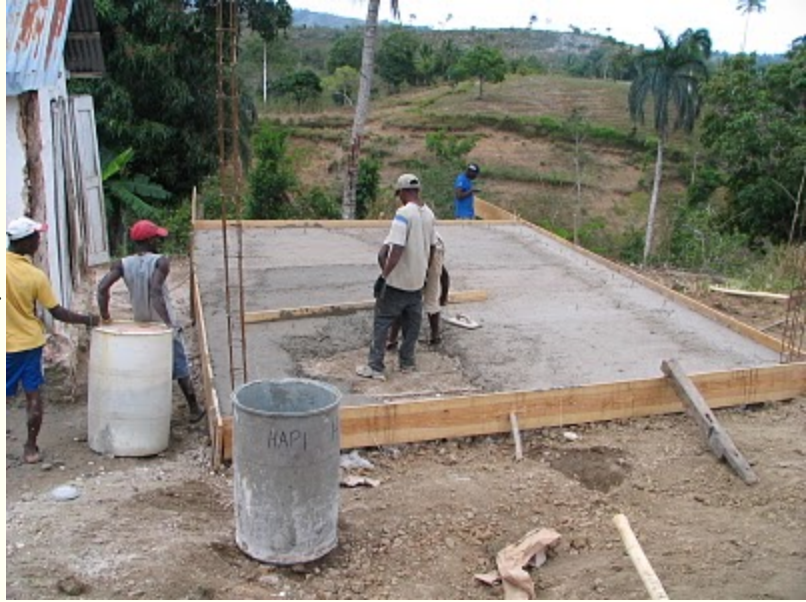
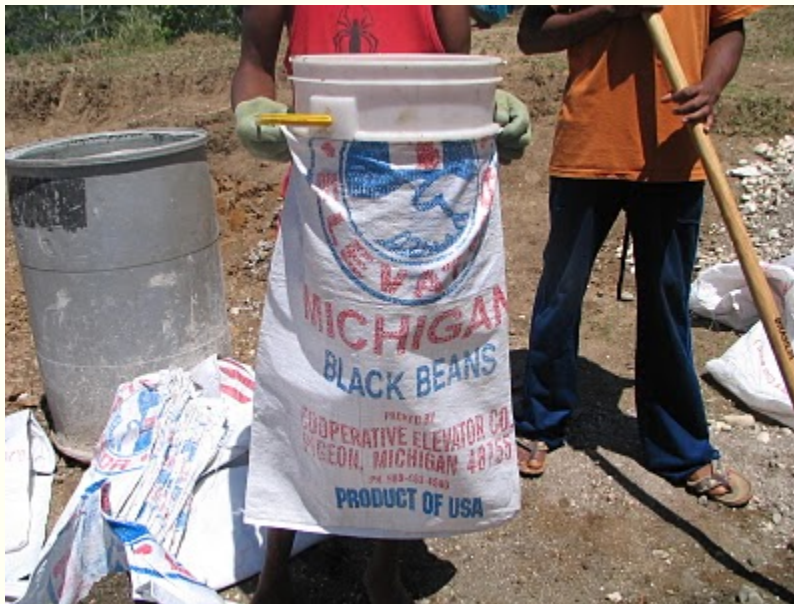
The foundation went in without problems using typical Haitian techniques. The cement slab was done without difficulties. Rerod spikes were placed along the foundation which would stick up into the first layer of bags. I had to insist on putting a grid of rerod in the central areas. The "boss man" wanted only the peripheral rerod.

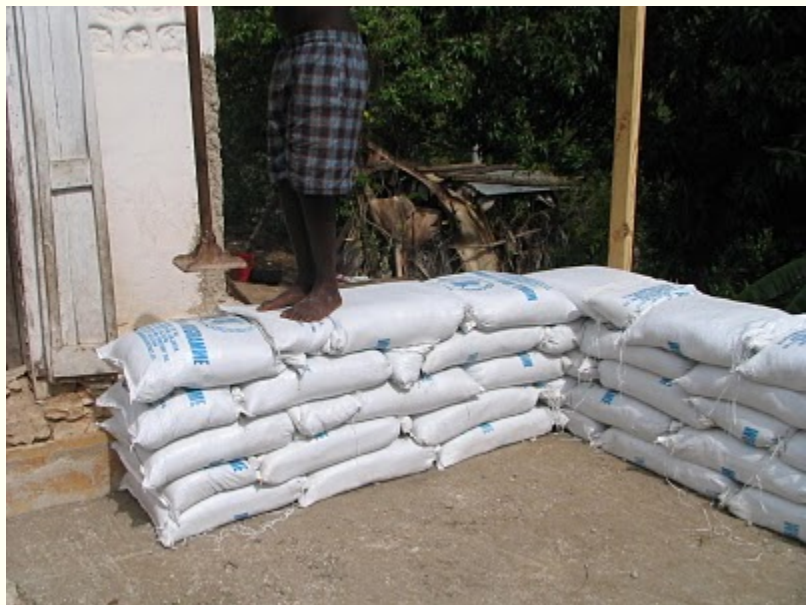
Laying the bags: We didn't use a slide sheet. Moving bags was somewhat problematic due to the barbed wire. Two rows of barbed wire was laid down on each row of bags. Next time I plan to omit the barbed wire. It is hard to deal with even though it seems very effective. Instead I will use rerod to stabilize the bags. At half wall, drive rerod down through the bags to the foundation. Space

them so at least one rod goes through each bag. Mark the top layer of bags at this height with a marker. At full height, drive another set of rods down into the wall pasted the marked row of bags This would be much easier and accomplish just as effective a system to prevent bag shifting. I don't know the relative cost of this procedure, but, the ease and time saved would, I think, make it a good idea. Bags of course should be overlapped to avoid ends over each other. Several instances of doing this wrong missed my attention. When it couldn't be redone, extra rerod was used to stabilize that area. As a result our house has almost a double system of barbed wire and rerod. The first layer or two of bags were laid against a form made of planks. There were not enough planks to do this at every level. As a result visual inspection as the bags were laid down led to less than perfect plumb and straightness of the walls. Next time we will have enough planks to complete the form to lay the bags down better. At the doors and windows bags were stacked alternating full and half bag against the frame. Rerod was used beside the frame to stabilize this weaker

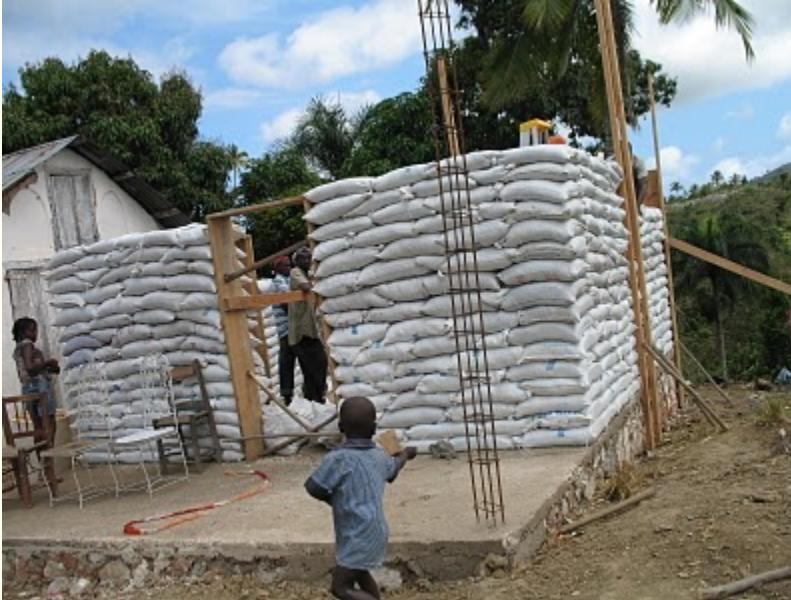
The doors and windows were framed using 12" wide planks. A double layer of framing was used on top of each door and window to support the bags above. The windows were 30" square. Placement of windows seemed high to me, but, it was the norm for Haitian practice. We left a space for the door in the first layer of bags. Our house had a raised floor and sheltered doorway. Some plans might require

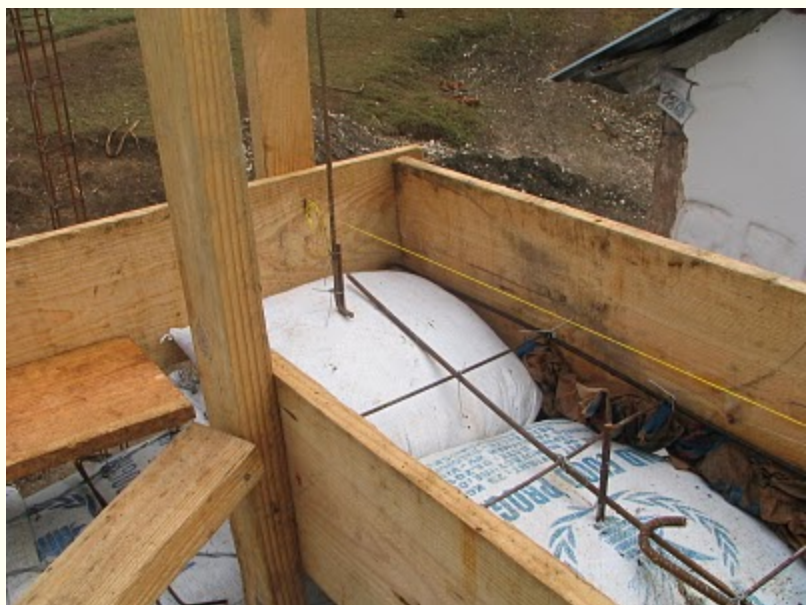
The form for the "bond beam" was made of planks (1x12's). A layer of rerod

using two heavy and one medium rerods was linked with cross bars of small rerod all tied with wire. The rebar will extend from deep in the wall up through the bond beam and wrap over the 2x4's of the rafters.

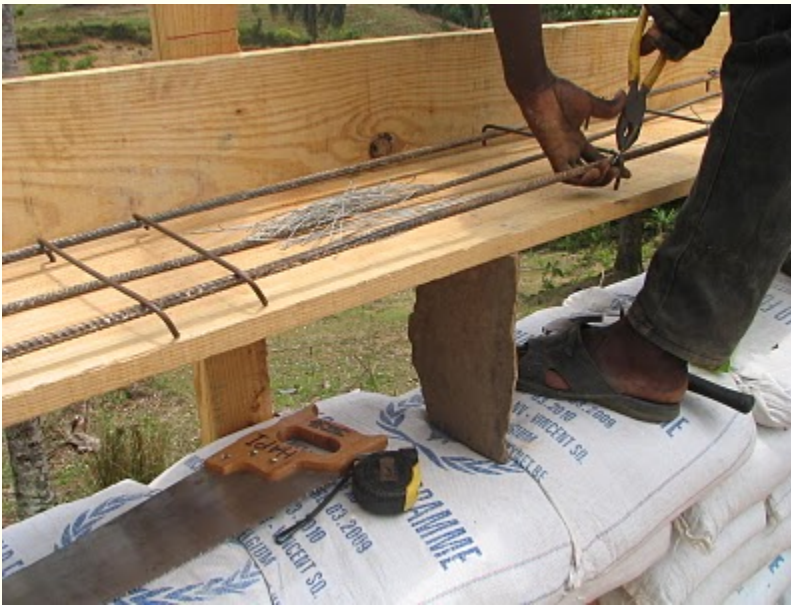
Venting: The plan called for vents within the bag walls on the high and low side. Using the planks on the bottom of the bond beam forms prevented rerod from being driven down into the bags and left sticking up above the cement. Attempts at a work-around were less than desirable. The eventual solution was to insert rerod into the wall, bring it up and over the rafter, back down and into the wall on the

other side. I'm not happy with this. This is where we had a problem with chain of command and communication too. All led to a failure to follow the planned rerod system to tie the wall, beam, and roof system together. Notice the gap under the back beam. This area was to hold vent block for ventilation. The blocks were not on site, so, we proceeded by using a plank at the bottom of the form to hold the cement. This latter led to a disastrous result. We proceeded to erect the walls leaving a place for the block expected later. On the high wall this created a gap about a foot high and almost the full length of the back wall. On the last day, the boss man knocked out the plank under the back bond beam. The bond beam immediately fell in the middle creating an evil grin. This was levered up most of the way and the block area filled with bags and rocks. The vent block never did come. The fall of the back bond beam caused a bow in the back corners. I believe that because of all the extra rerod used that the building will still meet the required stability in an earthquake. The day was saved for venting however.

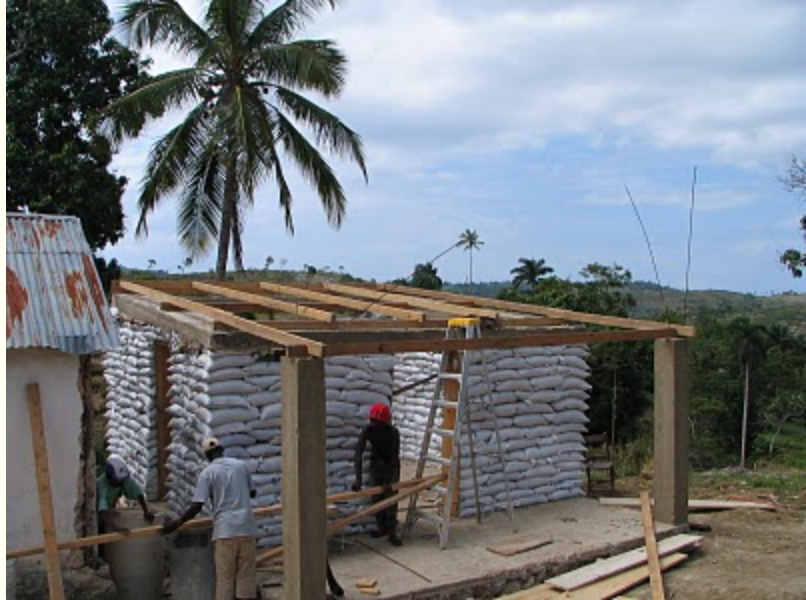
When the roof support system was put down, the purlins extended out over the sides an appropriate distance for the planned overhang. However I turned around at one point just in time to see the boss man sawing off the last of these along the wall line. As a result the roof has no overhang on the sides. Since we left at this point, it is yet to be seen how he will treat the wall/roof juncture.

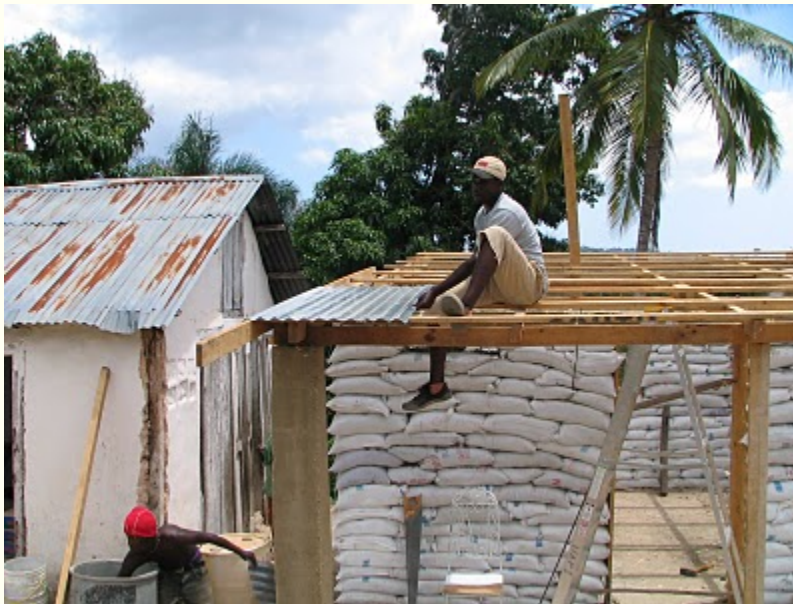
Because of the crooked roof, extra metal had to be patched on the one corner and the metal was bent over on the other corner. The original "square" of 2x4's was not. That is he measured the length of the sides but never the diagonal. This resulted in a parallelogram to which the truly rectangular sheet metal could not be applied without going over on one side and

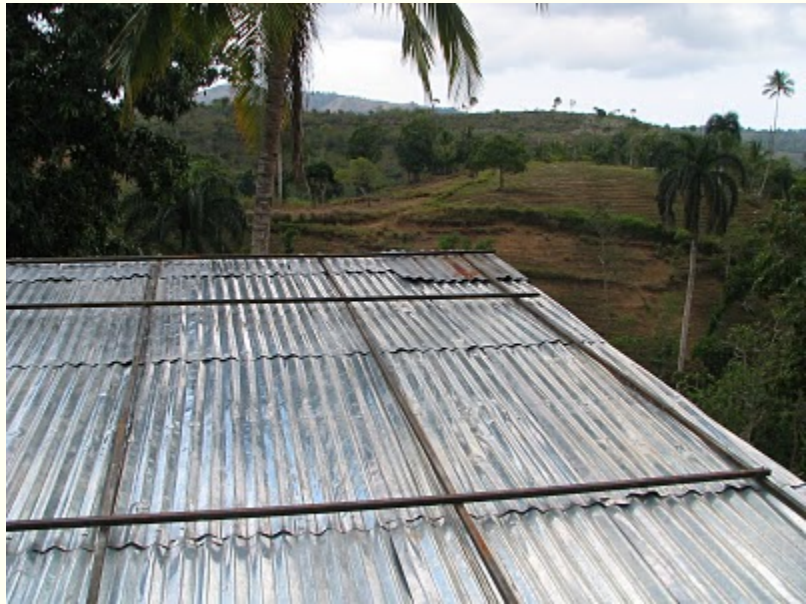
As with so many other things, the welder and equipment never appeared on the horizon. So I put a grid of square steel on the roof using lag screws to tie it to the long axis 2x4's. This too was difficult due to the irregular pattern of the 2x4's below. A fortunate thing was that a good, easy to use generator was available so I could use an electric drill to pre-drill tubing and wood. I first placed tubes on the long

axis. Then I put cross pieces at each end and in the middle. I would have used more cross pieces, but, the only drill bit I brought bent about 1/3 of the way through making it almost impossible to drill the holes.

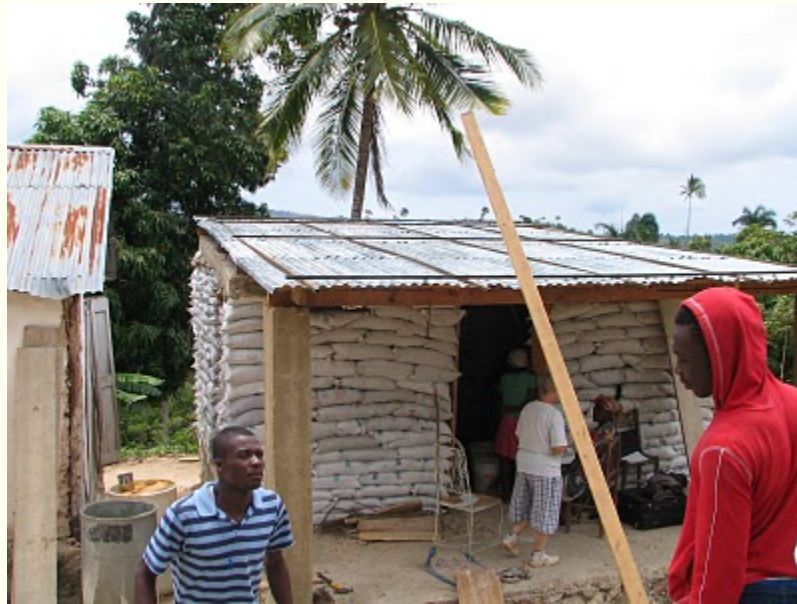
When we left after 3 weeks, the parging or crepitzing (cement coating) was started on the inside. They will finish the parging inside and out. The gutter is yet to be installed along the porch. The last thing I did before leaving was to install a grid of 1" square steel tube on top of the sheet metal. This will prevent the metal from being blown off in high wind. Originally, I was going to weld the grid. The plan was changed due to lack of a welder. It is connected and fastened into the rafters with 5" lag screws. Fortunately, a generator was available to enable me to use an electric drill. The bit bent about 1/3 of the way through the installation however or another cross member would have been added. When walking on the roof, use planks on the roof to avoid denting the very thin sheet metal. Trying to walk over the purlin areas is too difficult. The steel tubes were left extending out about 8 inches to support the gutter. The two water barrels were left for the homeowner to collect water. An artist has been commissioned to paint a bowl of flowers with "Kay Espwa" (house of hope) underneath it on the front wall. This is the name chosen by the home owner. (I liked the idea of naming the house like was done for "The Sun House".
