ALL ABOUT FLOORS

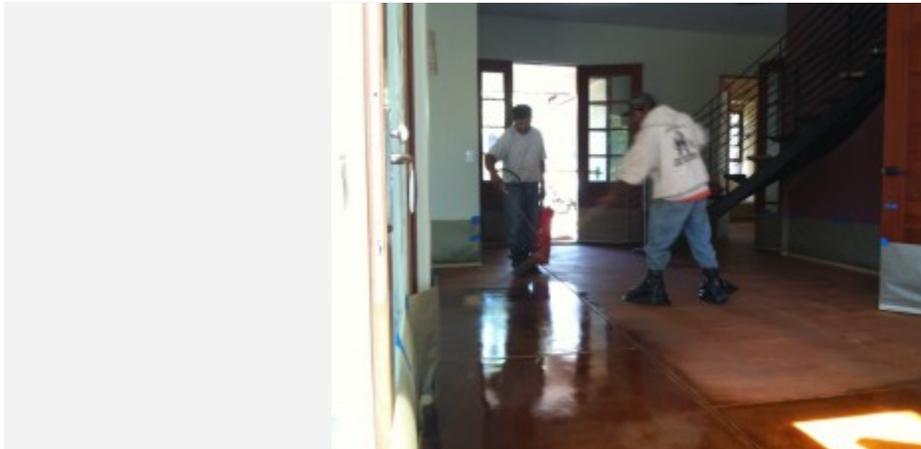
The urethane sealer going on over the acid stain

Acid stain is not a paint or a dye, but rather a difficult to predict chemical reaction between the stain and the concrete, and as Bryan Lucay from Groundworks who did the acid stain said “anything you don’t like about your concrete will be magnified by stain”. Sure enough! The dark spot with the 2×4 is still a bit dark, and the few areas of lumpy trowel marks are now in high relief, and the cracks are nicely outlined in stain, but the overall effect is really nice. It is not the mirror-smooth high gloss effect I had imagined, but Paul pointed out to me, if the floor had been perfectly smooth with a high gloss, we’d have to sweep and mop a lot more than we are ever realistically going to do to keep it from looking grungy... with a lower sheen, it won’t show the dirt quite so much 😊

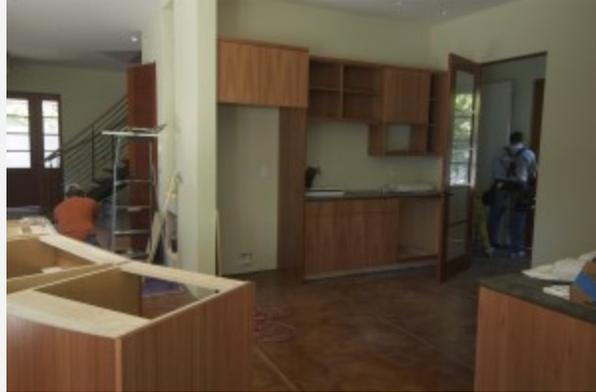
The view into the kitchen showing the mottled floor.

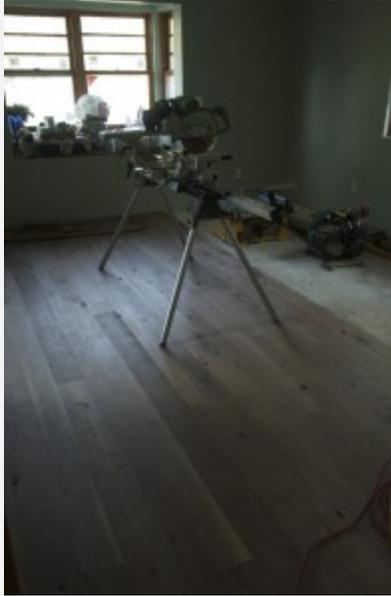
The wood flooring goes in! You can see many of the knot holes, nail holes, cracks, insect damage and other "character marks" that come with reclaimed wood. The walnut will be bleached to a lighter tone

Upstairs, the reclaimed walnut flooring is going in. There was a bit of angst over the flooring too, as our contractors for the floor install, California Wood Floors, checked the moisture of the sub floor and the moisture of the wood that had been acclimating, and said the moisture levels were a bit on the high side, and we should close up the house, but the heat on, and put in a dehumidifier in anticipation of putting the floor in. Well... we don't have any heat upstairs outside of the bathrooms, so there won't be dry hot air from a forced air heating system drying out the floor in the winter. Heat upstairs will flow up the stairwell from the downstairs radiant floor heating and be distributed by the HRV (heat recovery ventilation system), so I called the guys and we discussed our somewhat unconventional heating, and what that would mean for moisture balance in the house, and we agreed that although our moisture levels were a bit high, we were as likely to induce problems like cupping by drying the wood out to an artificial level than we were to prevent problems like gapping – especially since there wouldn't be any forced air heating. So in the end we decided to go forward with the wood as is. The one thing strongly in our favor is that since this wood is salvaged, it is probably something like 100 years old, and it has had plenty of time to finish moving around and adjusting. We're hoping!

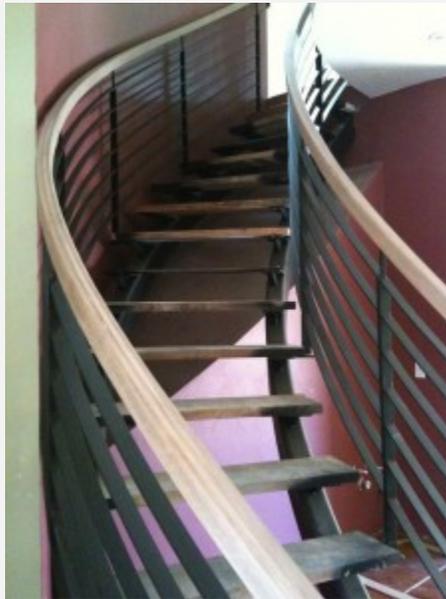
The stair railing is also in now. Glued in place and held with about 150 clamps while gluing, the railing is also walnut to match the floor and the treads
