Virginia sewer experiment data used in

NINETEEN YEARS AGO a 65 m experimental sewer section was commissioned in Virginia, Free State. It comprised three sets of 900 mm diameter concrete pipe, each of which contained nine different types of cementitious materials. In the intervening period valuable information was obtained by monitoring the performance of these materials, and this information has now been combined with the predictive theory, developed in the United States and known as the Life Factor Model (LFM), to produce a sewer design manual. It will be published later this year by the PIPES Division of the Concrete Manufacturers' Association (CMA).

sewer design

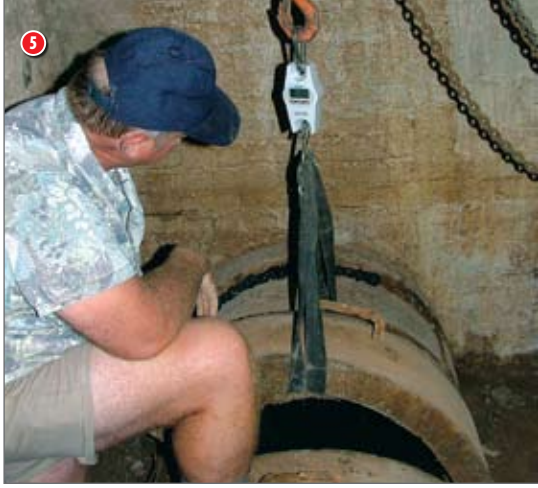
5 Kassie Botha, who is looking after the project on behalf of PIPES cc, removes the lid of a sample pipe before weighing and checking it for corrosion

Based on information available at that time it was assumed that CAC/DOL concrete would corrode ten times slower than PC/SIL concrete. Samples of CAC/DOL plus other materials were placed in the sewer and their masses were checked regularly as a means of predicting their corrosion rates. It should be noted, however, that mass loss is only an indication of corrosion rate and should be used in conjunction with the relative corrosion rates of aggregates and binders. The comparative rates of mass loss tend to be somewhat lower than actual corrosion rates.

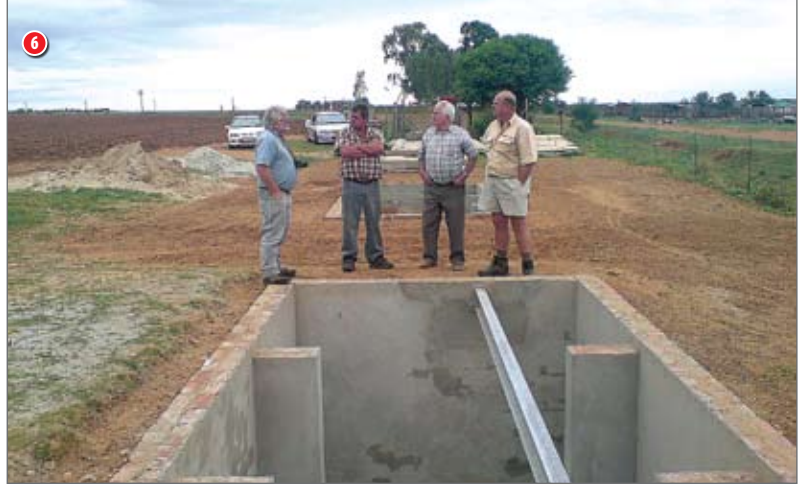
6 The fourth manhole before the top slab was placed into position

The three badly deteriorated pipes plus sections of pipes on either side of them were removed and replaced with manholes. Detailed measurements were then taken to ascertain the relative corrosion rates of the different materials. The measured relative corrosion rates for the unprotected materials, using a value of 1,0

The information obtained to date is limited to a few of the possible materials that could have been used as corrosion control measures and there is still considerable scope for further refinement. With this in mind, new 250 mm long pipe samples have been placed in the manholes that were constructed in the gaps left by the pipes that were removed. Placing these pipe samples in manholes introduces a significant change to the way in which inspections are done as it is no longer necessary to divert the flow through the bypass section. The pipe samples have removable top sections which can be measured and weighed. Such an exercise was done earlier this year and indications are that the corrosion loss will be measurable later this year, three years after the pipes were installed.
